2021 Data Report for

West Maggie Lake, Iron County

Site ID: 360172

West Maggie Lake, Iron County 2021 CLMP Results

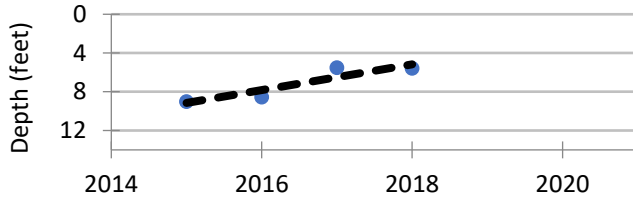
Secchi Disk Transparency (feet)

Year	# Readings	Min	Max	Avg	Std. Dev	Carlson TSI
2018	11	2.0	9.5	5.6	3.4	52
2013-2017	32	2.5	11.0	5.6	1.3	48
2021 All CLMP Lakes	2817	1.0	50.0	12.7	2.9	42

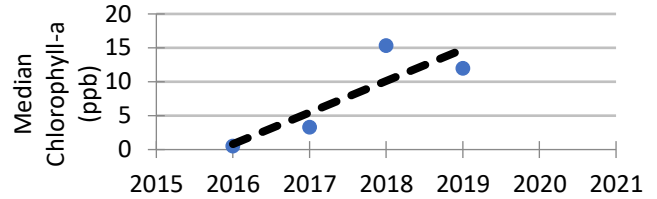
Chlorophyll-a (parts per billion)

Year	# Samples	Min	Max	Med	Std. Dev	Carlson TSI
2019	5	1.3	42.0	12.0	15.4	55
2014-2018	9	<1.0	4.7	1.9	1.8	33
2021 All CLMP Lakes	635	< 1.0	42.0	2.2	3.4	39

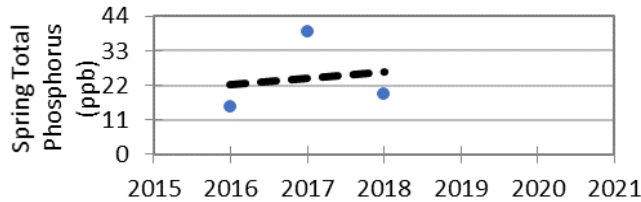
Spring Phosphorus (parts per billion)

Year	# Samples	Min	Max	Avg	Std. Dev	Carlson TSI
2018	1	19.0	19.0	19.0	NA	NA
2013-2017	2	15.0	39.0	27.0	17.0	17.0
2021 All CLMP Lakes	220	<= 3	100.0	14.9	11.0	11.0

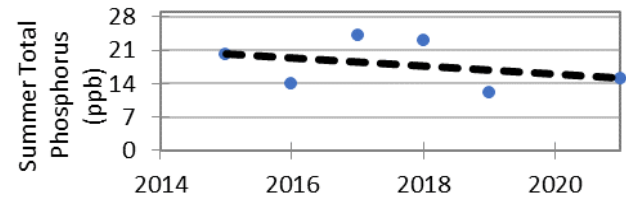
Summer Phosphorus (parts per billion)

Year	# Samples	Min	Max	Avg	Std. Dev	Carlson TSI
2021	1	15.0	15.0	15.0	NA	43
2016-2019	4	12.0	24.0	18.3	6.1	45
2015	1	20.0	20.0	20.0	NA	47
2021 All CLMP Lakes	281	<= 3	65.0	12.8	9.3	38

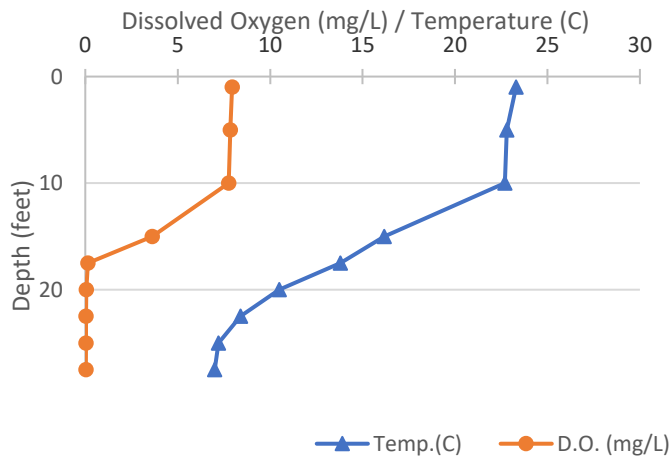
7/16/2016

If you enrolled in Dissolved Oxygen/Temperature, the summary page will have a graph of one of the profiles taken during the late summer (typically August or September). If your lake stratifies, we will use a graph showing the earliest time of stratification, because identifying the timing of this condition and the depth at which it occurs is typically the most important use of dissolved oxygen measurements.

Dissolved Oxygen and Temperature Profile

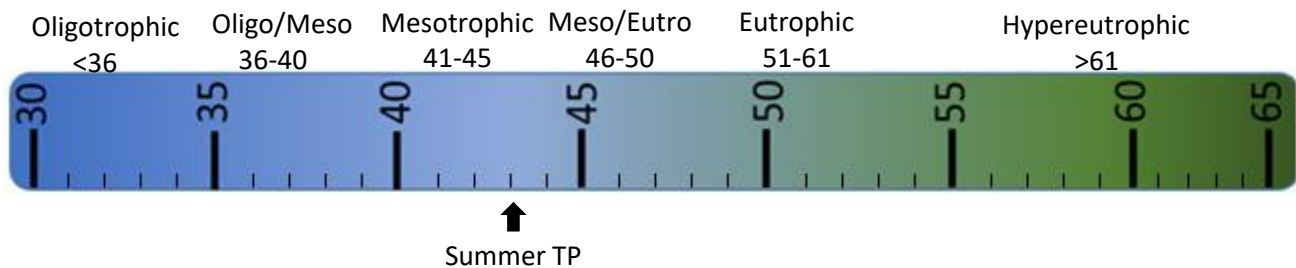
With a TSI score of 43 based on 2021 summer total phosphorus, this lake is rated as a mesotrophic lake.

TSI for West Maggie Lake in 2021	
Average	
Secchi Disk	
Summer TP	43
Chlorophyll-a

In 1977, limnologist Dr. Robert Carlson developed a numerical scale (0-100) where the numbers indicate the level of nutrient enrichment. Using the proper equations, we can convert results from Summer Total Phosphorus, Secchi Depth, and Chlorophyll-a to this Trophic Status Index (TSI). The TSI numbers are furthermore grouped into general categories (oligotrophic, mesotrophic, eutrophic, and hypereutrophic), to quickly give us a way to understand the general nutrient level of any lake.

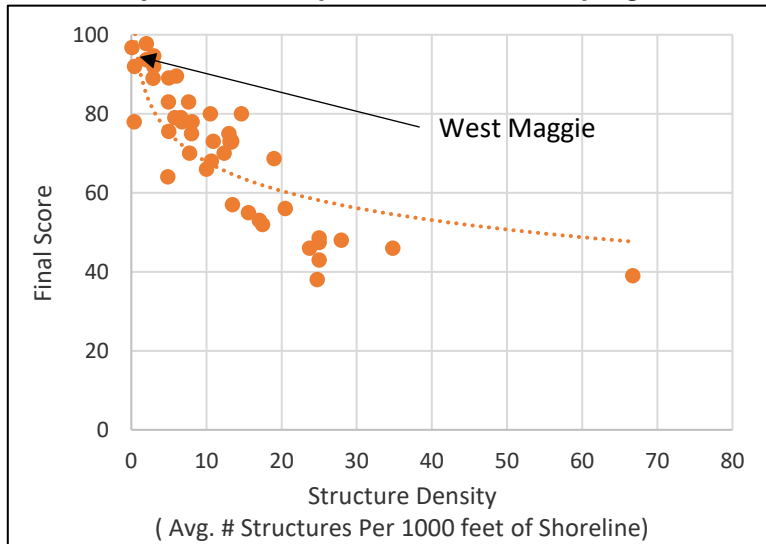
How does your lake compare to others in the program?

West Maggie Lake:	
Number of Sections:	8
Number of Structures:	25
Structure Density:	3.1
Final Score:	95

All 42 Participating Lakes from 2015-2018:	
Avg. Number of Sections:	16.3
Avg. Number of Structures:	248.5
Avg. Structure Density:	15.2
Avg. Final Score:	70.5

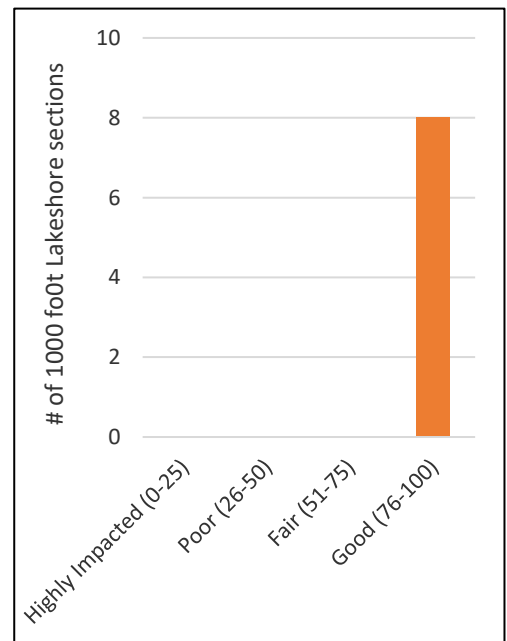
Overall, the lakeshore habitat of West Maggie Lake is doing excellent and scored much higher than average when compared to other lakes in the program. All of the 1000 foot sections scored Good. Several had perfect scores (sections 2,7,8)

While still in good shape overall, the littoral zone was on average the weakest point in West Maggie's Lake habitat (scoring an average of 88). This is a great score, but if looking for ways to improve, this is the component to concentrate on. To improve the littoral zone score, leave woody debris in place and allow native aquatic vegetation to grow in the shallow waters.

The lowest scoring section was number 5, which had a 75 for the littoral score. This section in particular could be a focus for improvement.

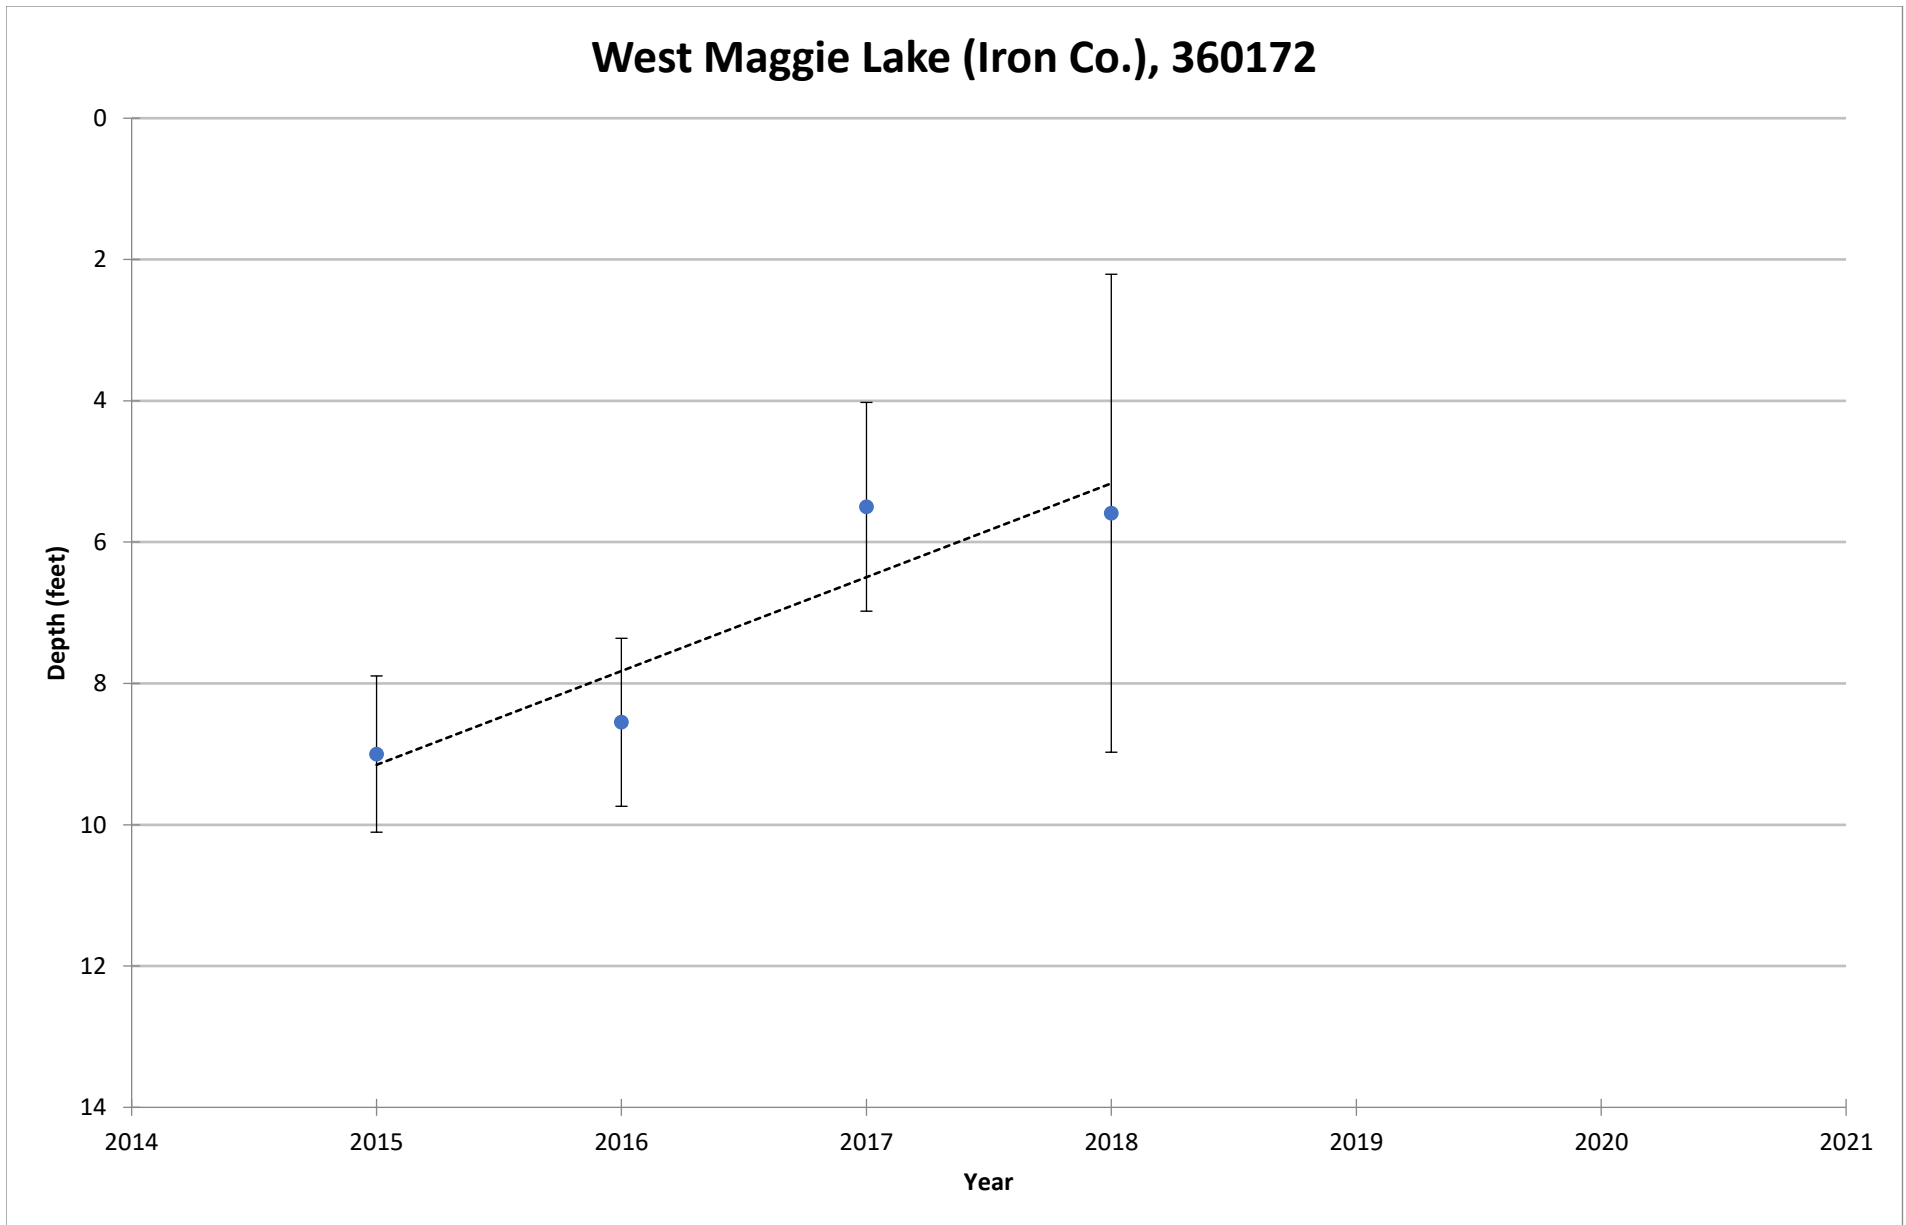
West Maggie Lake (Iron Co.), 360172

COOPERATIVE LAKES MONITORING PROGRAM
SUMMER MEAN TRANSPARENCY

Vertical bars indicate standard deviation

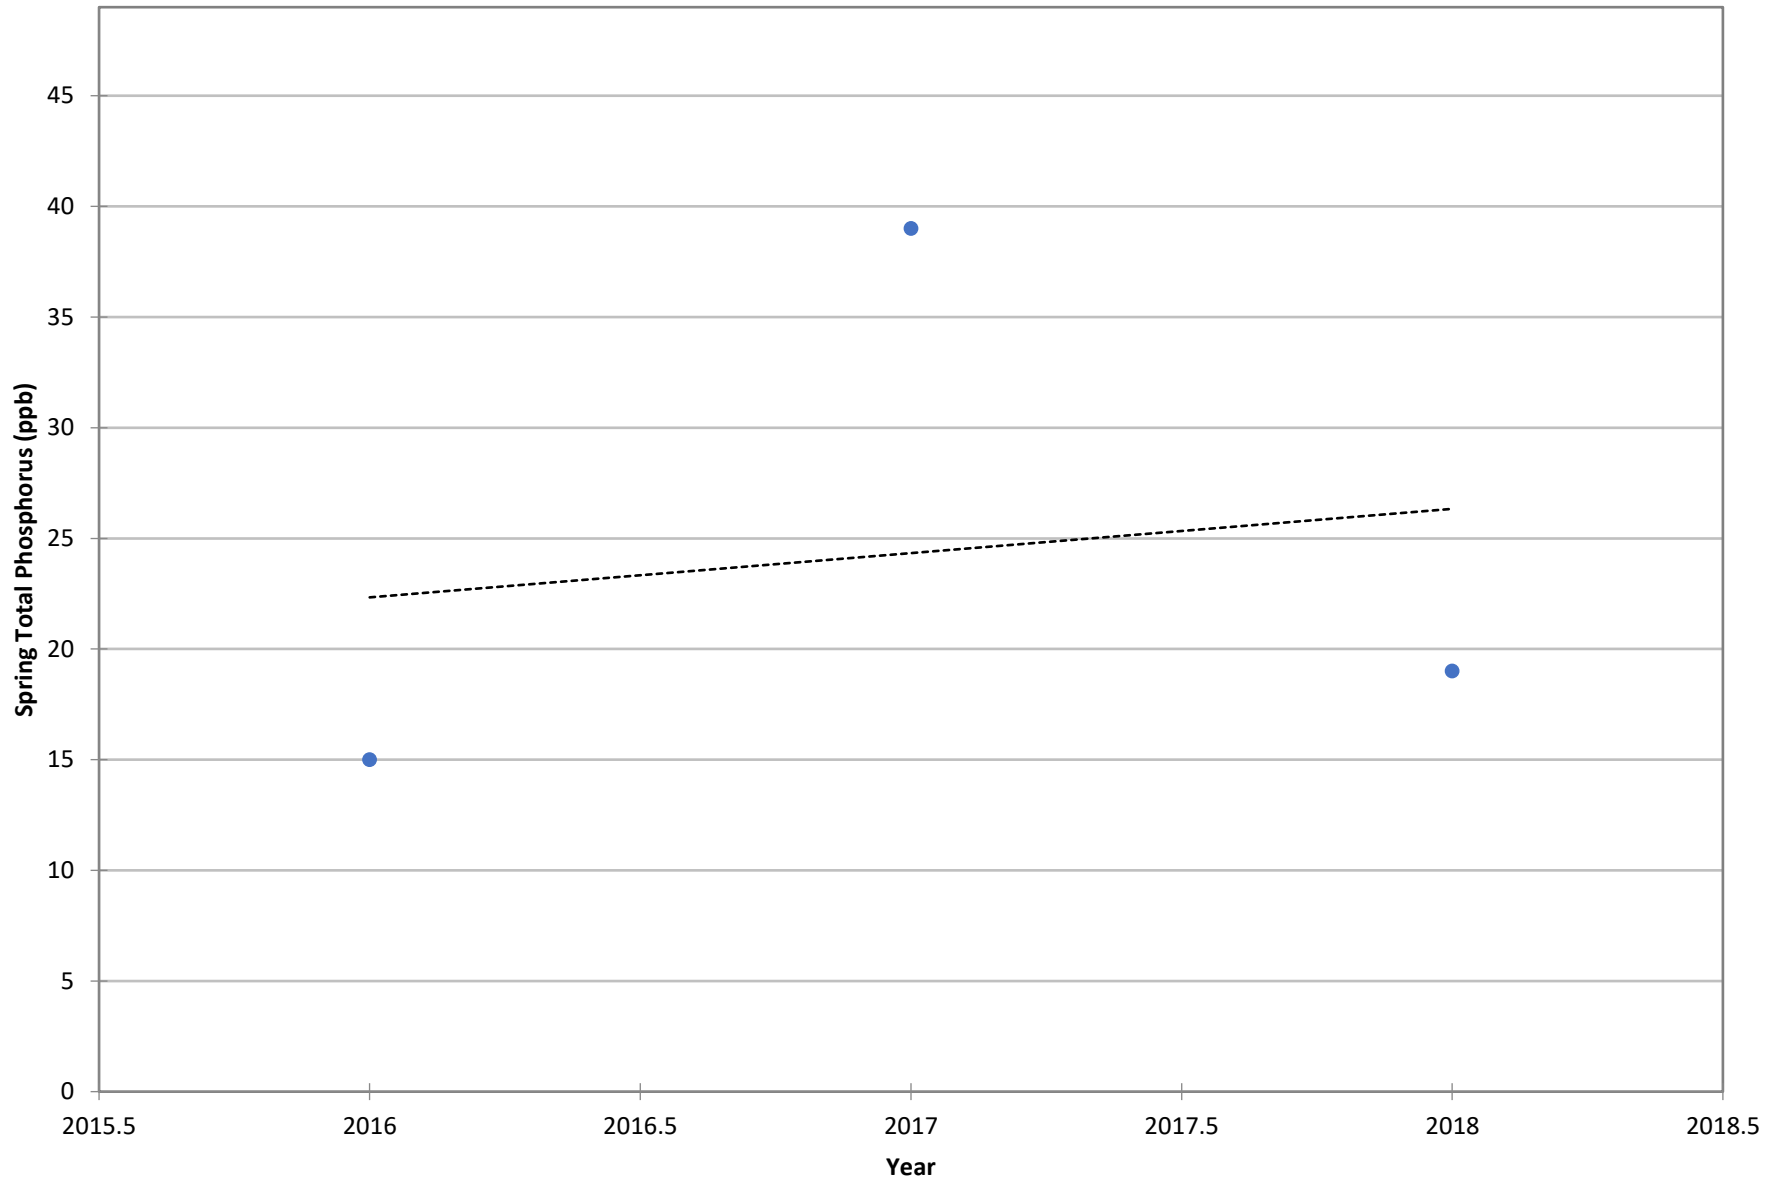
West Maggie Lake (Iron Co.), 360172

COOPERATIVE LAKES MONITORING PROGRAM
SPRING TOTAL PHOSPHORUS

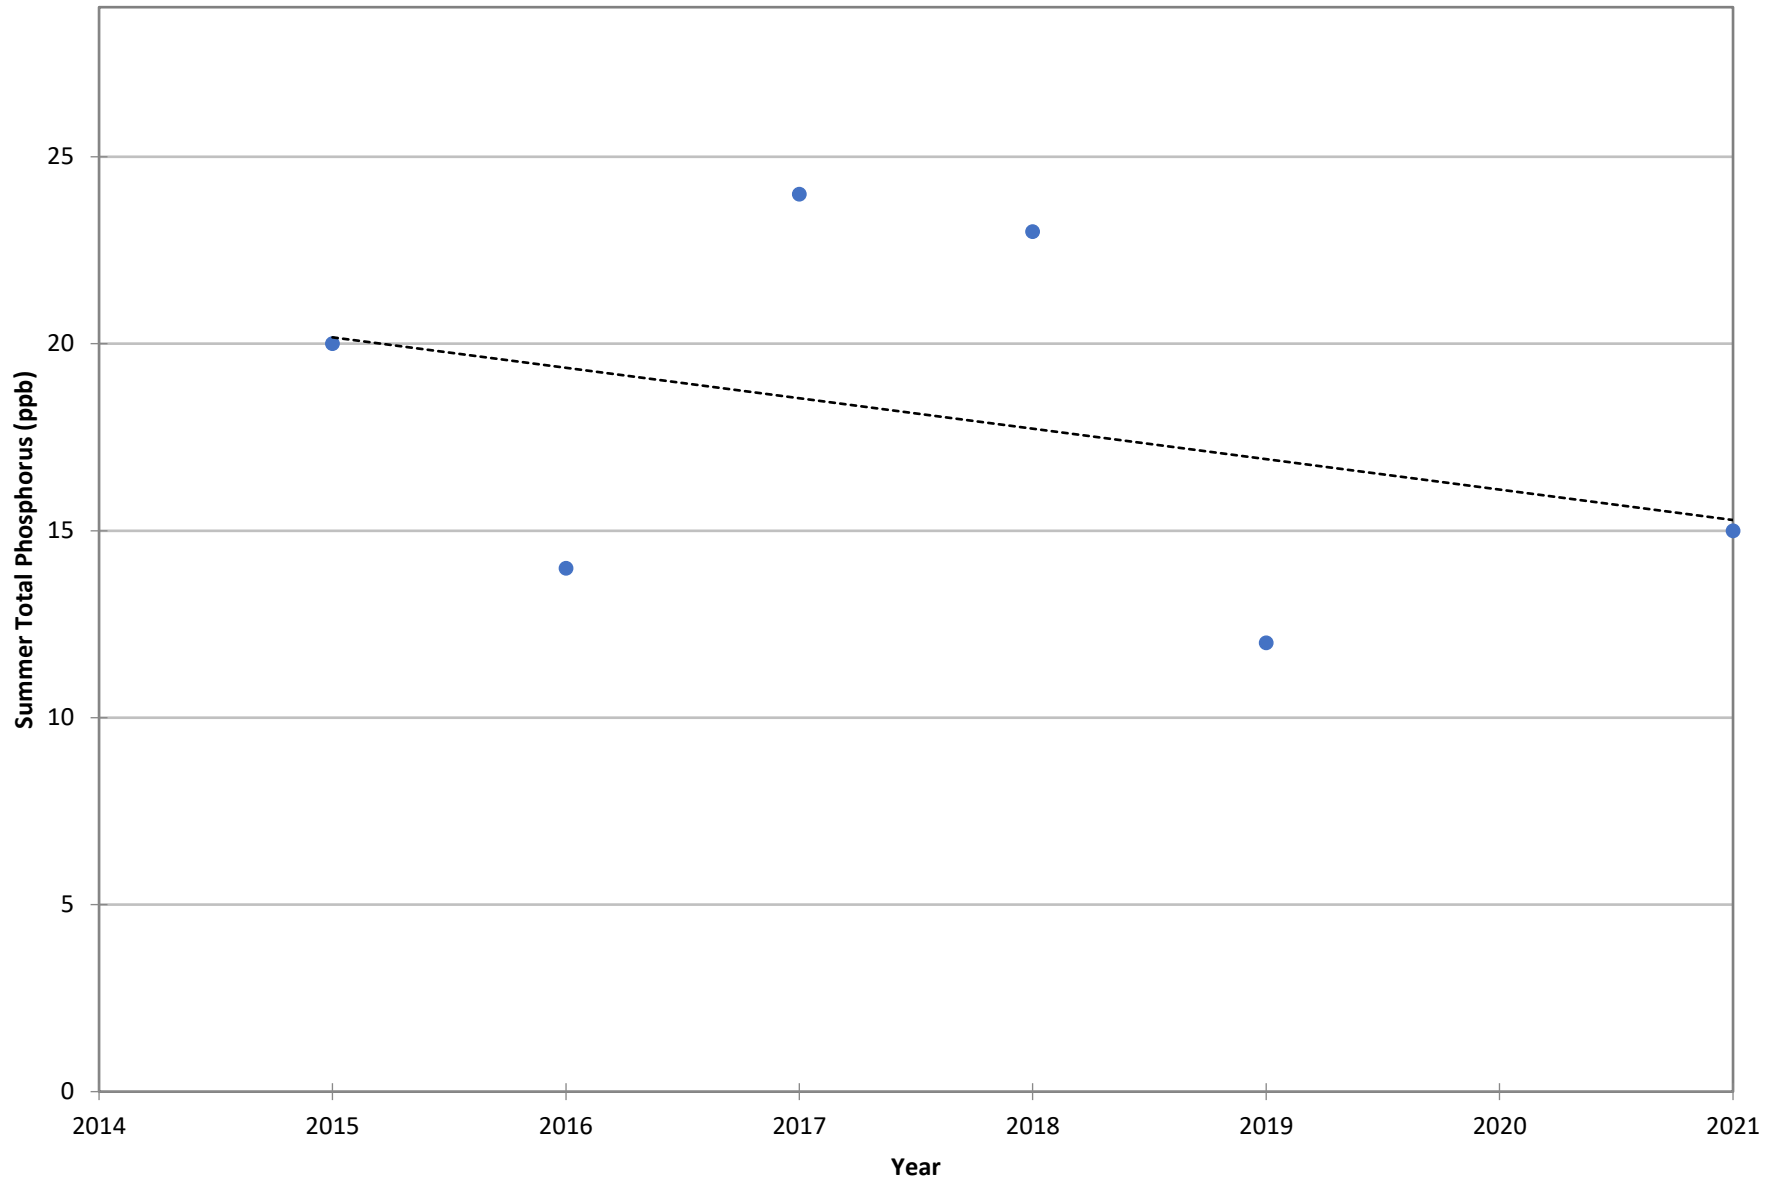
West Maggie Lake (Iron Co.), 360172

COOPERATIVE LAKES MONITORING PROGRAM
SUMMER TOTAL PHOSPHORUS

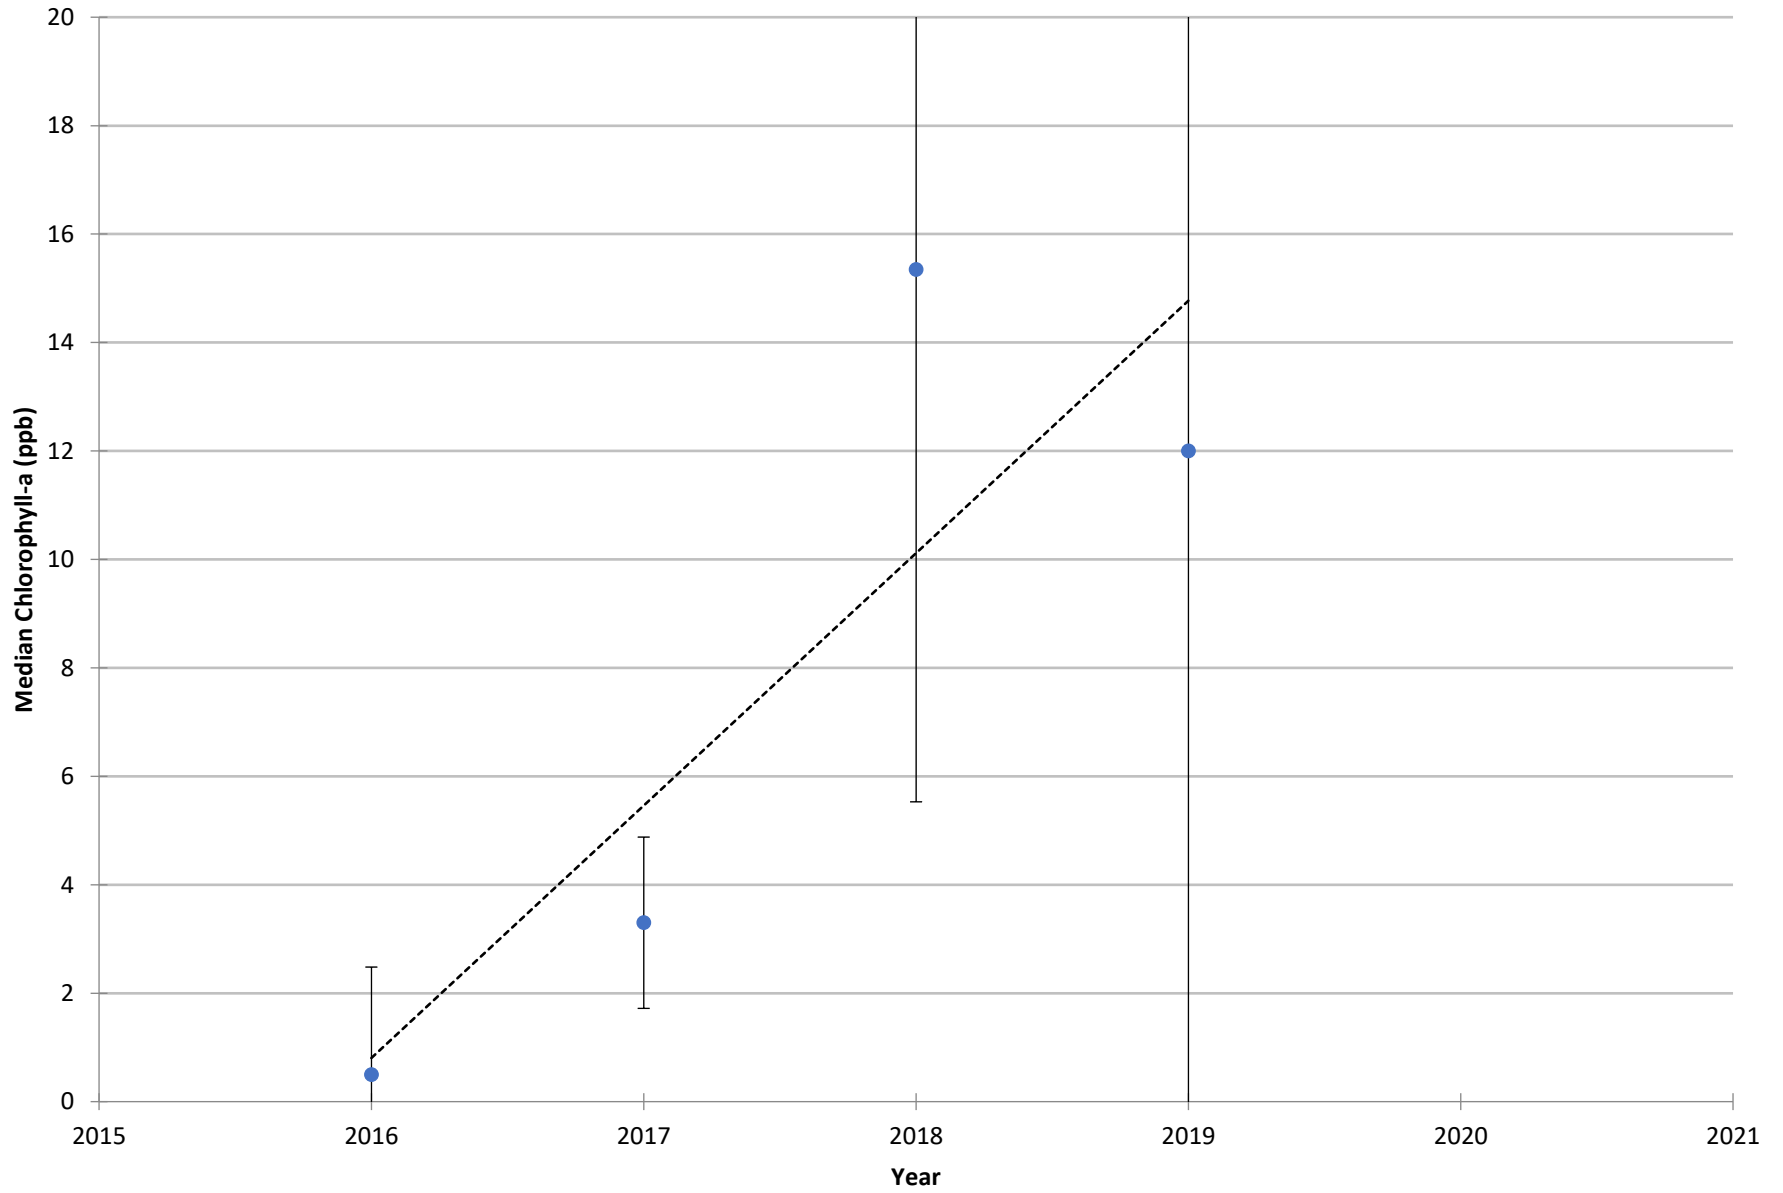
West Maggie Lake (Iron Co.), 360172

COOPERATIVE LAKES MONITORING PROGRAM
SUMMER MEDIAN CHLOROPHYLL-A

Vertical bars indicate standard deviation

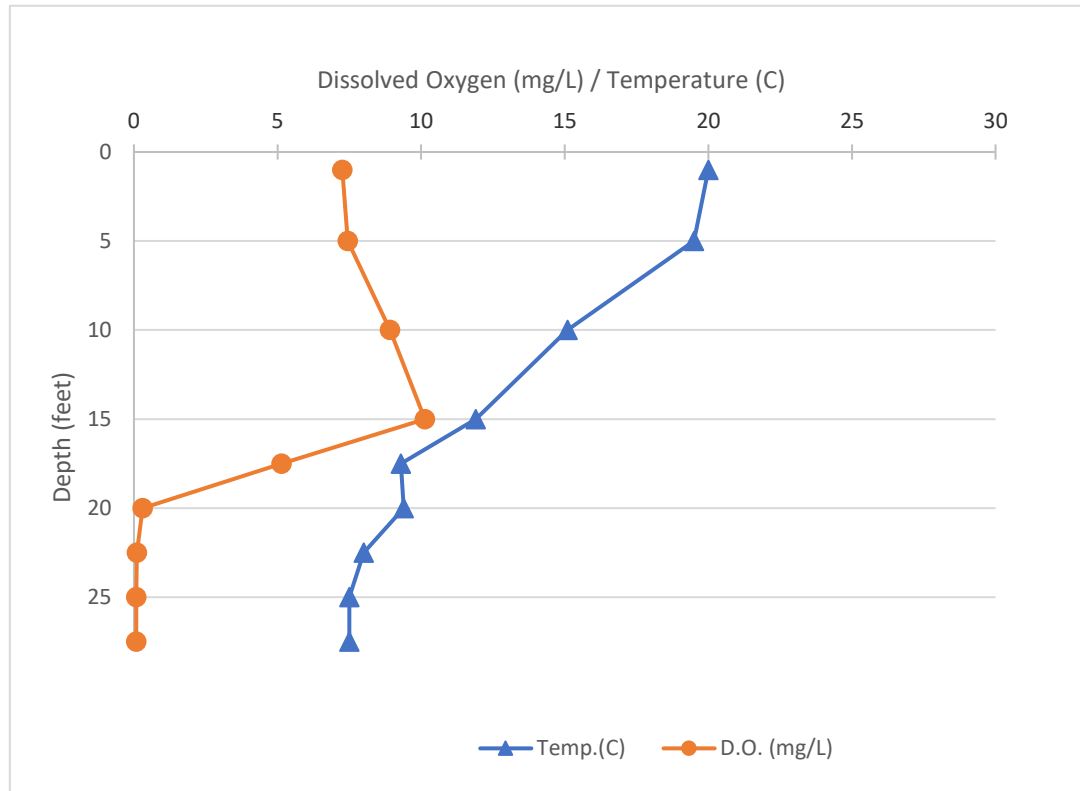
5/26/2016

Dissolved Oxygen and Temperature Profile

Depth (ft)	Temp.(C)	D.O. (mg/L)
1	20	7.26
5	19.5	7.45
10	15.1	8.92
15	11.9	10.13
17.5	9.3	5.14
20	9.4	0.3
22.5	8	0.1
25	7.5	0.08
27.5	7.5	0.08

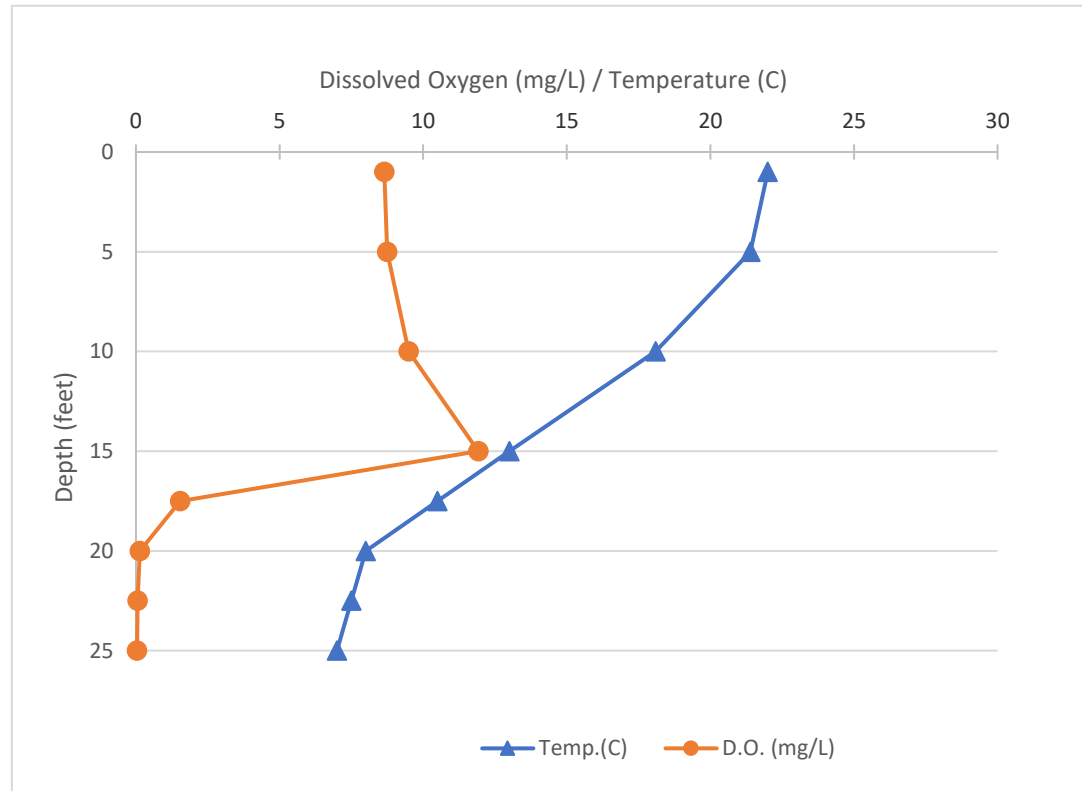
6/12/2016

Dissolved Oxygen and Temperature Profile

Depth (ft)	Temp.(C)	D.O. (mg/L)
1	22	8.65
5	21.4	8.75
10	18.1	9.5
15	13	11.92
17.5	10.5	1.54
20	8	0.14
22.5	7.5	0.06
25	7	0.04

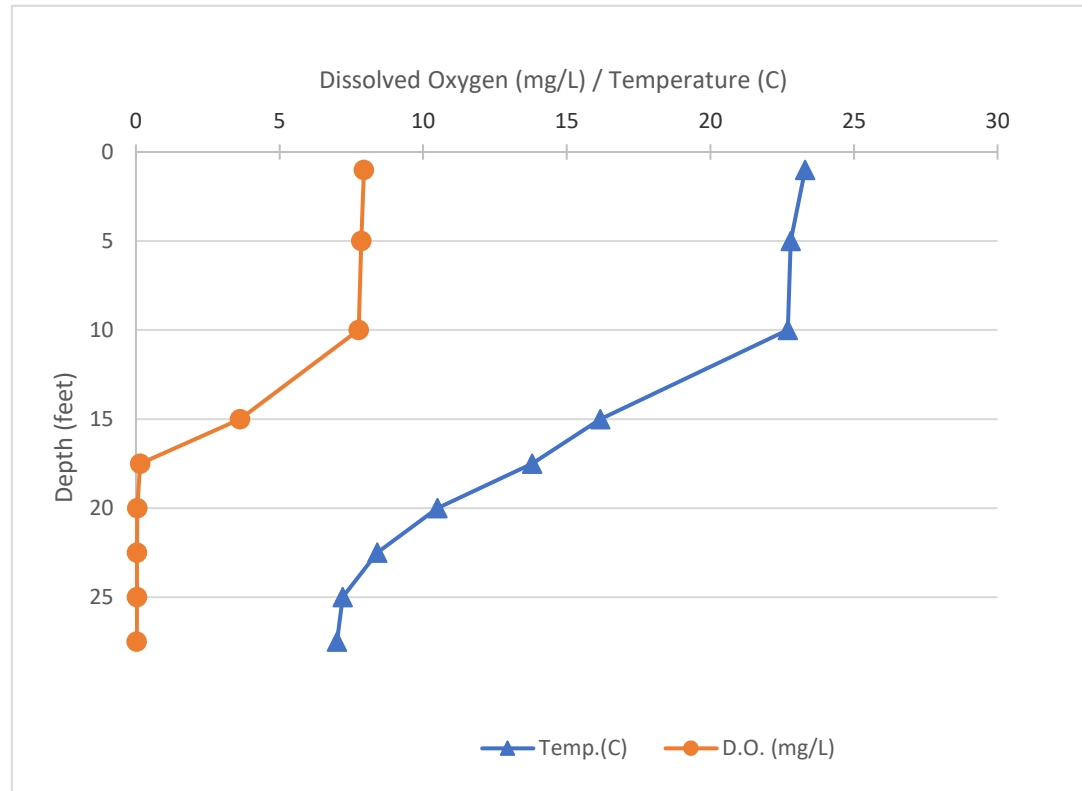
7/16/2016

Dissolved Oxygen and Temperature Profile

Depth (ft)	Temp.(C)	D.O. (mg/L)
1	23.3	7.94
5	22.8	7.85
10	22.7	7.76
15	16.17	3.62
17.5	13.8	0.15
20	10.5	0.05
22.5	8.4	0.04
25	7.2	0.04
27.5	7	0.03

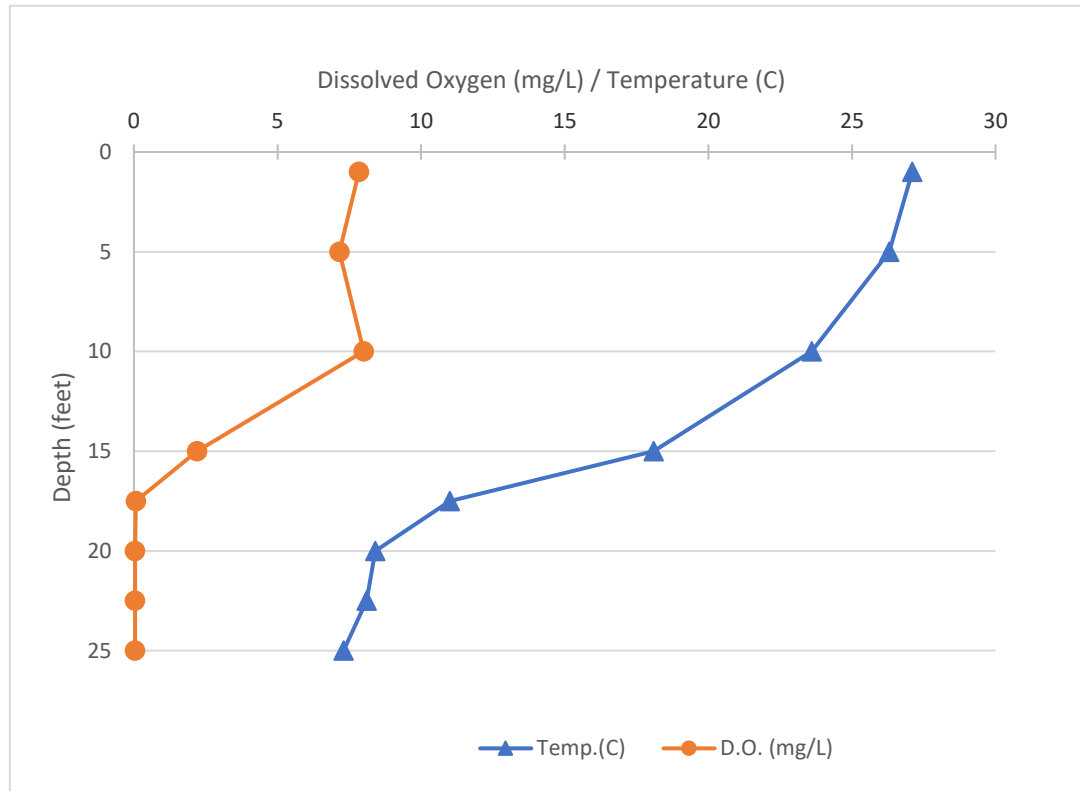
7/23/2016

Dissolved Oxygen and Temperature Profile

Depth (ft)	Temp.(C)	D.O. (mg/L)
1	27.1	7.83
5	26.3	7.15
10	23.6	8
15	18.1	2.2
17.5	11	0.07
20	8.4	0.04
22.5	8.1	0.04
25	7.3	0.04

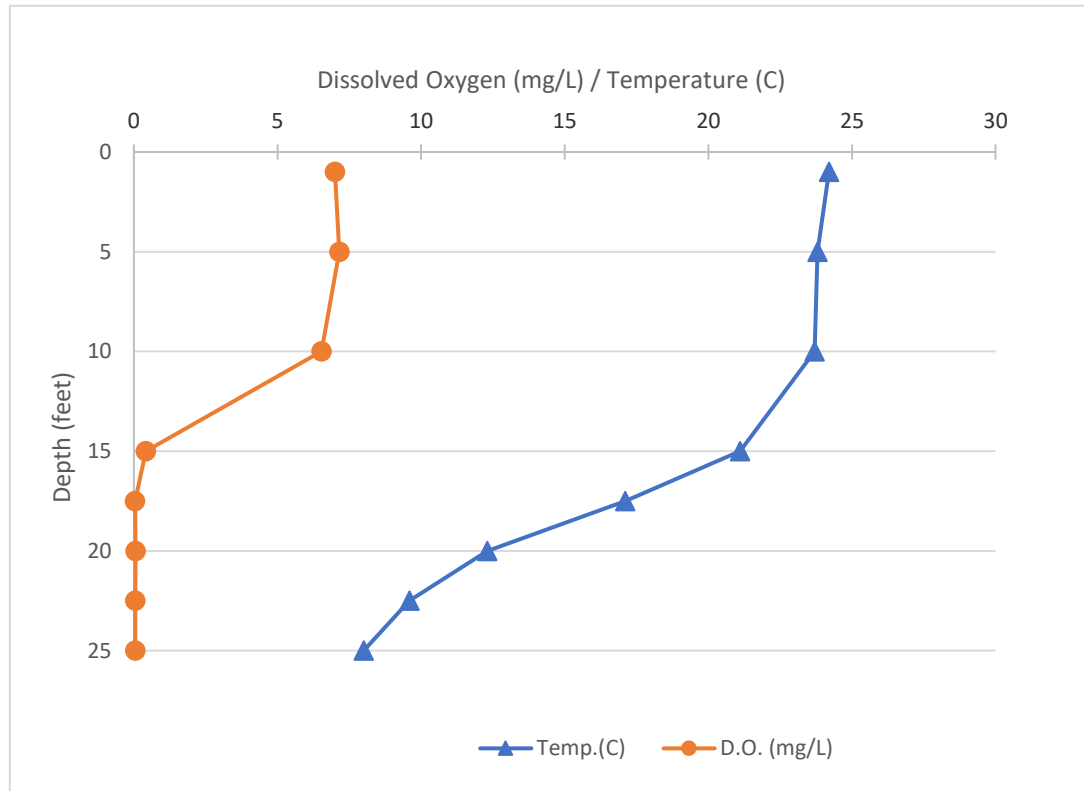
8/14/2016

Dissolved Oxygen and Temperature Profile

Depth (ft)	Temp.(C)	D.O. (mg/L)
1	24.2	7
5	23.8	7.15
10	23.7	6.53
15	21.1	0.42
17.5	17.1	0.04
20	12.3	0.06
22.5	9.6	0.05
25	8	0.05

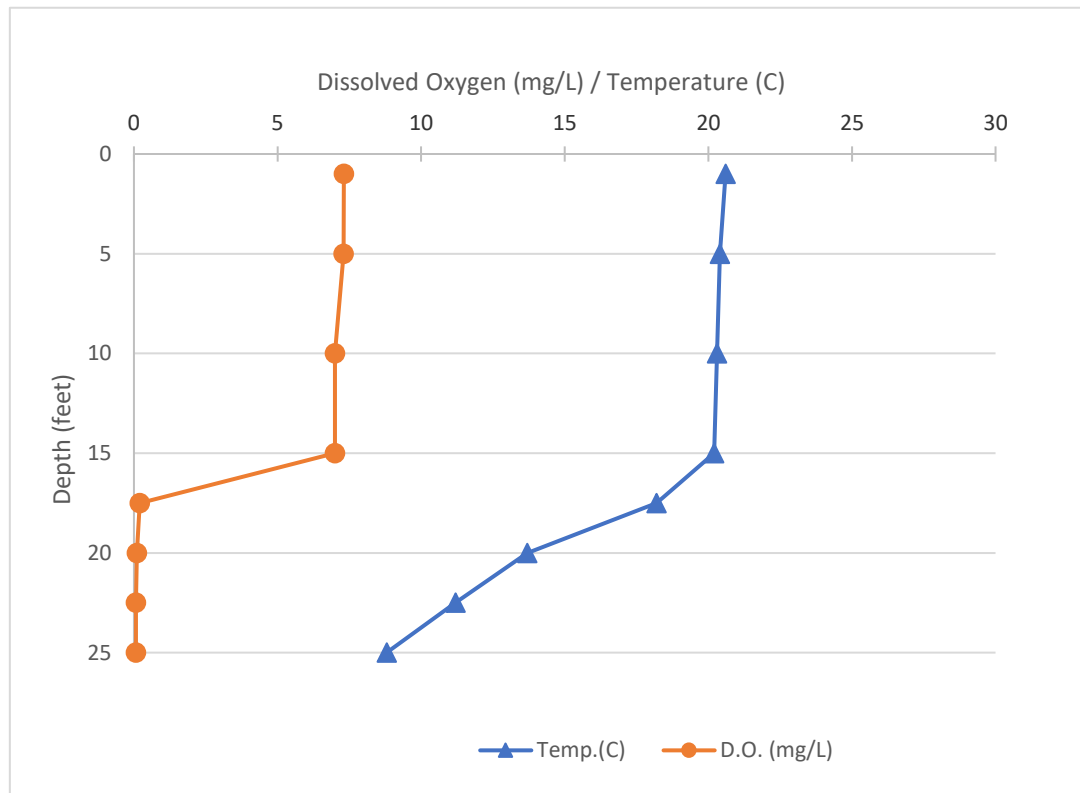
9/11/2016

Dissolved Oxygen and Temperature Profile

Depth (ft)	Temp.(C)	D.O. (mg/L)
1	20.6	7.31
5	20.4	7.3
10	20.3	7
15	20.2	7
17.5	18.2	0.2
20	13.7	0.1
22.5	11.2	0.07
25	8.8	0.07
