# 2021 Data Report for

# Pentwater Lake, Oceana County

Site ID: 640089

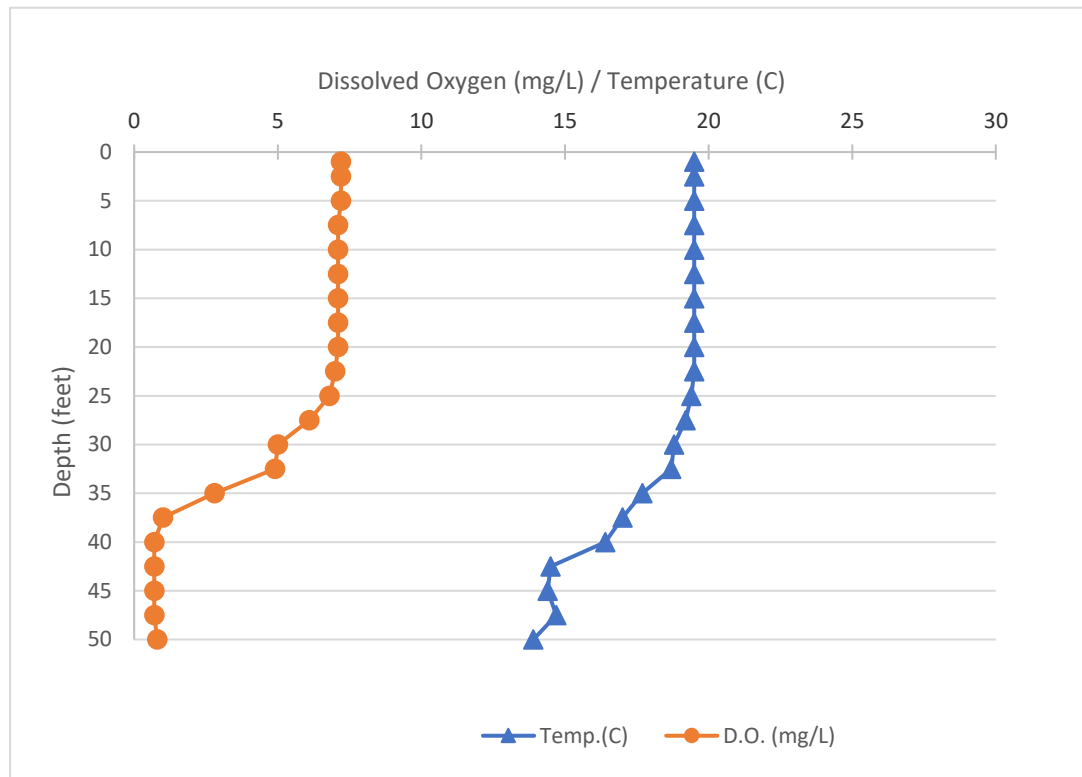
9/7/2010

Depth (ft)	Temp.(C)	D.O. (mg/L)
1	19.5	7.2
2.5	19.5	7.2
5	19.5	7.2
7.5	19.5	7.1
10	19.5	7.1
12.5	19.5	7.1
15	19.5	7.1
17.5	19.5	7.1
20	19.5	7.1
22.5	19.5	7
25	19.4	6.8
27.5	19.2	6.1
30	18.8	5
32.5	18.7	4.9
35	17.7	2.8
37.5	17	1
40	16.4	0.7
42.5	14.5	0.7
45	14.4	0.7
47.5	14.7	0.7
50	13.9	0.8
