# 2021 Data Report for Portage Lake, St. Joseph County

Site ID: 750245

# Portage Lake, St. Joseph County 2021 CLMP Results

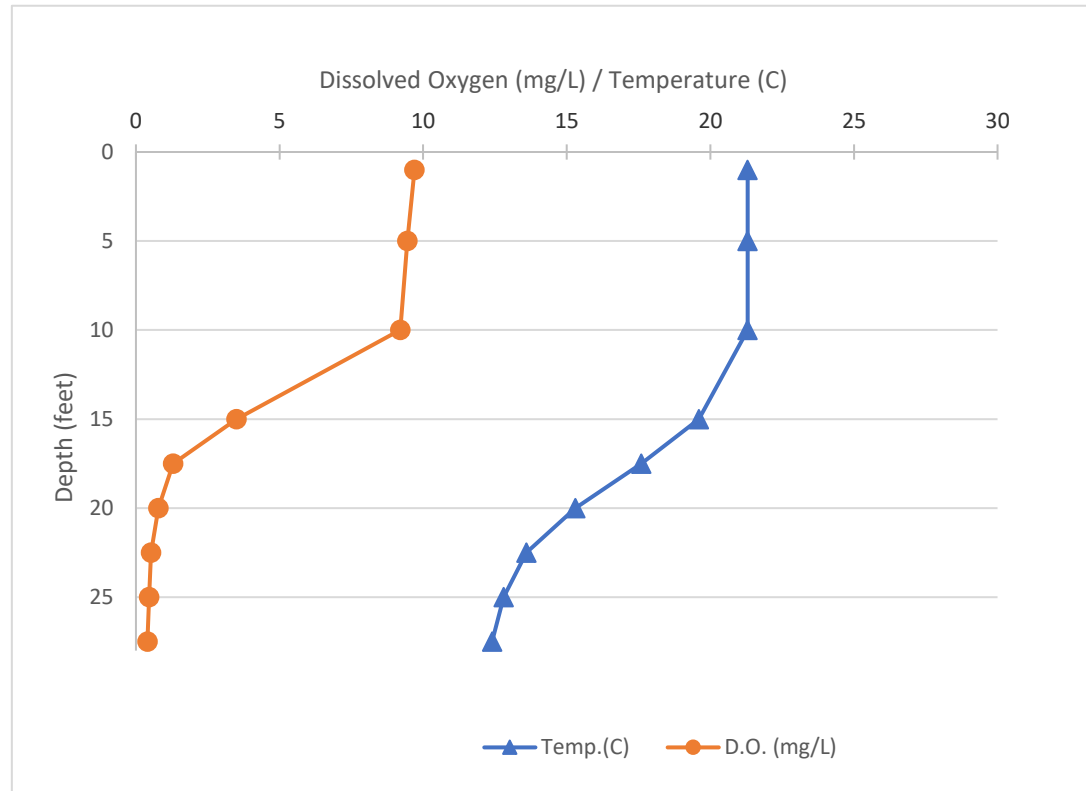
Name: Portage Lake  
County: St. Joseph  
Site ID: 750245  
Date: 9/6/2019

Depth (ft)	Temp.(C)	D.O. (mg/L)
1	21.3	9.7
5	21.3	9.45
10	21.3	9.2
15	19.6	3.5
17.5	17.6	1.3
20	15.3	0.78
22.5	13.6	0.53
25	12.8	0.46
27.5	12.4	0.4
