2021 Data Report for Rose Lake, Osceola County

Site ID: 670058

Rose Lake, Osceola County 2021 CLMP Results

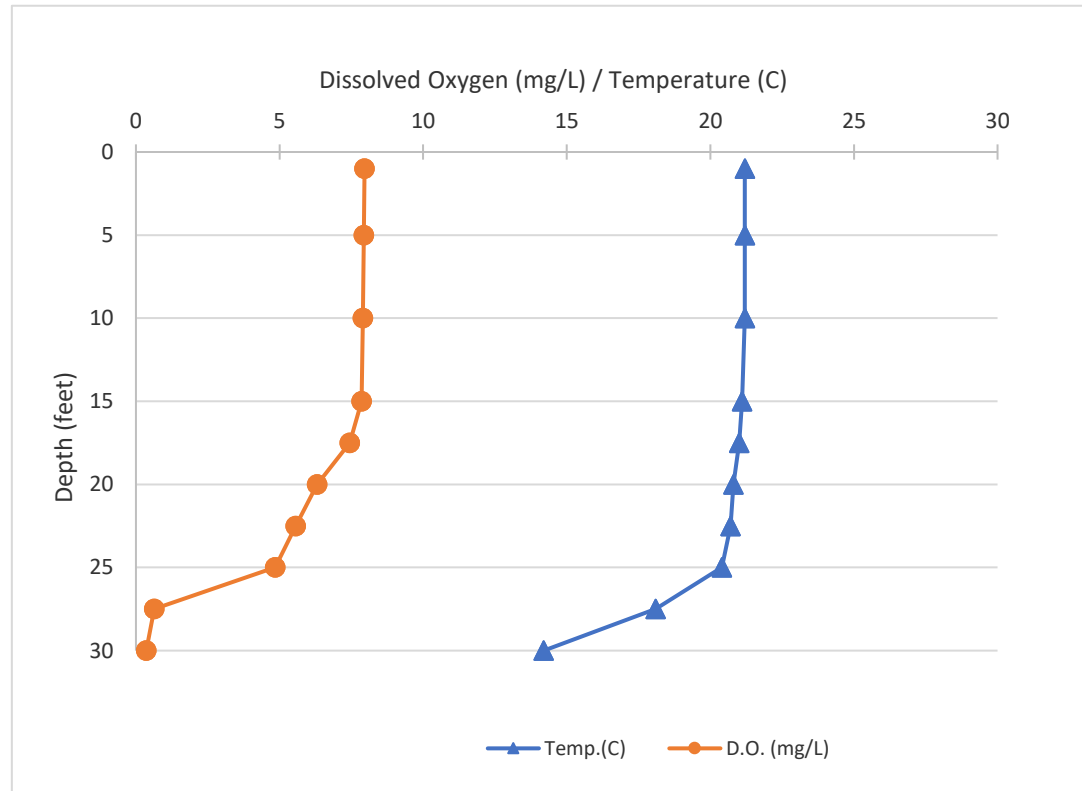
Name: Rose Lake
 County: Osceola
 Site ID: 670058
 Date: 9/12/2021

Dissolved Oxygen and Temperature Profile

Depth (ft)	Temp.(C)	D.O. (mg/L)
1	21.2	7.96
1	21.2	7.96
5	21.2	7.94
5	21.2	7.94
10	21.2	7.9
10	21.2	7.9
15	21.1	7.86
15	21.1	7.86
17.5	21	7.44
17.5	21	7.44
20	20.8	6.31
20	20.8	6.31
22.5	20.7	5.56
22.5	20.7	5.56
25	20.4	4.85
25	20.4	4.85
27.5	18.1	0.64
27.5	18.1	0.64
30	14.2	0.36
30	14.2	0.36
