2021 Data Report for Scram Lake, Kent County

Site ID: 410728

Scram Lake, Kent County 2021 CLMP Results

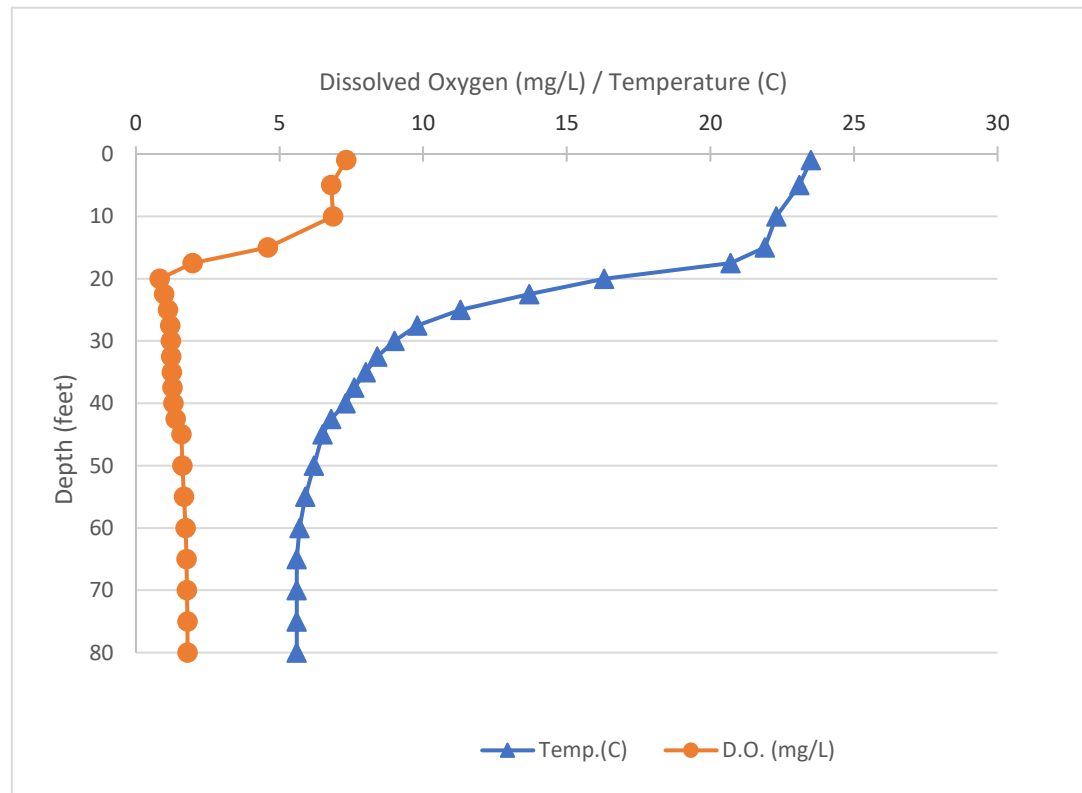
9/10/2021

Dissolved Oxygen and Temperature Profile

Depth (ft)	Temp.(C)	D.O. (mg/L)
1	23.5	7.32
5	23.1	6.8
10	22.3	6.87
15	21.9	4.59
17.5	20.7	1.97
20	16.3	0.83
22.5	13.7	0.98
25	11.3	1.12
27.5	9.8	1.2
30	9	1.22
32.5	8.4	1.23
35	8	1.25
37.5	7.6	1.27
40	7.3	1.31
42.5	6.8	1.38
45	6.5	1.59
50	6.2	1.62
55	5.9	1.67
60	5.7	1.73
65	5.6	1.76
70	5.6	1.77
75	5.6	1.8
80	5.6	1.8
