2021 Data Report for Spider Lake, Grand Traverse County

Site ID: 280395

Spider Lake, Grand Traverse County 2021 CLMP Results

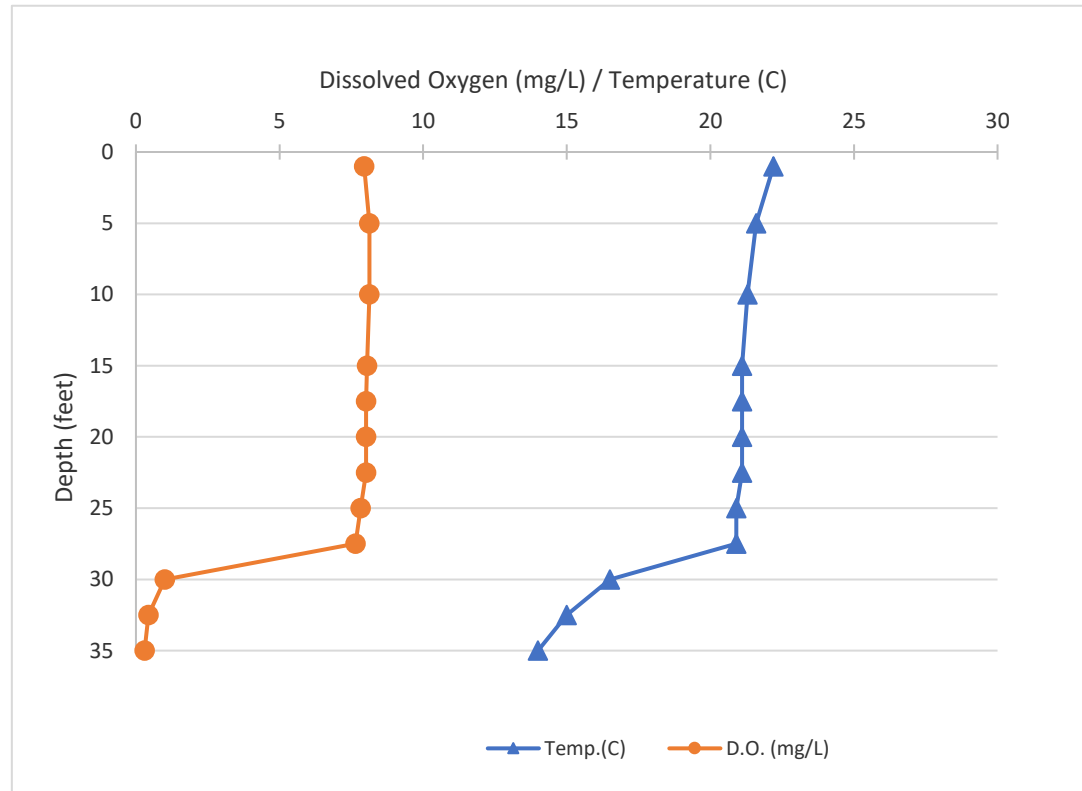
9/10/2021

Dissolved Oxygen and Temperature Profile

Depth (ft)	Temp.(C)	D.O. (mg/L)
1	22.2	7.95
5	21.6	8.13
10	21.3	8.13
15	21.1	8.05
17.5	21.1	8.01
20	21.1	8.01
22.5	21.1	8.01
25	20.9	7.82
27.5	20.9	7.65
30	16.5	1
32.5	15	0.44
35	14	0.3
