# **2021 Data Report for Stony Lake, Oceana County**

Site ID: 640049

# Stony Lake, Oceana County 2021 CLMP Results

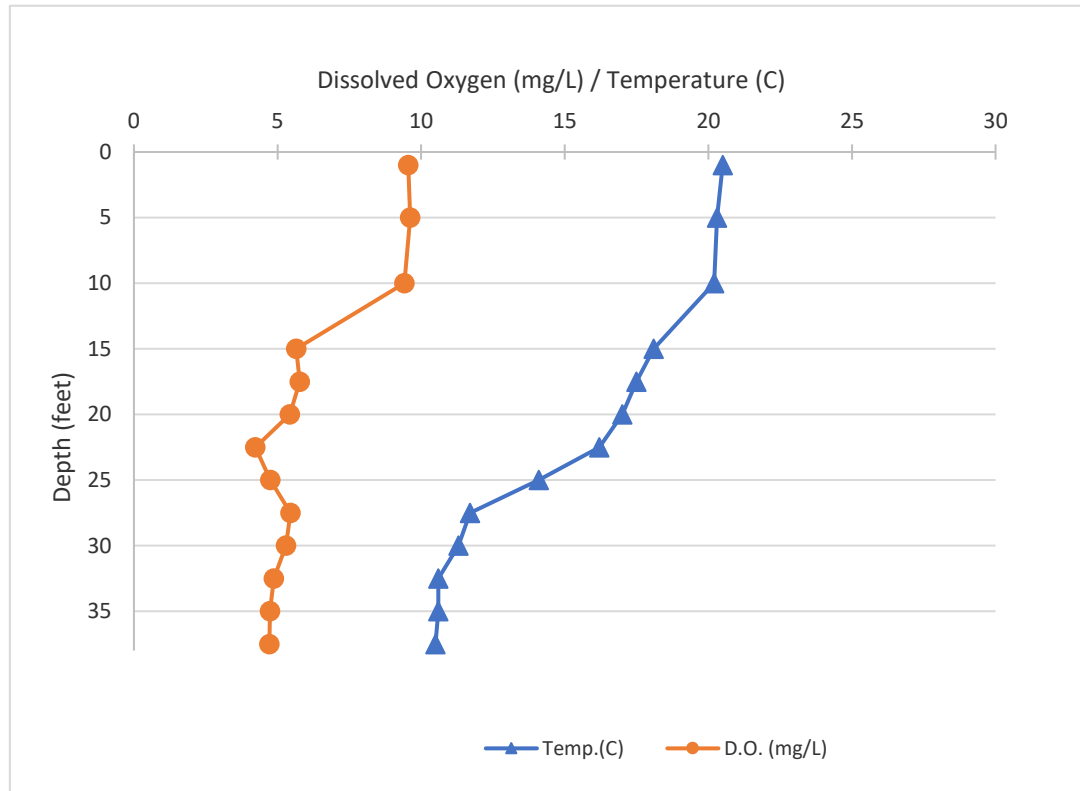
9/19/2021

### Dissolved Oxygen and Temperature Profile

Depth (ft)	Temp.(C)	D.O. (mg/L)
1	20.5	9.55
5	20.3	9.62
10	20.2	9.42
15	18.1	5.65
17.5	17.5	5.77
20	17	5.43
22.5	16.2	4.23
25	14.1	4.75
27.5	11.7	5.45
30	11.3	5.29
32.5	10.6	4.87
35	10.6	4.74
37.5	10.5	4.72
