**2021 Data Report
for
Birch Lake, Cass County**

Site ID: 140187

Birch Lake, Cass County 2021 CLMP Results

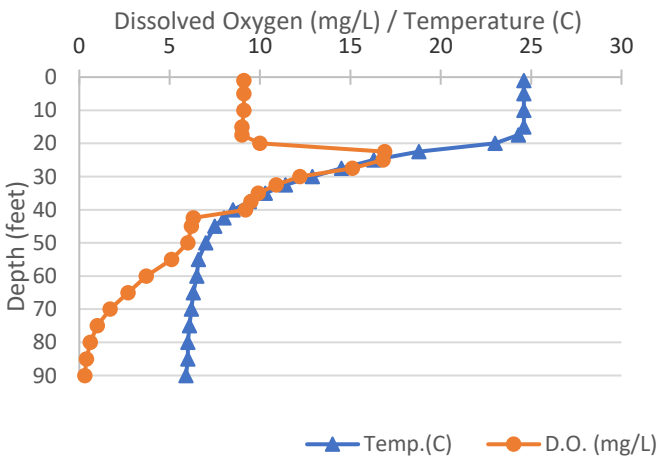
7/17/2021

Dissolved Oxygen and Temperature Profile

Due to its low nutrient levels, the lake is able to maintain dissolved oxygen throughout the most of the water column for the entire summer, though dissolved oxygen gets low or anoxic on the very bottom waters.

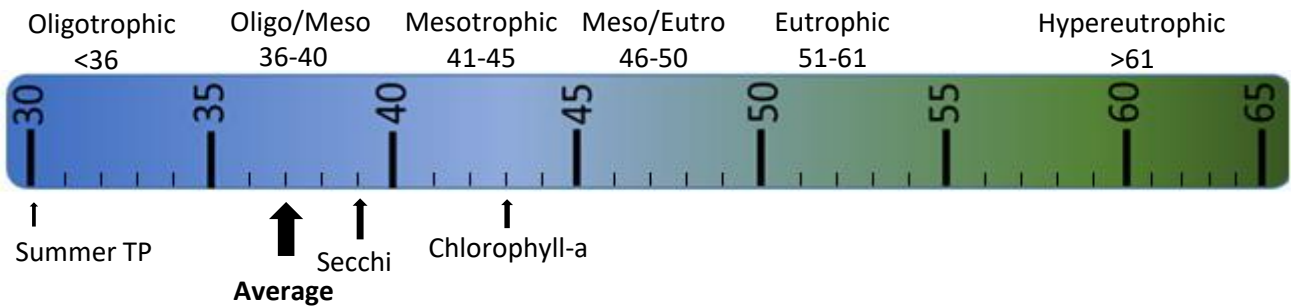
TSI for Birch Lake in 2021	
Average	37
Secchi Disk	39
Summer TP	30
Chlorophyll-a	43

With an average TSI score of 37 based on 2021 Secchi transparency, chlorophyll-a, and summer total phosphorus data, this lake is rated between the oligotrophic and mesotrophic lake classification. The lake leans slightly more oligotrophic than mesotrophic.

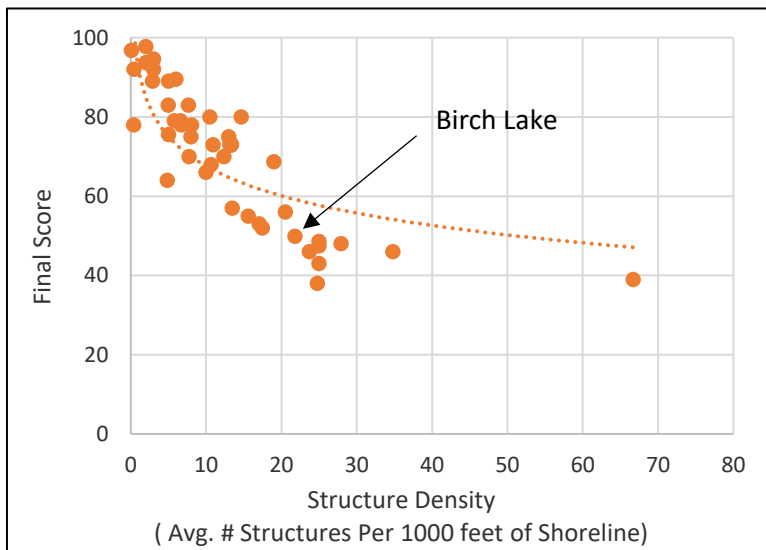
How does your lake compare to others in the program?

Birch Lake:	
Number of Sections:	16
Number of Structures:	349
Structure Density:	21.8
Final Score:	49.9

All 43 Participating Lakes from 2015-2017:	
Avg. Number of Sections:	16.3
Avg. Number of Structures:	248.5
Avg. Structure Density:	15.2
Avg. Final Score:	70.5

Overall, the lakeshore habitat of Birch Lake is below average when compared to the other lakes in the program. All of the lake sections score poor or fair (9 poor, 7 fair).

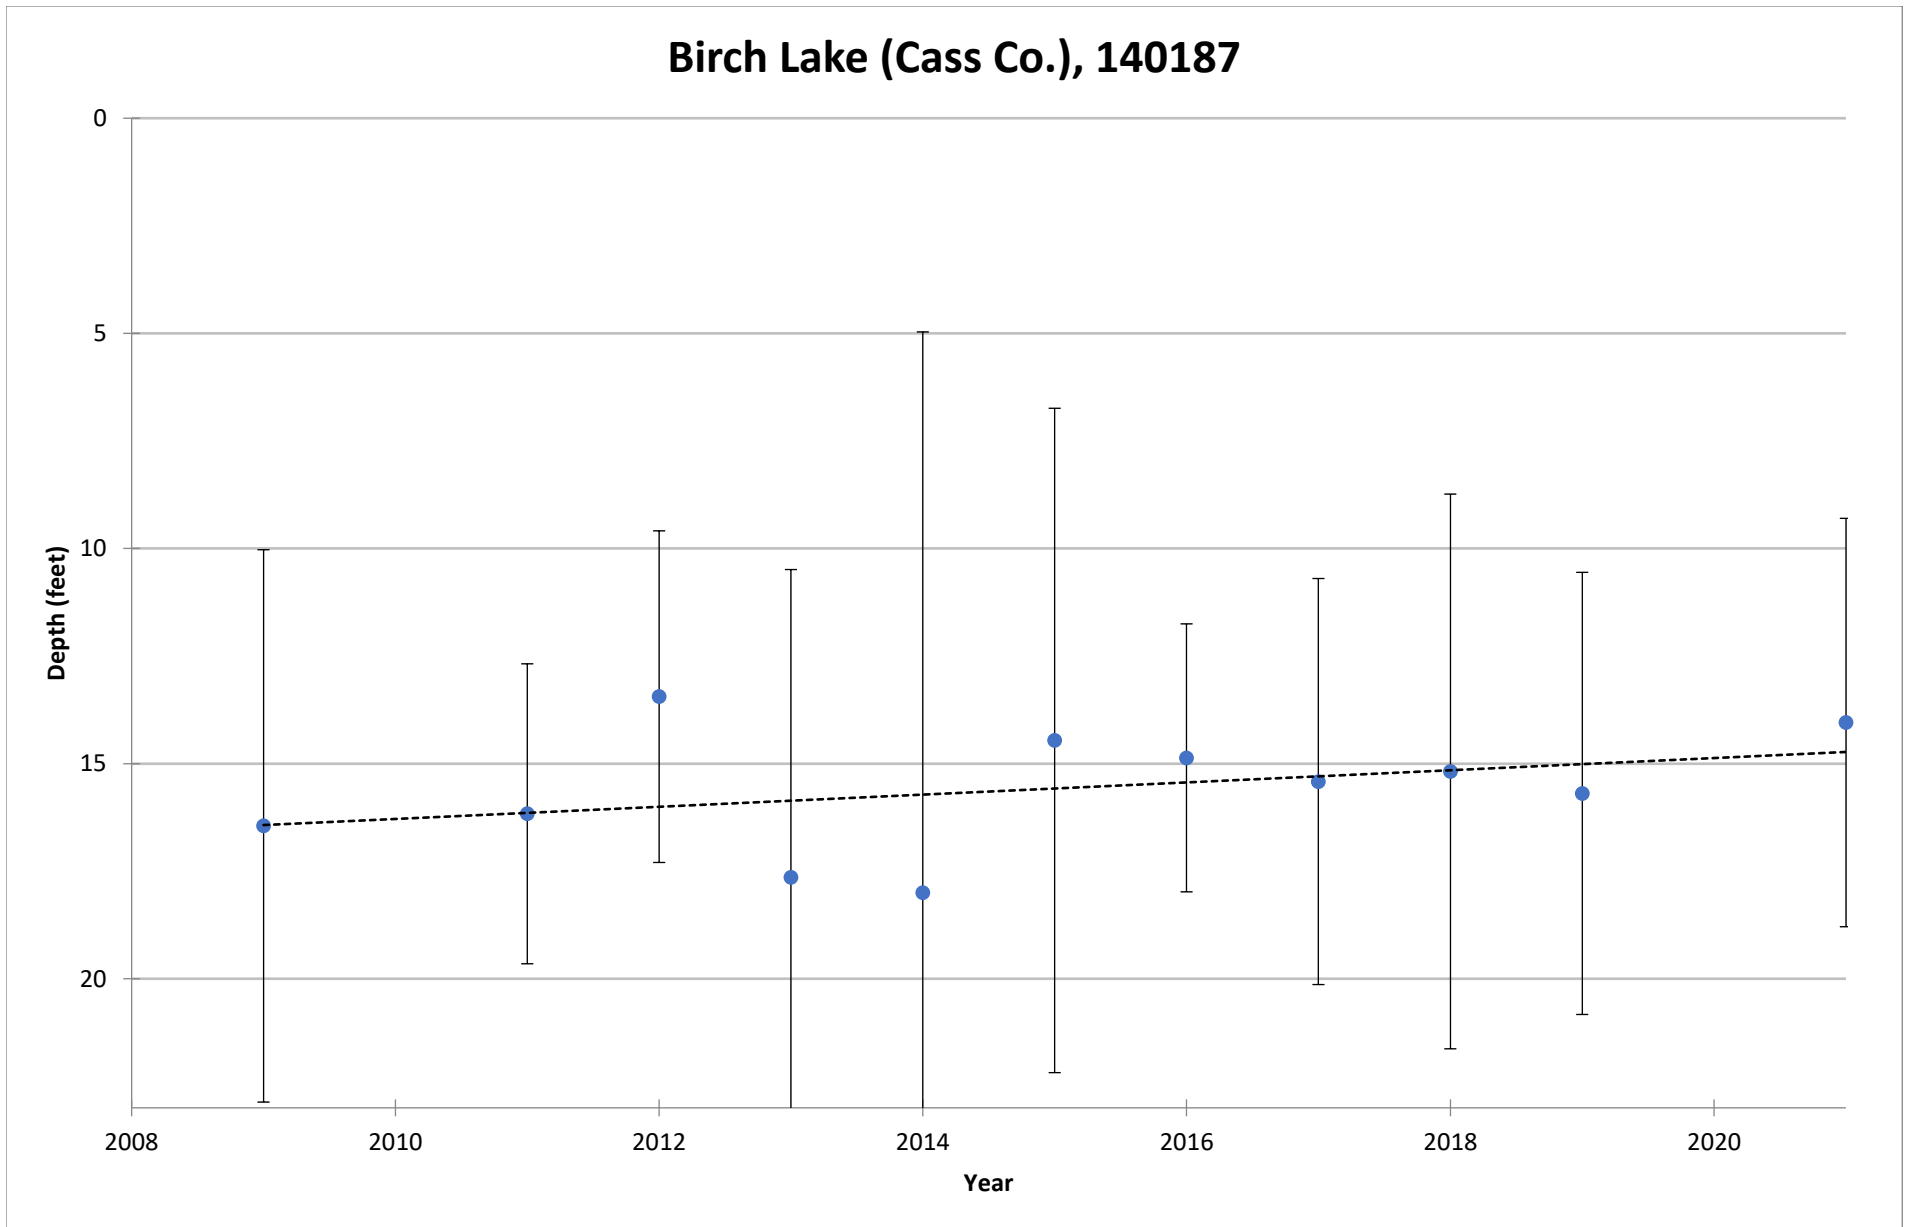
Birch Lake (Cass Co.), 140187

COOPERATIVE LAKES MONITORING PROGRAM
SUMMER MEAN TRANSPARENCY

Vertical bars indicate standard deviation

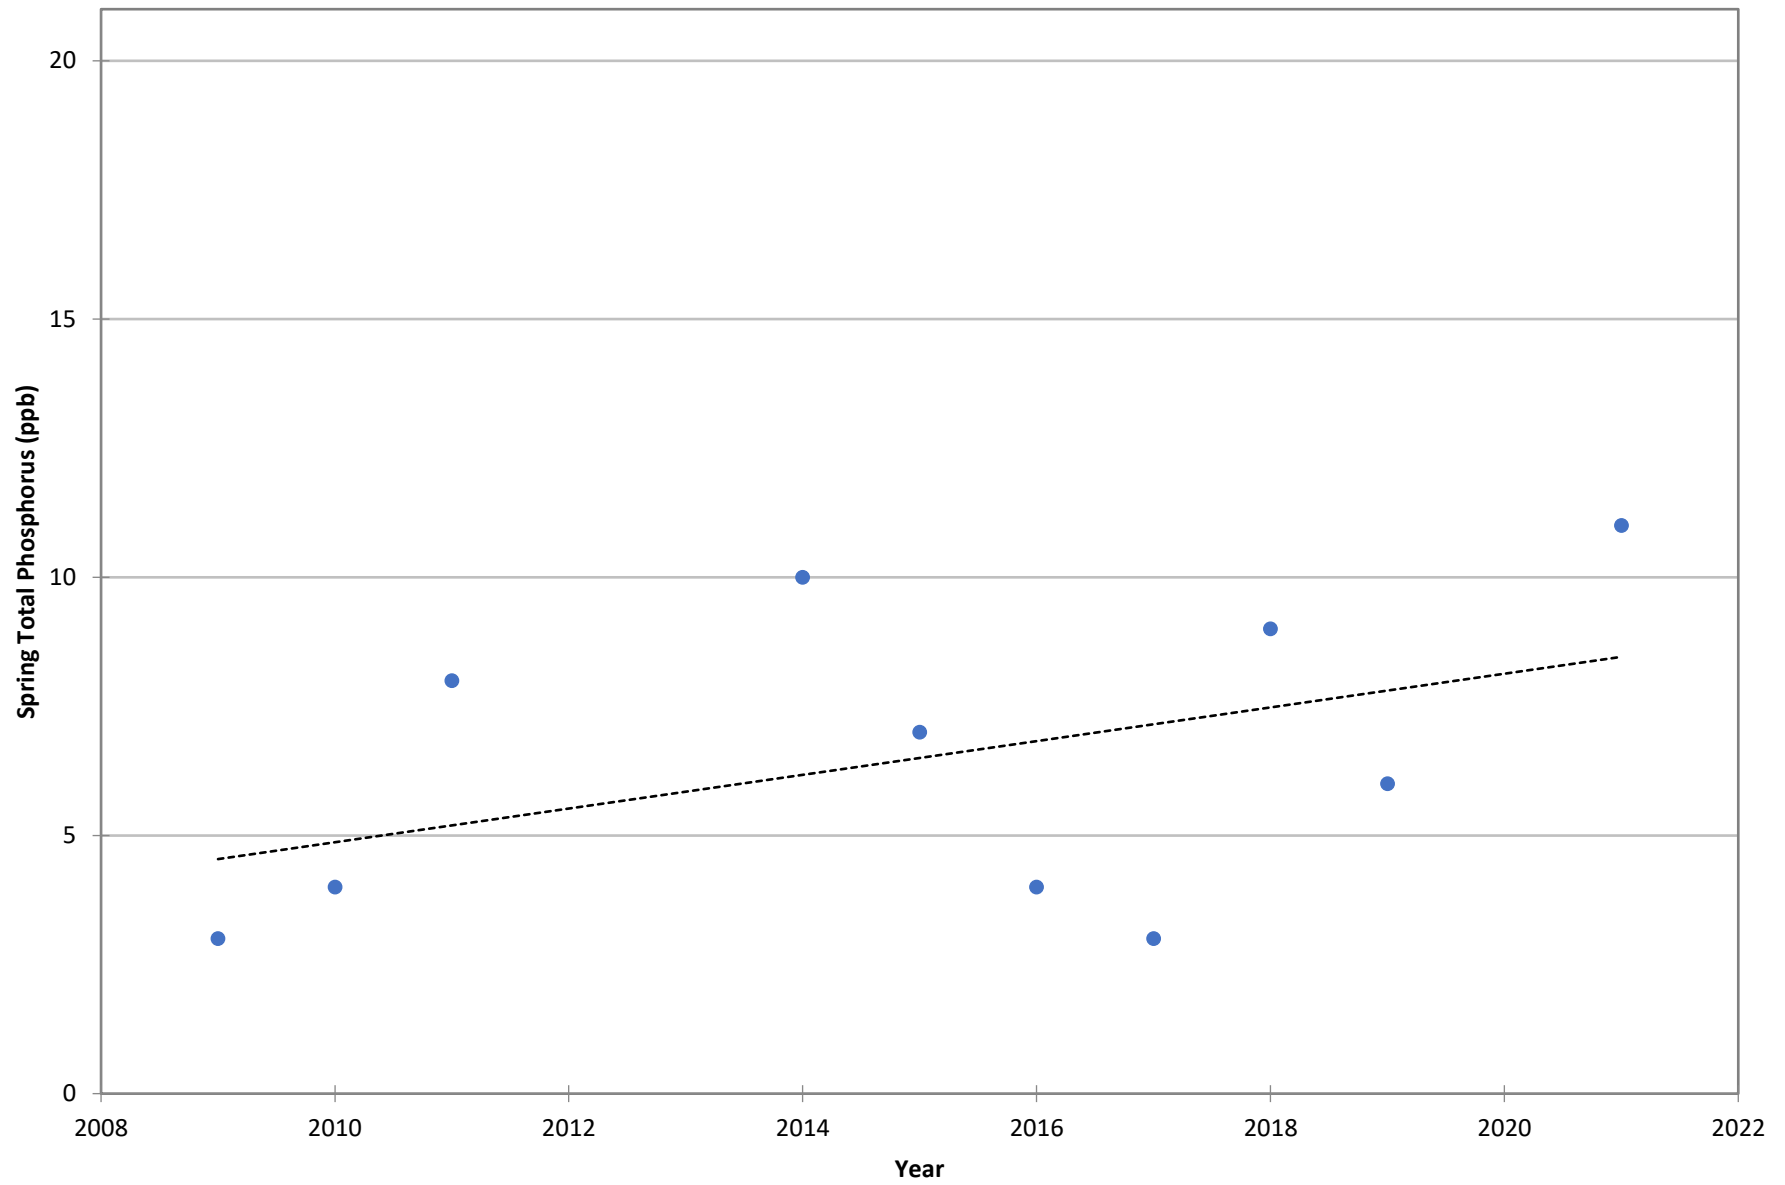
Birch Lake (Cass Co.), 140187

COOPERATIVE LAKES MONITORING PROGRAM
SPRING TOTAL PHOSPHORUS

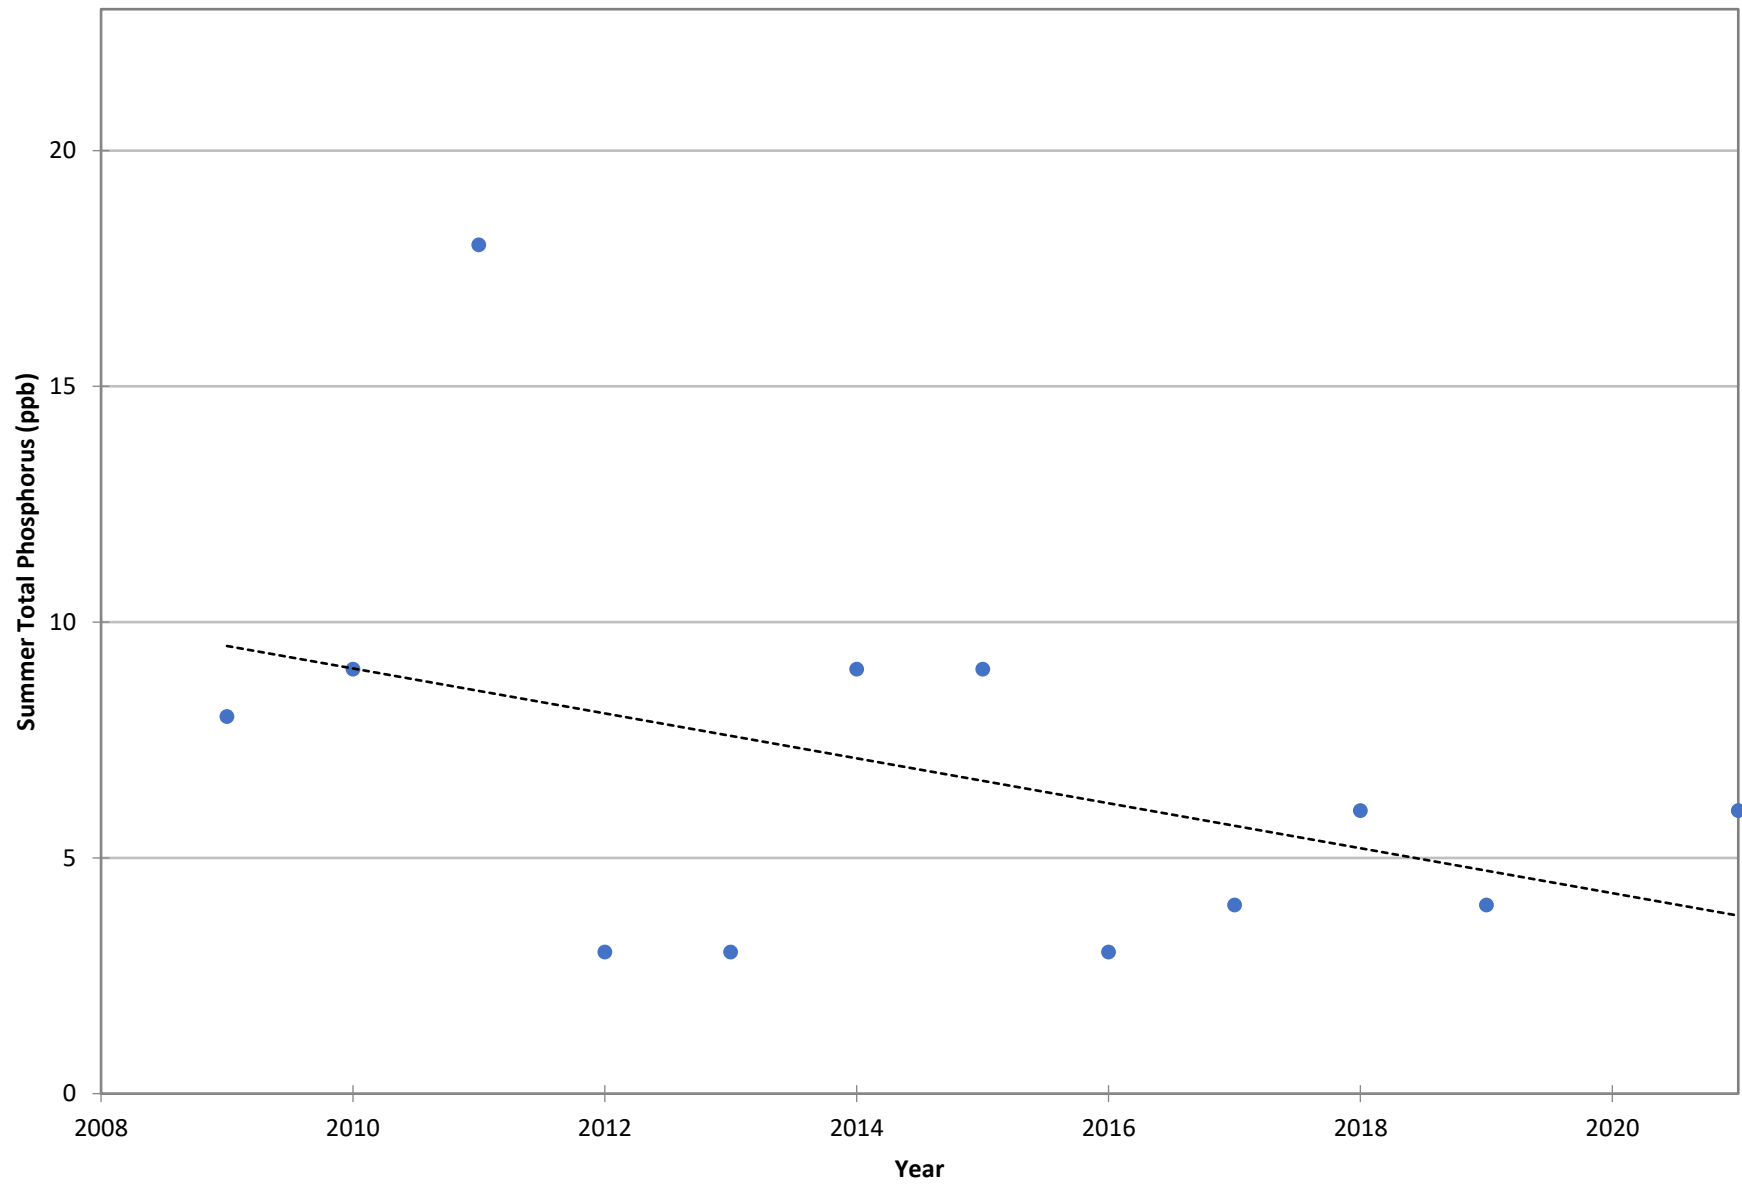
Birch Lake (Cass Co.), 140187

COOPERATIVE LAKES MONITORING PROGRAM
SUMMER TOTAL PHOSPHORUS

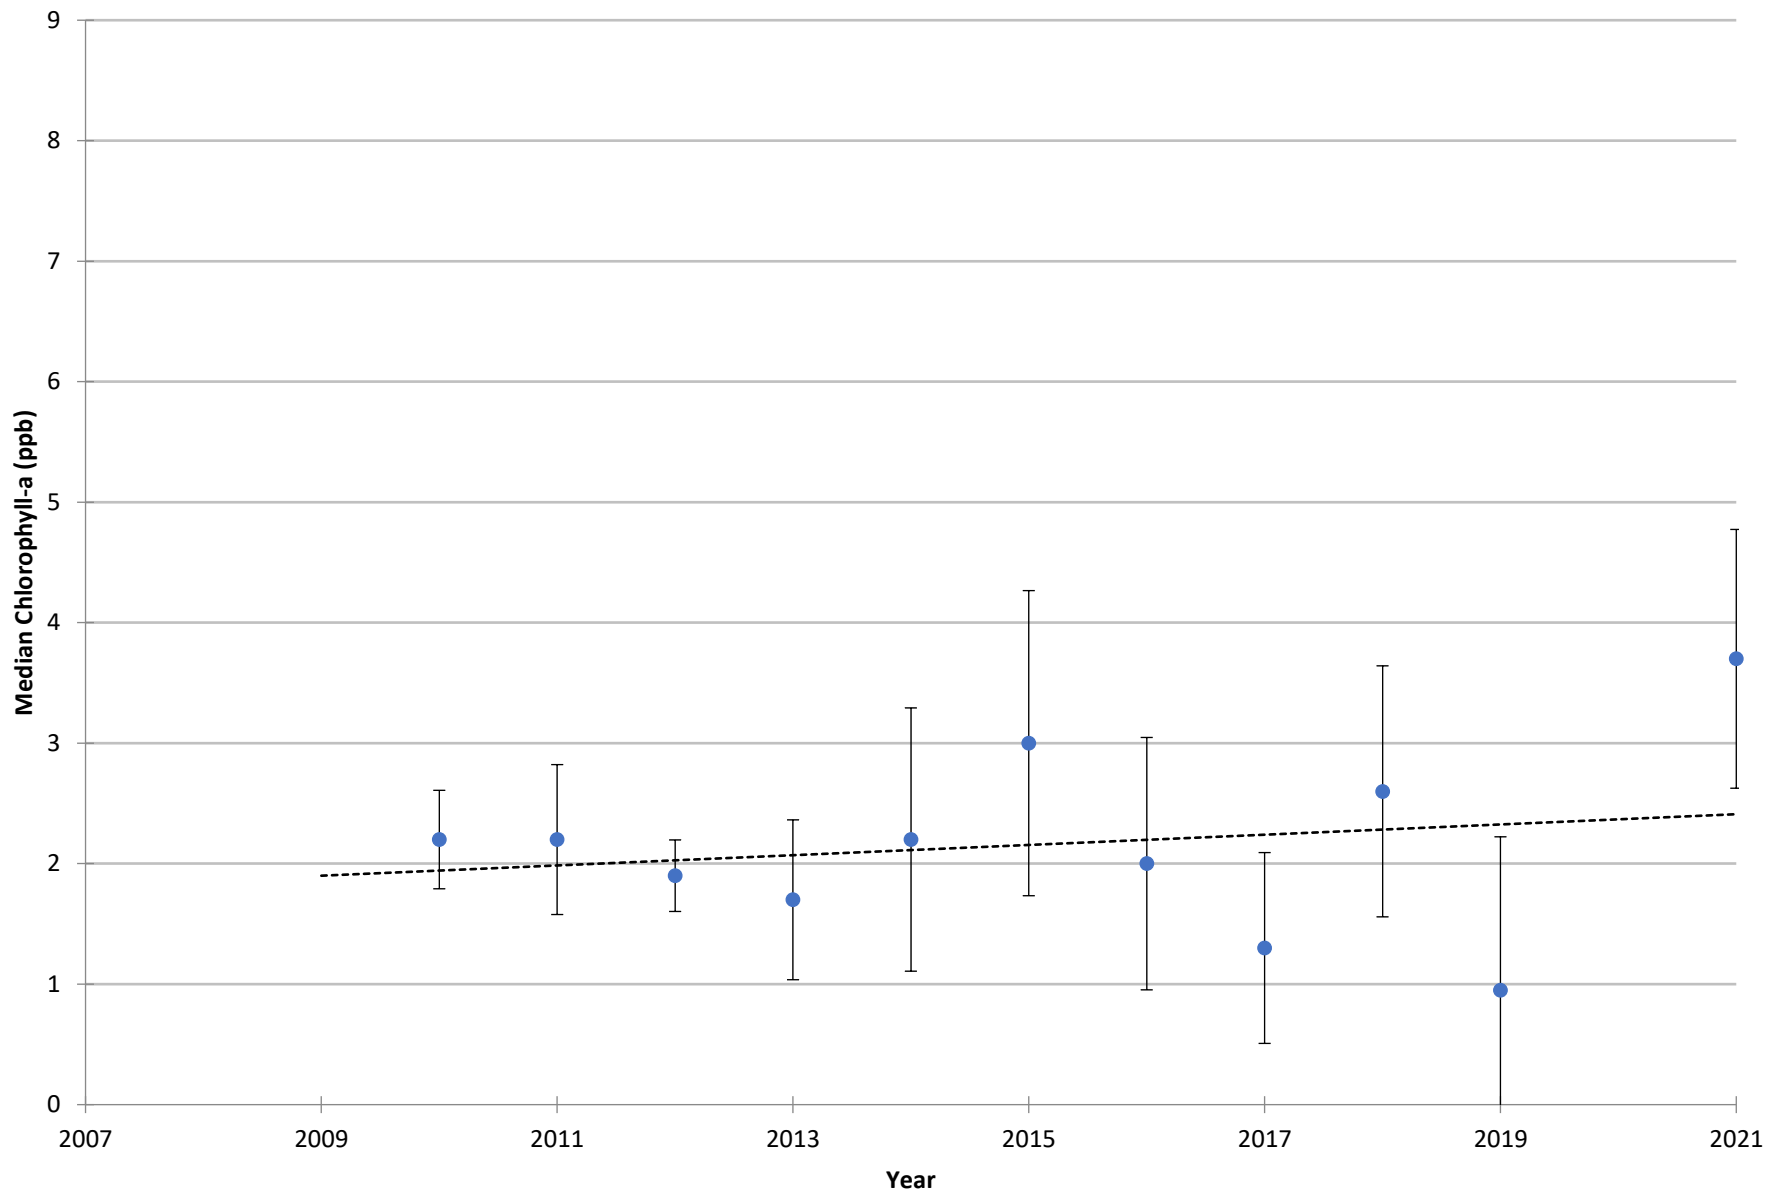
Birch Lake (Cass Co.), 140187

COOPERATIVE LAKES MONITORING PROGRAM
SUMMER MEDIAN CHLOROPHYLL-A

Vertical bars indicate standard deviation

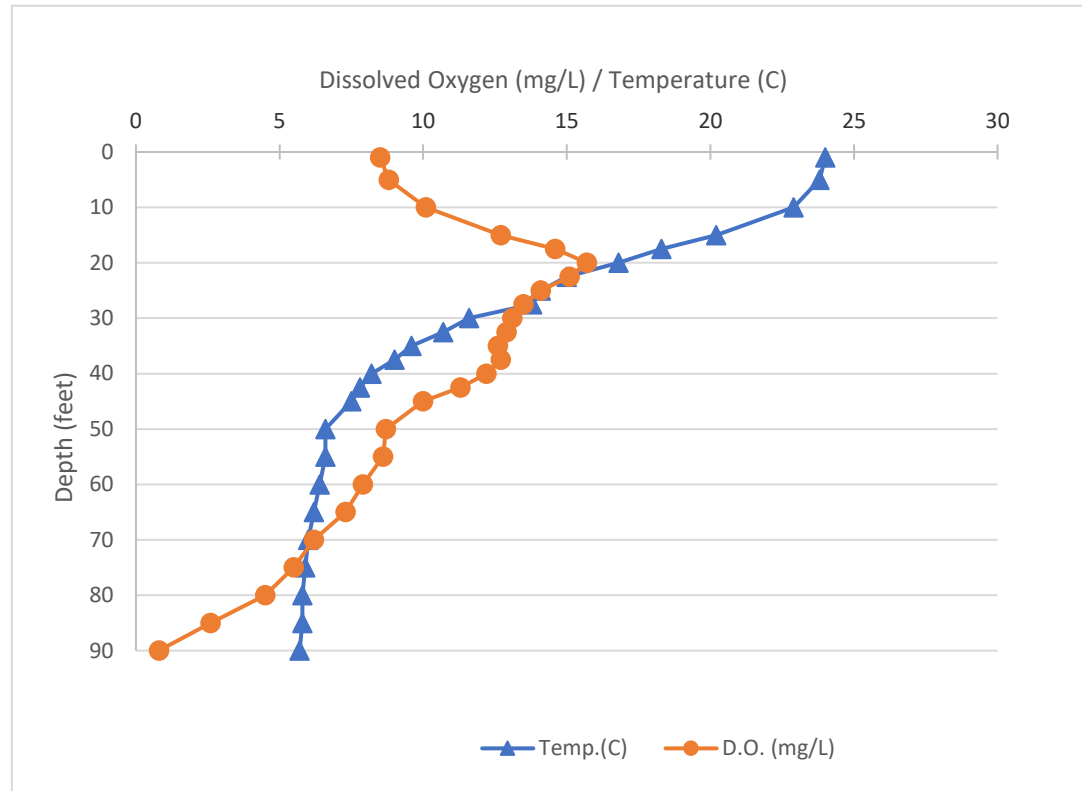
6/2/2021

Dissolved Oxygen and Temperature Profile

Depth (ft)	Temp.(C)	D.O. (mg/L)
1	24	8.5
5	23.8	8.8
10	22.9	10.1
15	20.2	12.7
17.5	18.3	14.6
20	16.8	15.7
22.5	15	15.1
25	14.1	14.1
27.5	13.8	13.5
30	11.6	13.1
32.5	10.7	12.9
35	9.6	12.6
37.5	9	12.7
40	8.2	12.2
42.5	7.8	11.3
45	7.5	10
50	6.6	8.7
55	6.6	8.6
60	6.4	7.9
65	6.2	7.3
70	6	6.2
75	5.9	5.5
80	5.8	4.5
85	5.8	2.6
90	5.7	0.8

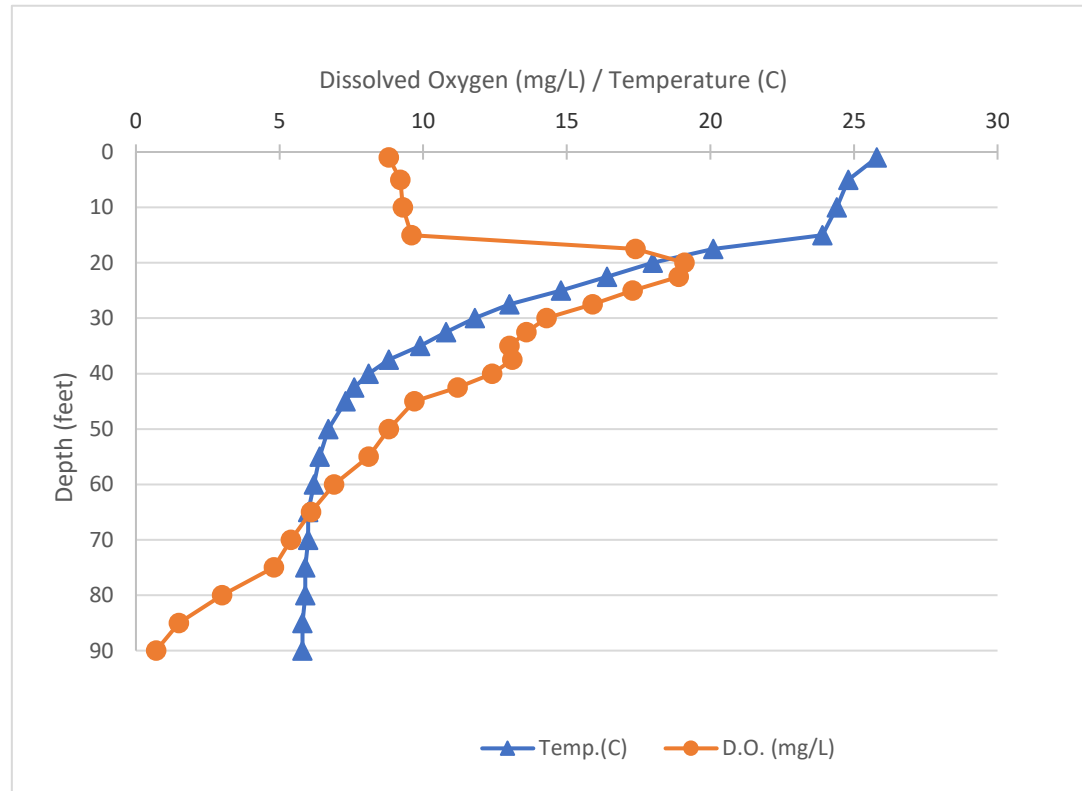
6/17/2021

Dissolved Oxygen and Temperature Profile

Depth (ft)	Temp.(C)	D.O. (mg/L)
1	25.8	8.8
5	24.8	9.2
10	24.4	9.3
15	23.9	9.6
17.5	20.1	17.4
20	18	19.1
22.5	16.4	18.9
25	14.8	17.3
27.5	13	15.9
30	11.8	14.3
32.5	10.8	13.6
35	9.9	13
37.5	8.8	13.1
40	8.1	12.4
42.5	7.6	11.2
45	7.3	9.7
50	6.7	8.8
55	6.4	8.1
60	6.2	6.9
65	6	6.1
70	6	5.4
75	5.9	4.8
80	5.9	3
85	5.8	1.5
90	5.8	0.7

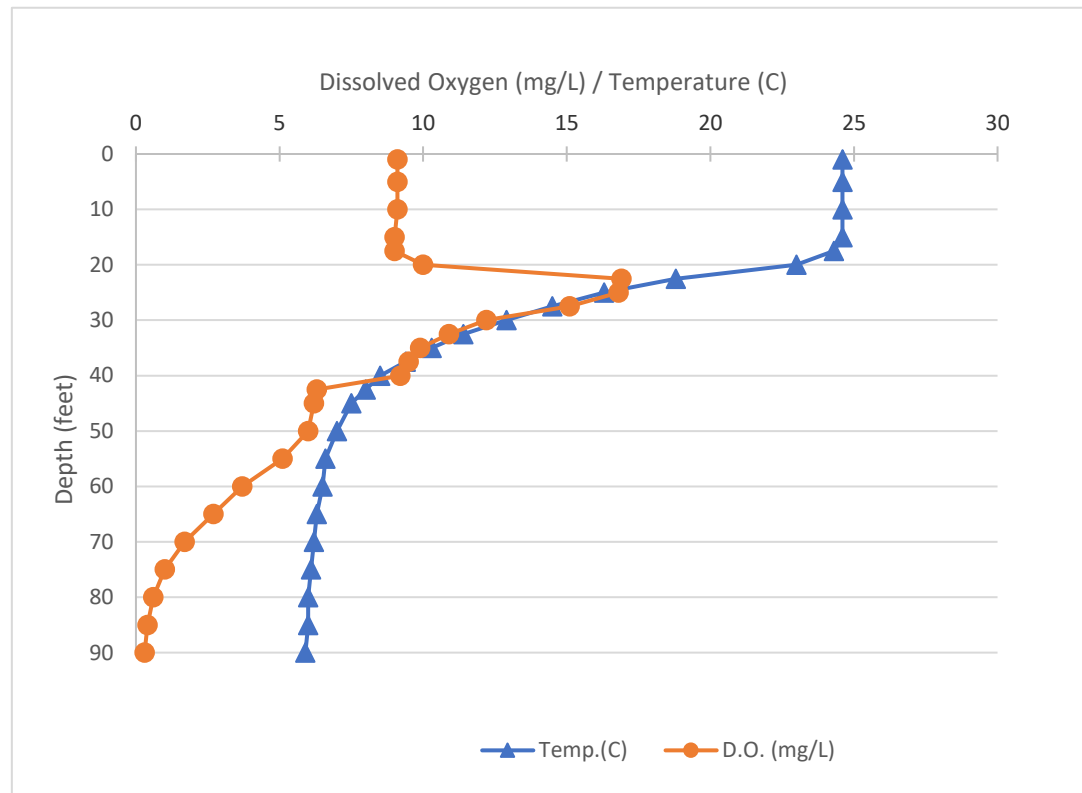
7/17/2021

Dissolved Oxygen and Temperature Profile

Depth (ft)	Temp.(C)	D.O. (mg/L)
1	24.6	9.1
5	24.6	9.1
10	24.6	9.1
15	24.6	9
17.5	24.3	9
20	23	10
22.5	18.8	16.9
25	16.3	16.8
27.5	14.5	15.1
30	12.9	12.2
32.5	11.4	10.9
35	10.3	9.9
37.5	9.4	9.5
40	8.5	9.2
42.5	8	6.3
45	7.5	6.2
50	7	6
55	6.6	5.1
60	6.5	3.7
65	6.3	2.7
70	6.2	1.7
75	6.1	1
80	6	0.6
85	6	0.4
90	5.9	0.3

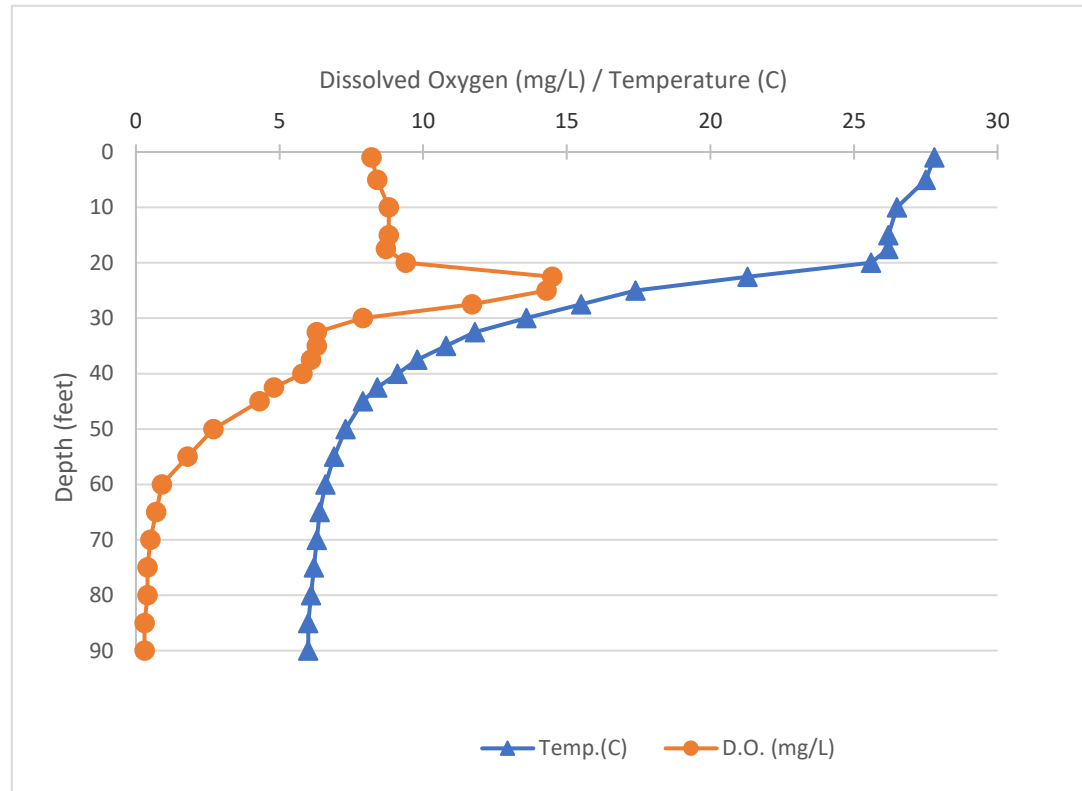
8/18/2021

Dissolved Oxygen and Temperature Profile

Depth (ft)	Temp.(C)	D.O. (mg/L)
1	27.8	8.2
5	27.5	8.4
10	26.5	8.8
15	26.2	8.8
17.5	26.2	8.7
20	25.6	9.4
22.5	21.3	14.5
25	17.4	14.3
27.5	15.5	11.7
30	13.6	7.9
32.5	11.8	6.3
35	10.8	6.3
37.5	9.8	6.1
40	9.1	5.8
42.5	8.4	4.8
45	7.9	4.3
50	7.3	2.7
55	6.9	1.8
60	6.6	0.9
65	6.4	0.7
70	6.3	0.5
75	6.2	0.4
80	6.1	0.4
85	6	0.3
90	6	0.3
