2021 Data Report for

Upper Herring Lake, Benzie County

Site ID: 100247

Upper Herring Lake, Benzie County 2021 CLMP Results

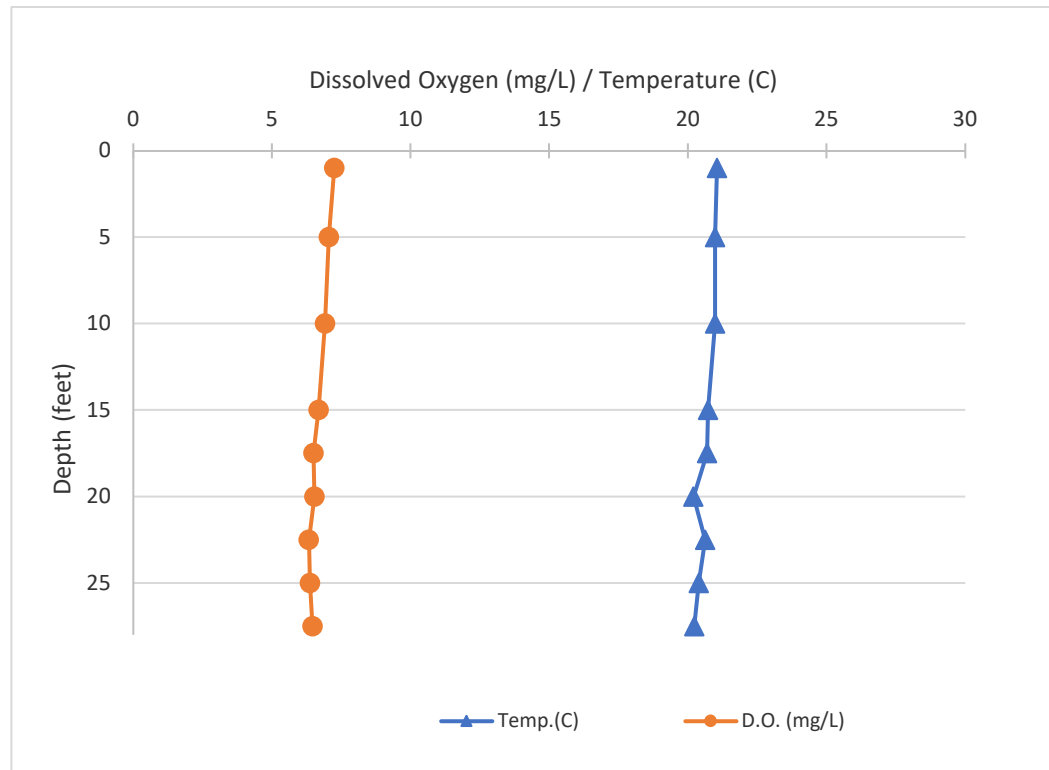
Name: Upper Herring Lake
County: Benzie
Site ID: 100247
Date: 9/9/2021

Dissolved Oxygen and Temperature Profile

Depth (ft)	Temp.(C)	D.O. (mg/L)
1	21.05	7.25
5	20.98	7.06
10	20.98	6.92
15	20.73	6.69
17.5	20.7	6.5
20	20.2	6.54
22.5	20.63	6.33
25	20.4	6.38
27.5	20.23	6.47
