# 2021 Data Report for Maceday Lake, Oakland County

Site ID: 630415

# Maceday Lake, Oakland County 2021 CLMP Results

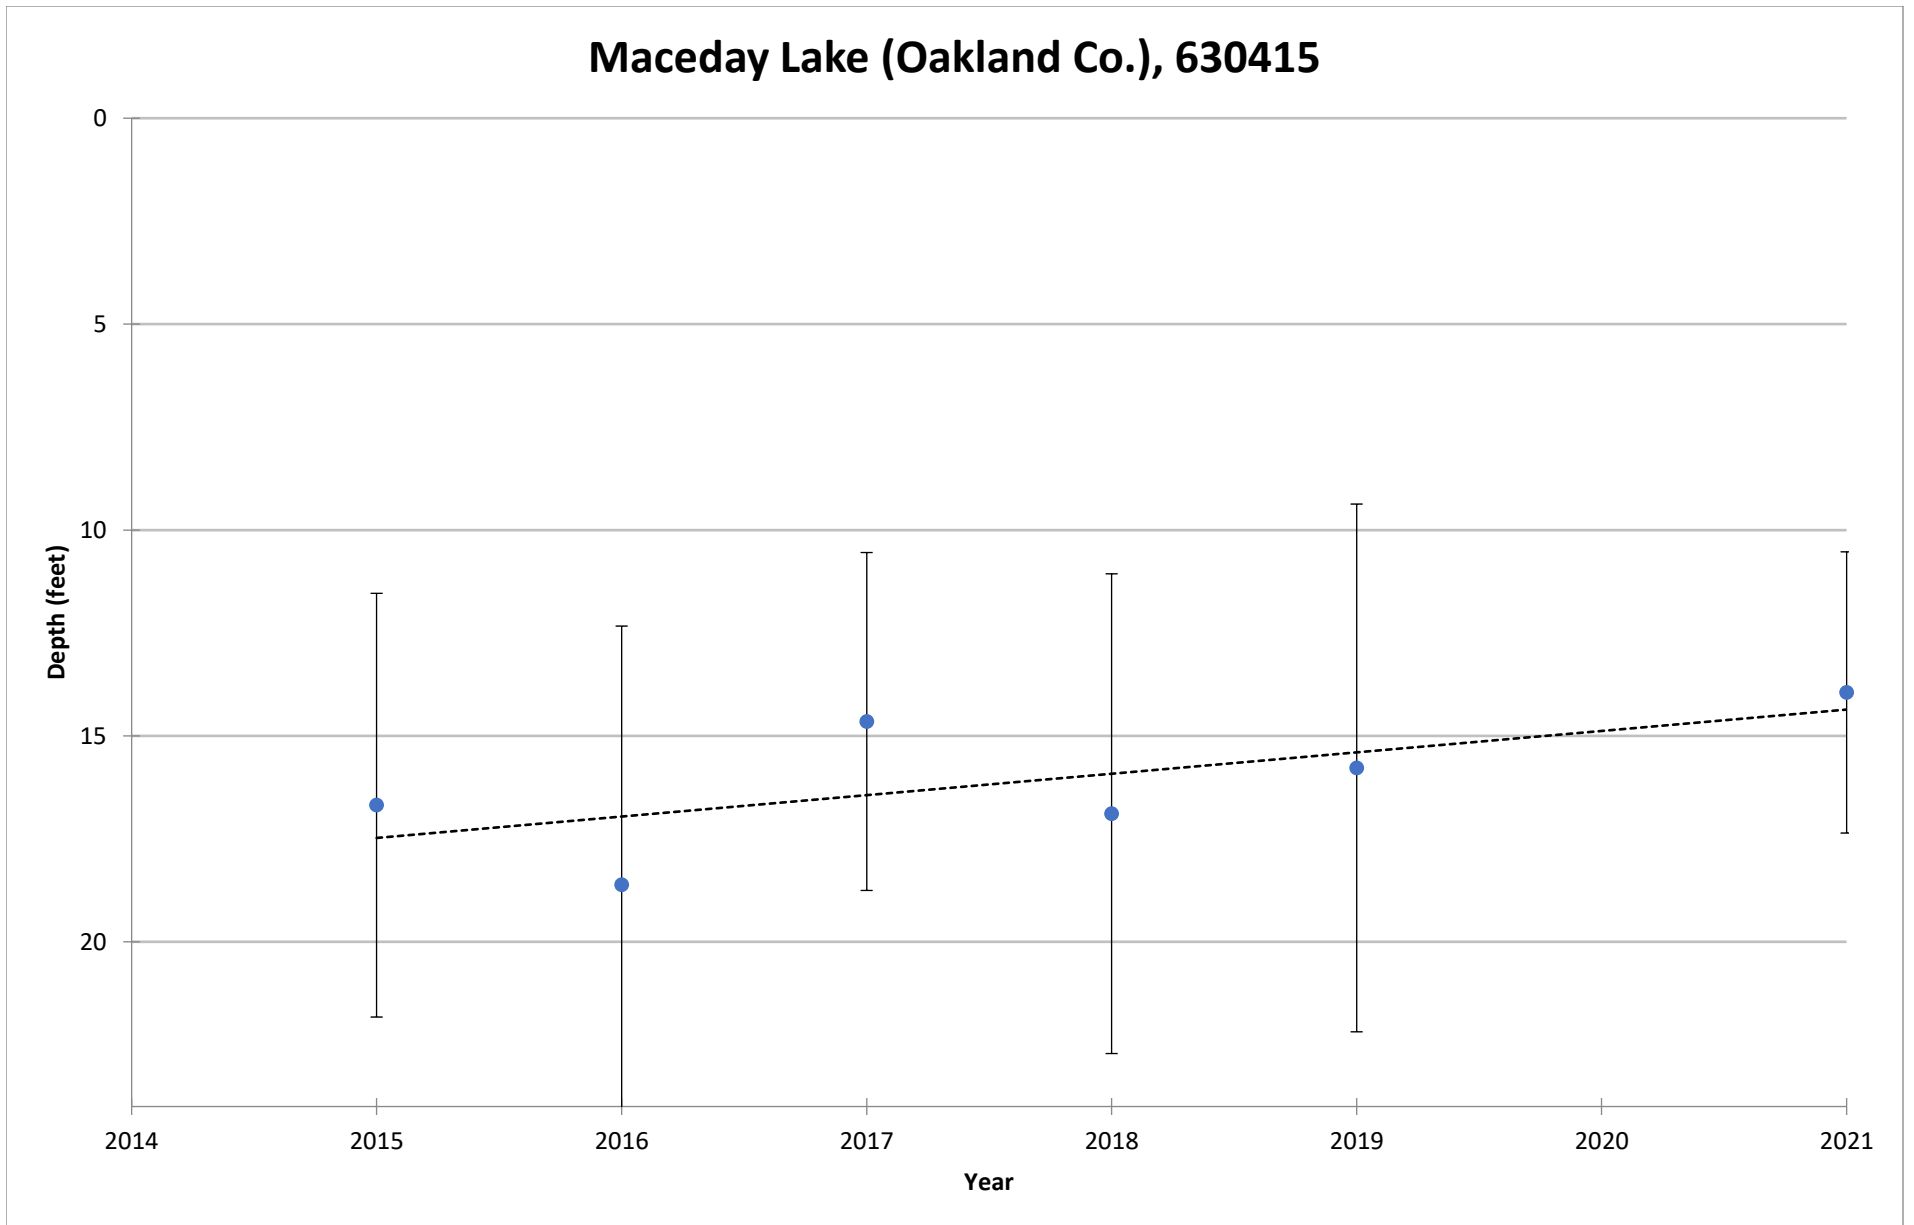
COOPERATIVE LAKES MONITORING PROGRAM  
SUMMER MEAN TRANSPARENCY

Vertical bars indicate standard deviation

Long term monitoring shows slight upward slopes on the parameters, indicating a slow movement toward higher nutrient levels in the lake.

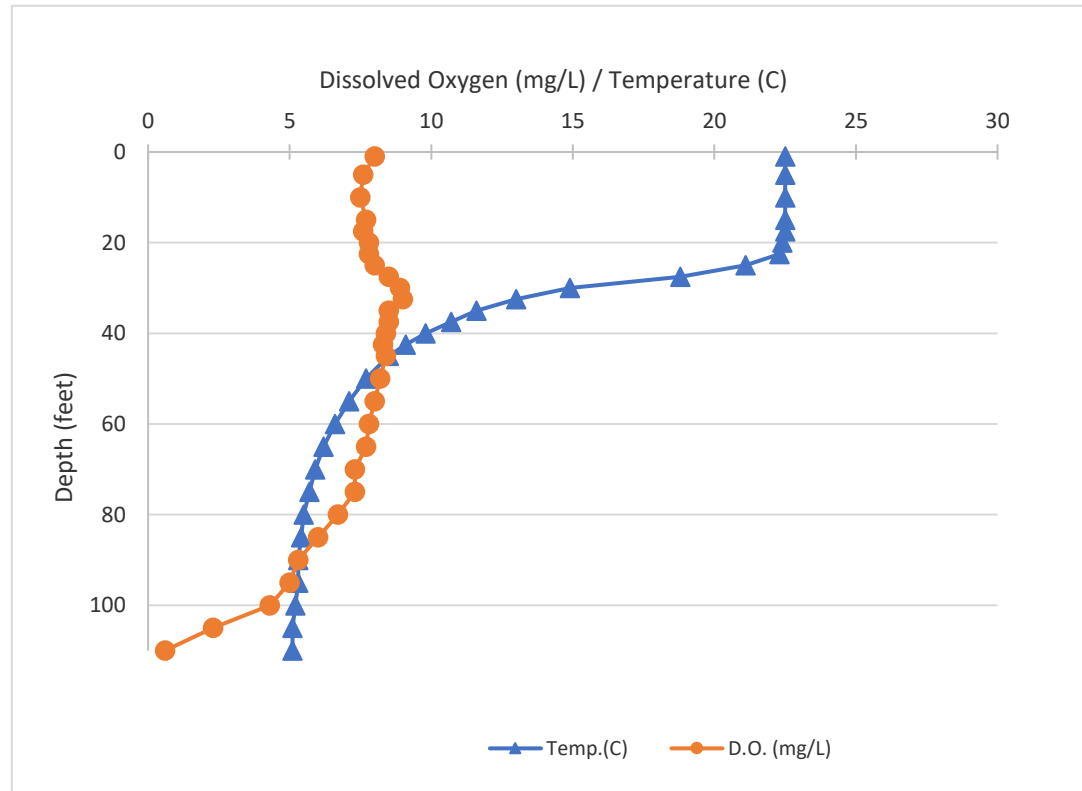
9/10/2021

Depth (ft)	Temp.(C)	D.O. (mg/L)
1	22.5	8
5	22.5	7.6
10	22.5	7.5
15	22.5	7.7
17.5	22.5	7.6
20	22.4	7.8
22.5	22.3	7.8
25	21.1	8
27.5	18.8	8.5
30	14.9	8.9
32.5	13	9
35	11.6	8.5
37.5	10.7	8.5
40	9.8	8.4
42.5	9.1	8.3
45	8.5	8.4
50	7.7	8.2
55	7.1	8
60	6.6	7.8
65	6.2	7.7
70	5.9	7.3
75	5.7	7.3
80	5.5	6.7
85	5.4	6
90	5.3	5.3
95	5.3	5
100	5.2	4.3
105	5.1	2.3
110	5.1	0.6

Due to its very low nutrient level, the lake is able to maintain dissolved oxygen throughout the most of the water column for the entire summer, though dissolved oxygen gets low or anoxic on the very bottom waters.
