2021 Data Report for

Little Platte Lake, Benzie County

Site ID: 100122

Little Platte Lake, Benzie County 2021 CLMP Results

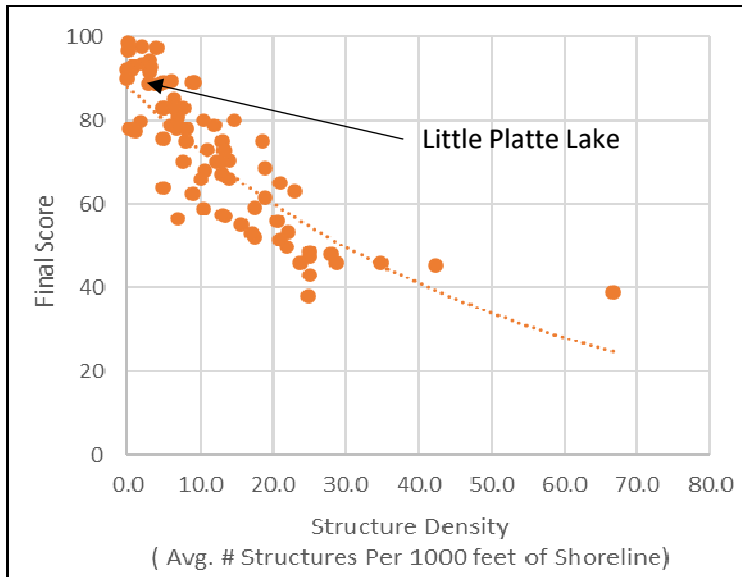
Little Platte Lake:	
Number of Sections:	29
Number of Structures:	259
Structure Density:	8.93
Final Score:	89

All 78 Participating Lakes from 2015-2021:	
Avg. Number of Sections:	16
Avg. Number of Structures:	214
Avg. Structure Density:	12.2
Avg. Final Score:	72

Note about graph to the left: The dotted line sets your average expectation of the score of your lake. If your lake is lower than the dotted line, then your shoreline health is lower than average compared to lakes with similar amount of shoreline development. And vice-versa in regards to a lake above the dotted line.

Overall, the lakeshore habitat of Little Platte Lake is doing well and scored higher than average when compared to other lakes in the program. All of the 1000 foot sections scored either Fair or Good: 6 fair, and 23 good.

Of the sections that scored Fair only, there are some improvements that could be made. Riparian scores are low to moderate here; as well as Erosion control. Based on scores alone it seems likely some houses have grassy yards to the water edge combined with sea walls or riprap. Working with these residents to remove these structures and increase unmowed areas could benefit the overall lake habitat. You can get plenty of ideas for improving shoreline health from the Michigan Natural Shoreline Partnership (<https://www.mishorelinepartnership.org/>).

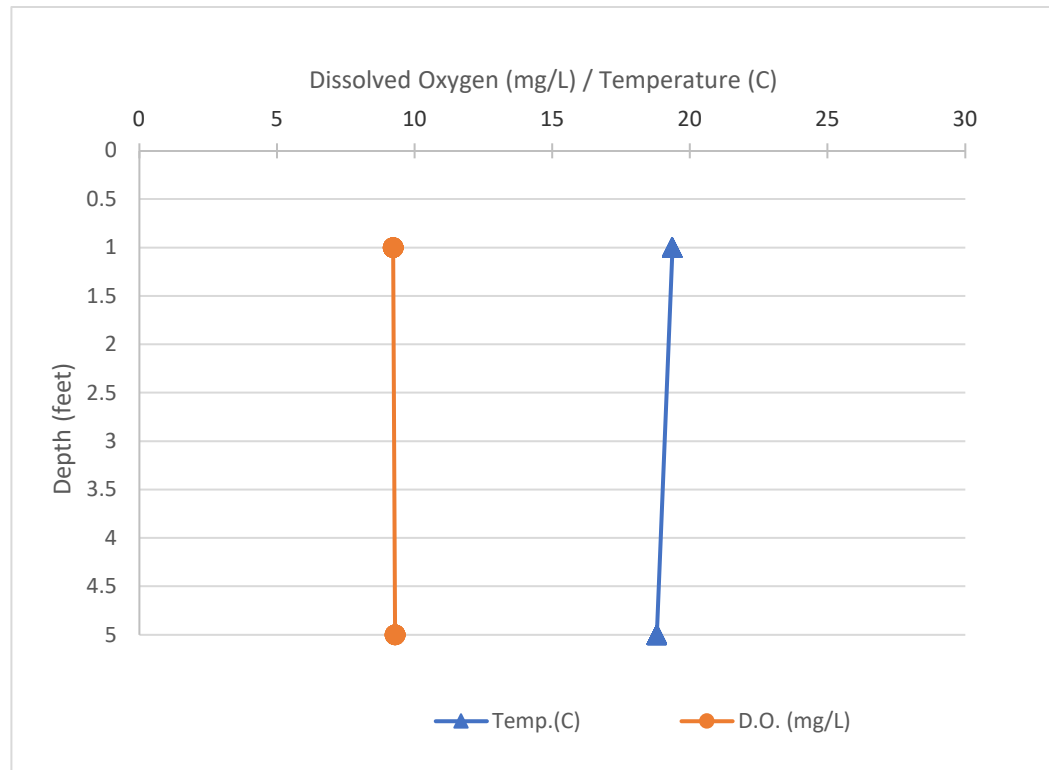
Name: Little Platte Lake
County: Benzie
Site ID: 100122
Date: 9/9/2021

Depth (ft)	Temp.(C)	D.O. (mg/L)
1	19.36	9.22
1	19.36	9.22
1	19.36	9.22
1	19.36	9.22
1	19.36	9.22
1	19.36	9.22
1	19.36	9.22
1	19.36	9.22
1	19.36	9.22
1	19.36	9.22
5	18.8	9.29
5	18.8	9.29
5	18.8	9.29
5	18.8	9.29
5	18.8	9.29
5	18.8	9.29
5	18.8	9.29
5	18.8	9.29
5	18.8	9.29
5	18.8	9.29
5	18.8	9.29
