2022 Data Report for Little Bass Lake, Lake County

Site ID: 430640

Little Bass Lake, Lake County 2022 CLMP Results

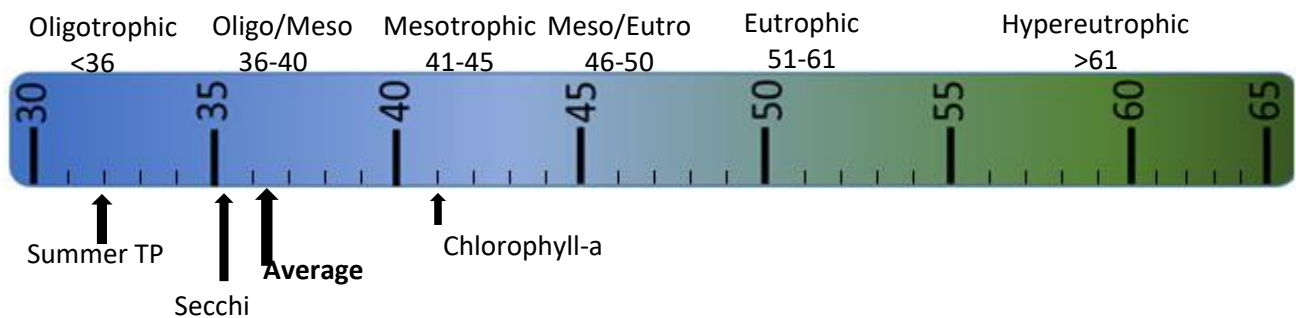
With an average TSI score of 36 based on 2022 Secchi transparency, chlorophyll-a, and summer total phosphorus data, this lake is rated between the oligotrophic and mesotrophic lake classification. The lake leans slightly more oligotrophic than mesotrophic.

TSI for Little Bass Lake in 2022	
Average	36
Secchi Disk	35
Summer TP	32
Chlorophyll-a	41

In 1977, limnologist Dr. Robert Carlson developed a numerical scale (0-100) where the numbers indicate the level of nutrient enrichment. Using the proper equations, we can convert results from Summer Total Phosphorus, Secchi Depth, and Chlorophyll-a to this Trophic Status Index (TSI). The TSI numbers are furthermore grouped into general categories (oligotrophic, mesotrophic, eutrophic, and hypereutrophic), to quickly give us a way to understand the general nutrient level of any lake.

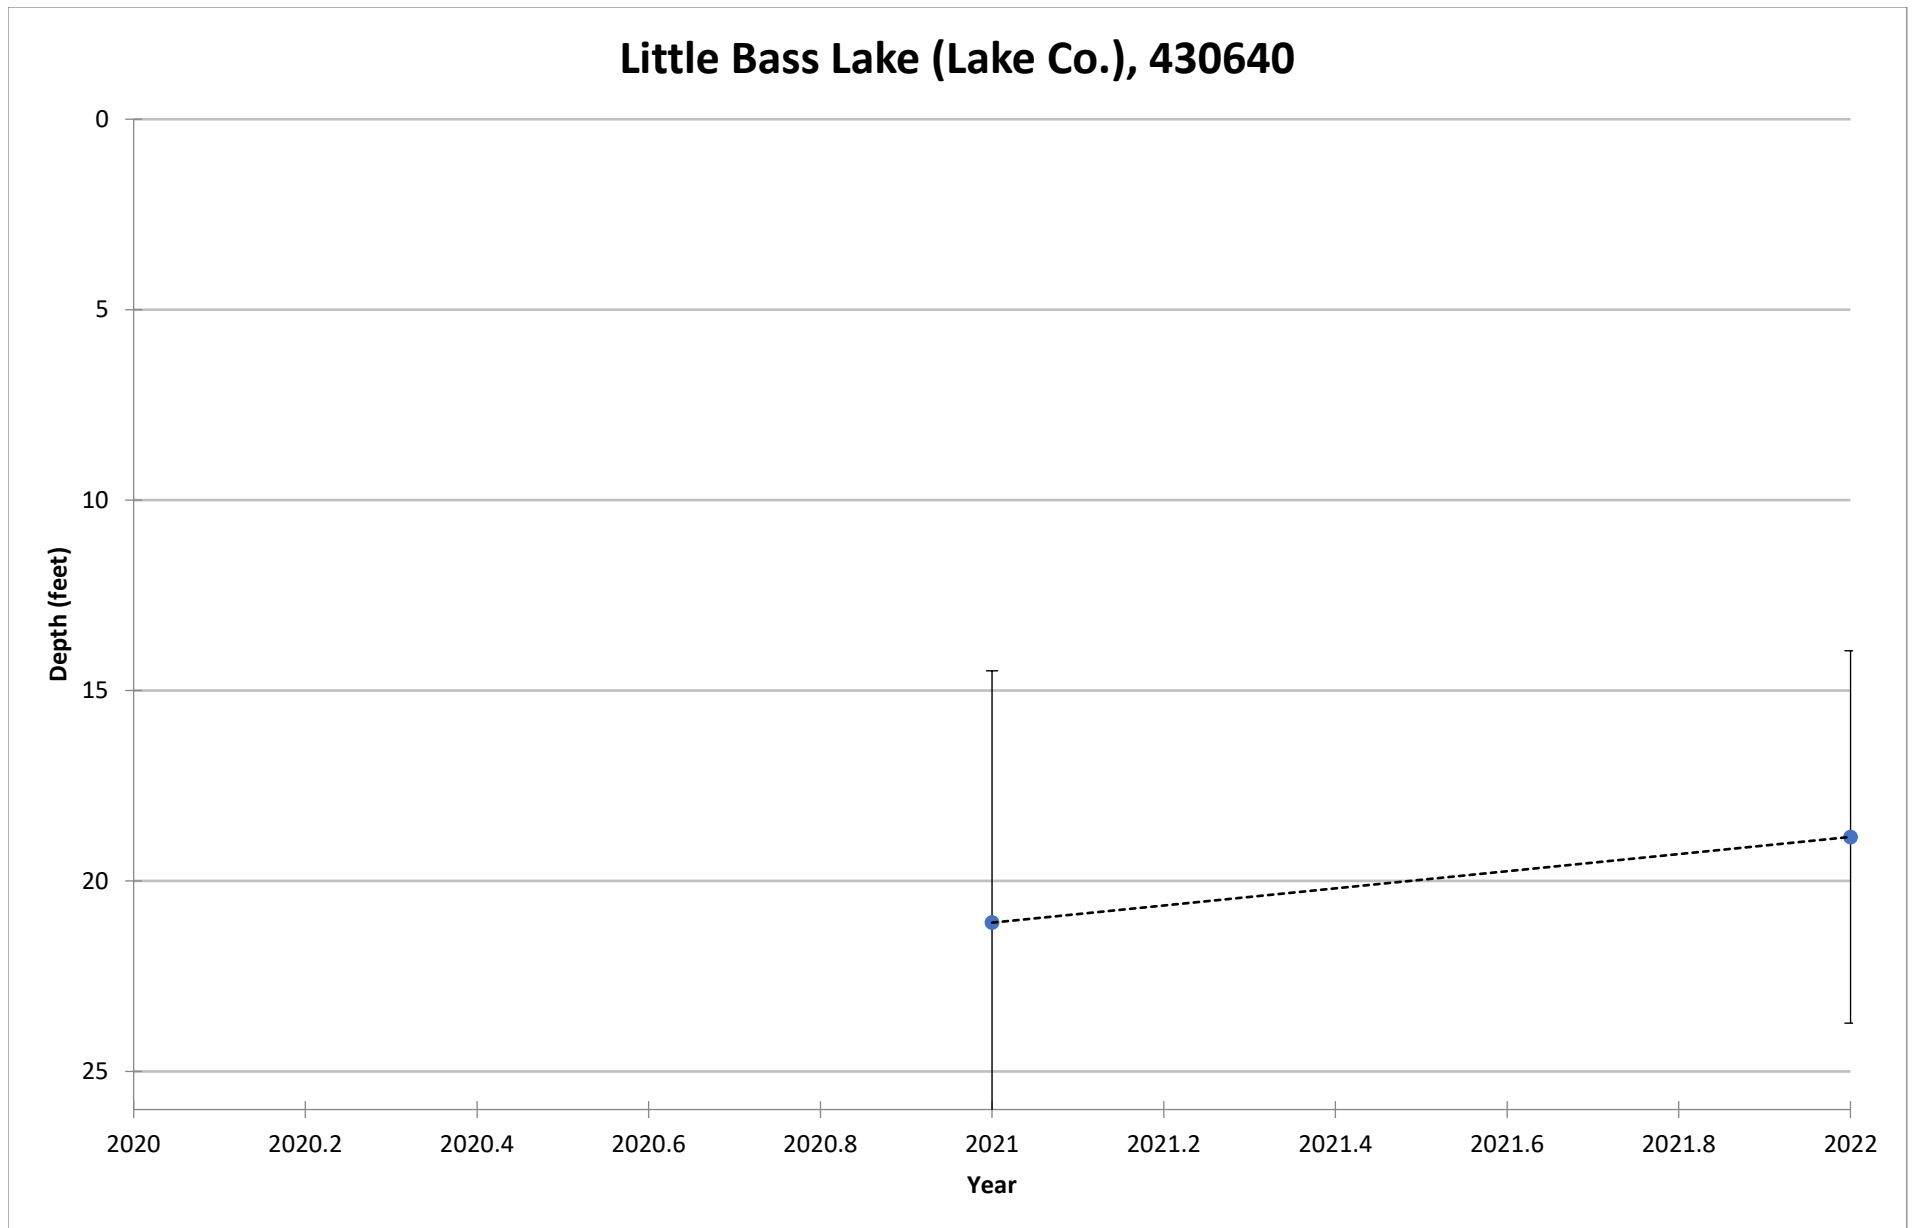
COOPERATIVE LAKES MONITORING PROGRAM
SUMMER MEAN TRANSPARENCY

Little Bass Lake (Lake Co.), 430640

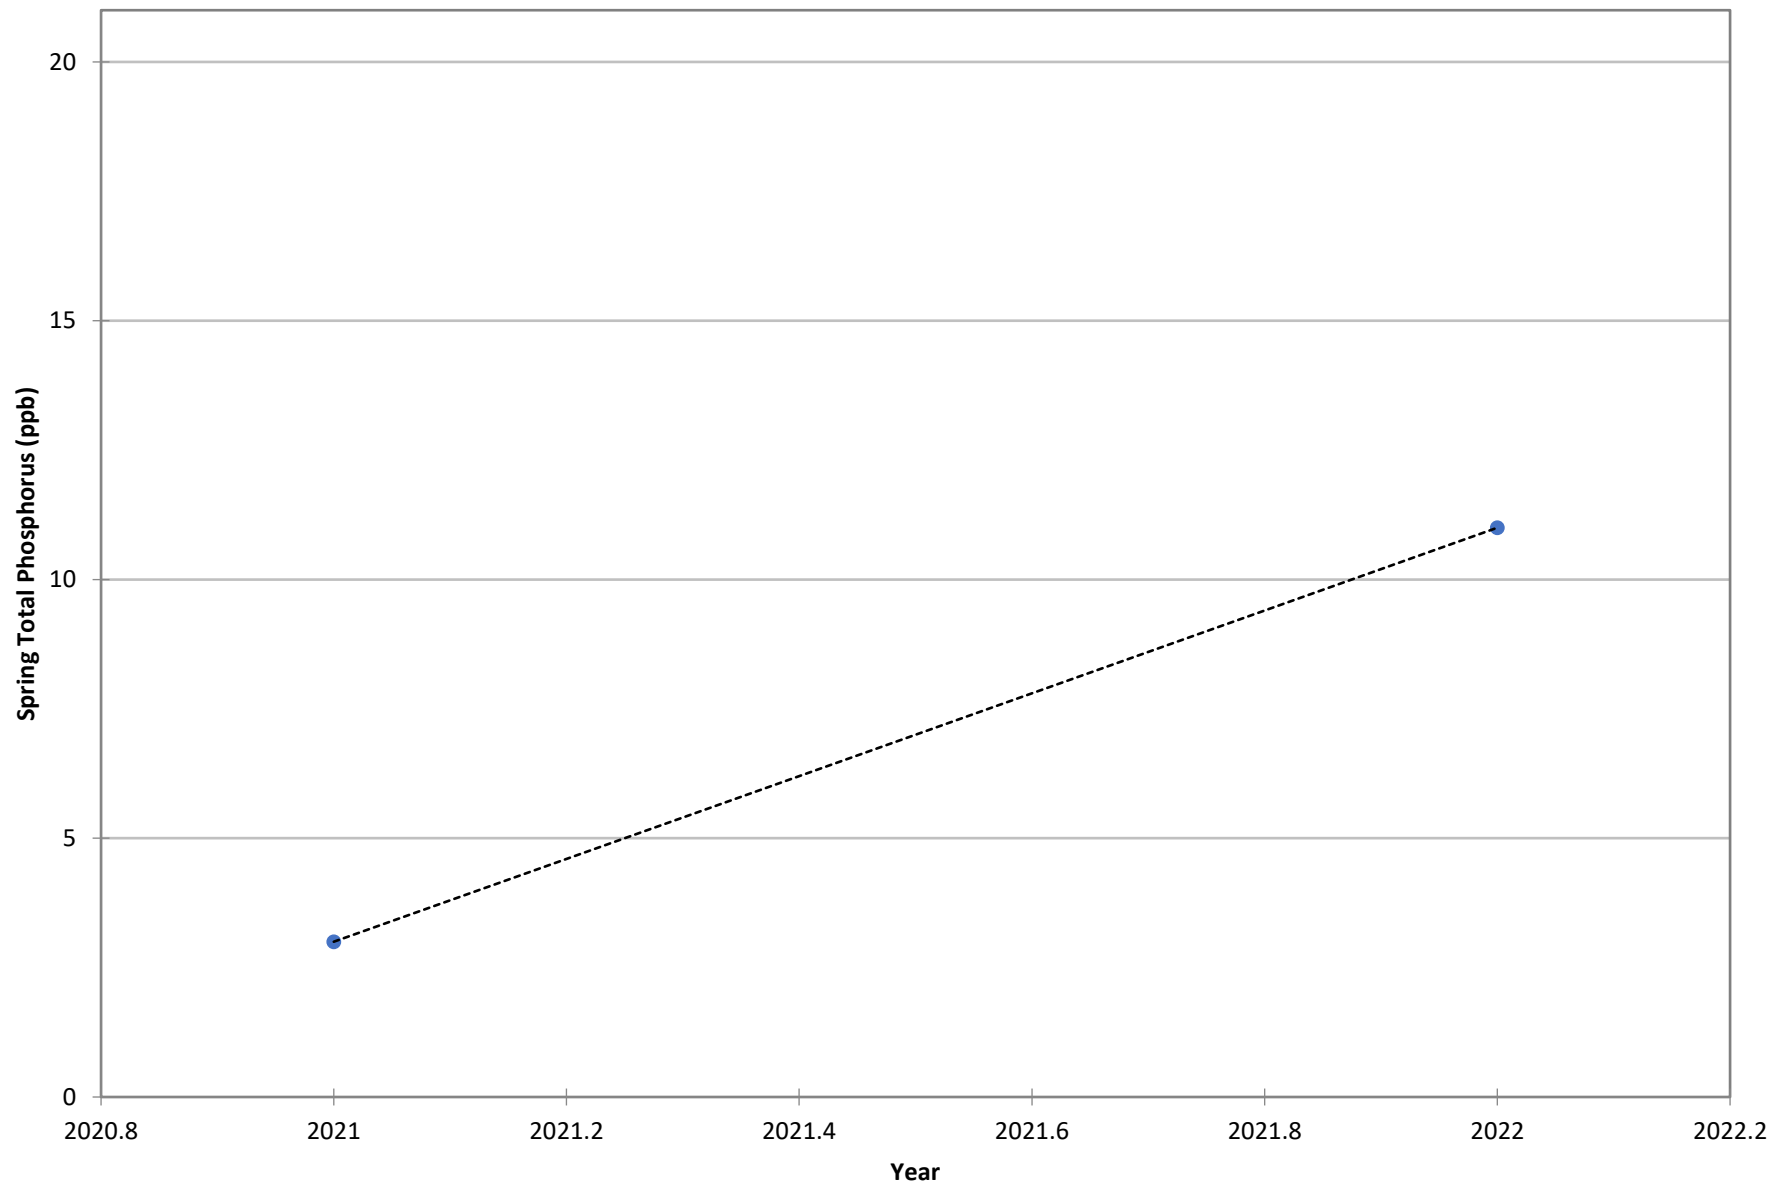
COOPERATIVE LAKES MONITORING PROGRAM
SPRING TOTAL PHOSPHORUS

Little Bass Lake (Lake Co.), 430640

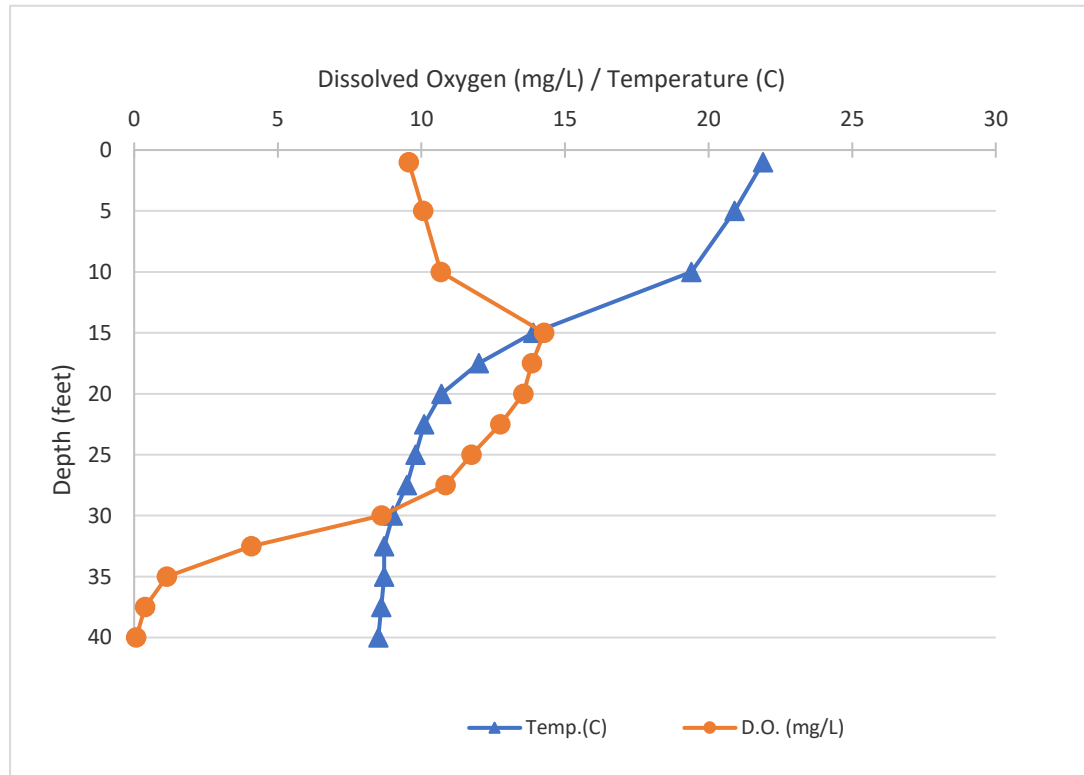
5/31/2022

Dissolved Oxygen and Temperature Profile

Depth (ft)	Temp.(C)	D.O. (mg/L)
1	21.9	9.56
5	20.9	10.06
10	19.4	10.68
15	13.9	14.28
17.5	12	13.85
20	10.7	13.55
22.5	10.1	12.75
25	9.8	11.75
27.5	9.5	10.84
30	9	8.62
32.5	8.7	4.08
35	8.7	1.14
37.5	8.6	0.38
40	8.5	0.07

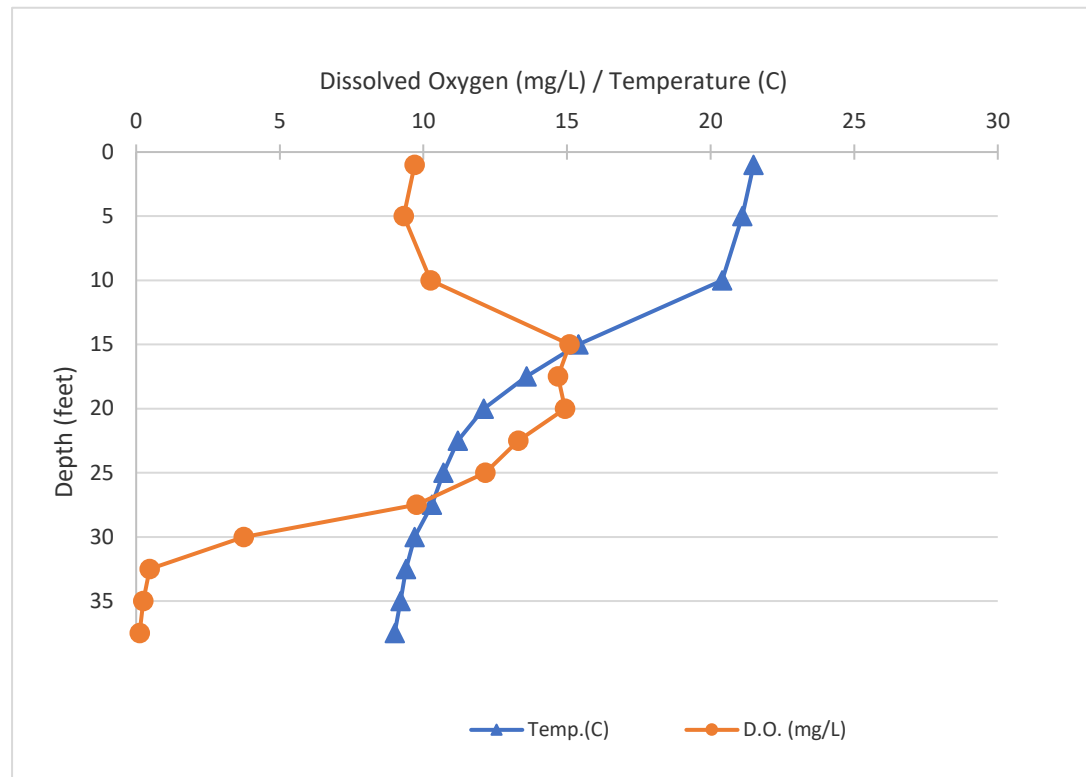
6/14/2022

Dissolved Oxygen and Temperature Profile

Depth (ft)	Temp.(C)	D.O. (mg/L)
1	21.5	9.7
5	21.1	9.32
10	20.4	10.25
15	15.4	15.09
17.5	13.6	14.69
20	12.1	14.93
22.5	11.2	13.31
25	10.7	12.16
27.5	10.3	9.76
30	9.7	3.75
32.5	9.4	0.47
35	9.2	0.25
37.5	9	0.12

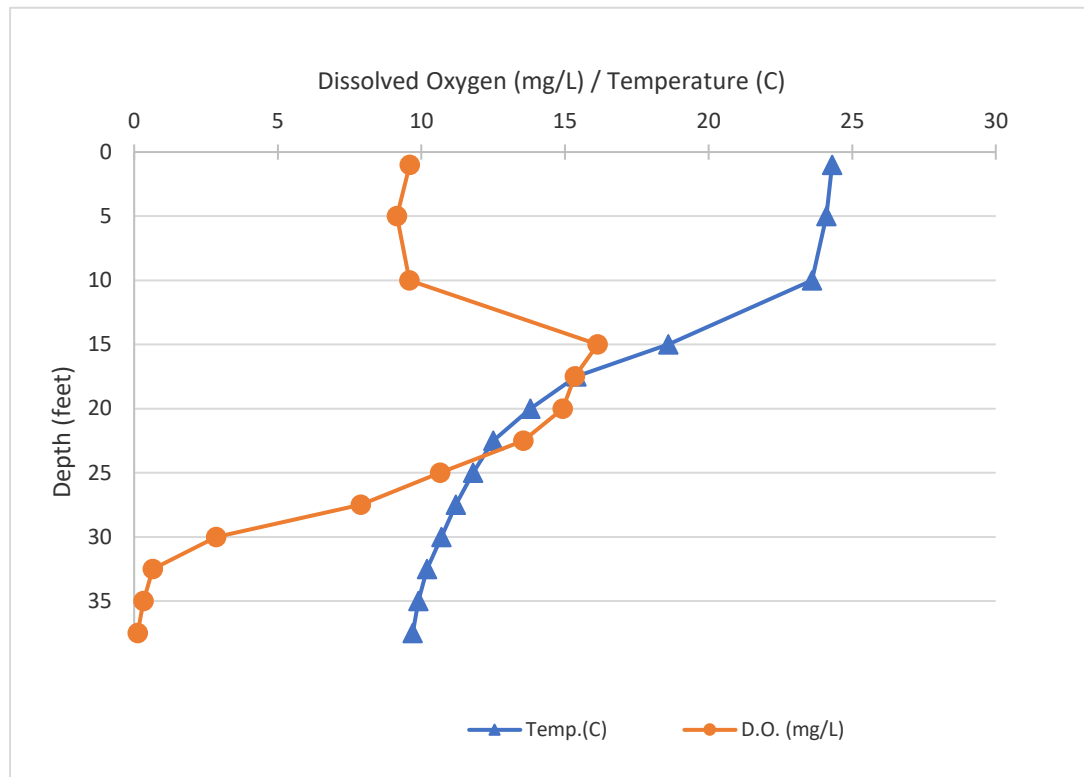
6/30/2022

Dissolved Oxygen and Temperature Profile

Depth (ft)	Temp.(C)	D.O. (mg/L)
1	24.3	9.6
5	24.1	9.15
10	23.6	9.58
15	18.6	16.14
17.5	15.4	15.35
20	13.8	14.92
22.5	12.5	13.55
25	11.8	10.65
27.5	11.2	7.89
30	10.7	2.85
32.5	10.2	0.65
35	9.9	0.33
37.5	9.7	0.12

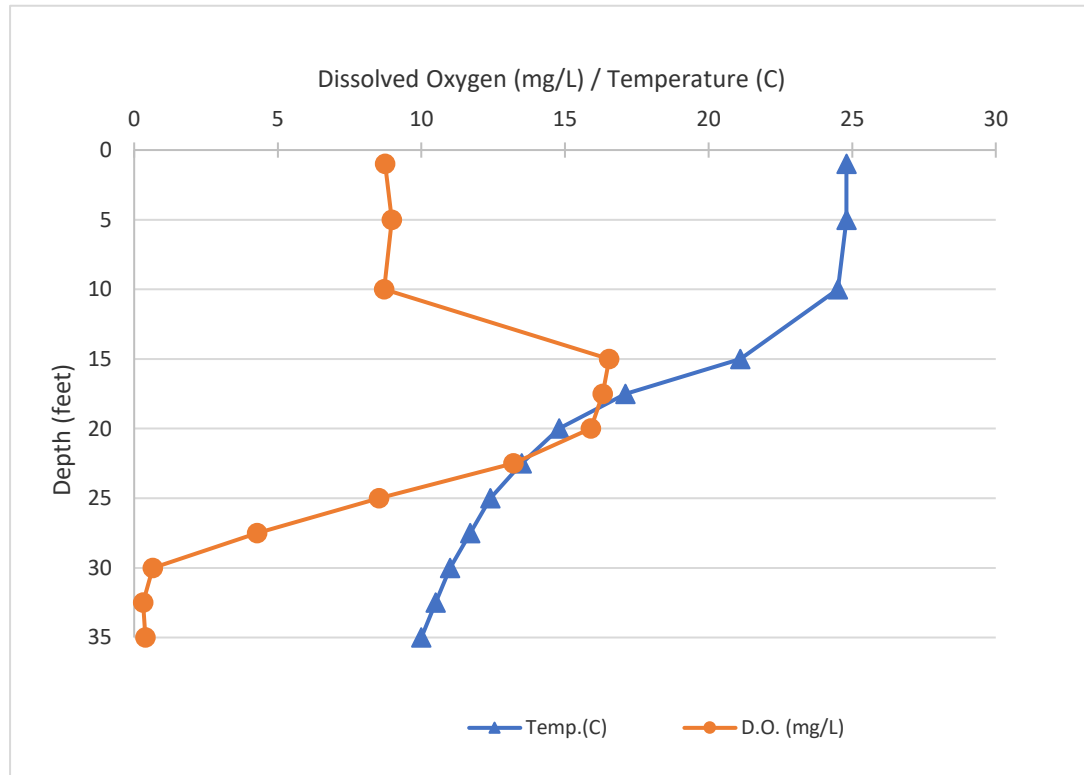
7/13/2022

Dissolved Oxygen and Temperature Profile

Depth (ft)	Temp.(C)	D.O. (mg/L)
1	24.8	8.74
5	24.8	8.97
10	24.5	8.7
15	21.1	16.54
17.5	17.1	16.31
20	14.8	15.9
22.5	13.5	13.21
25	12.4	8.53
27.5	11.7	4.28
30	11	0.65
32.5	10.5	0.31
35	10	0.39

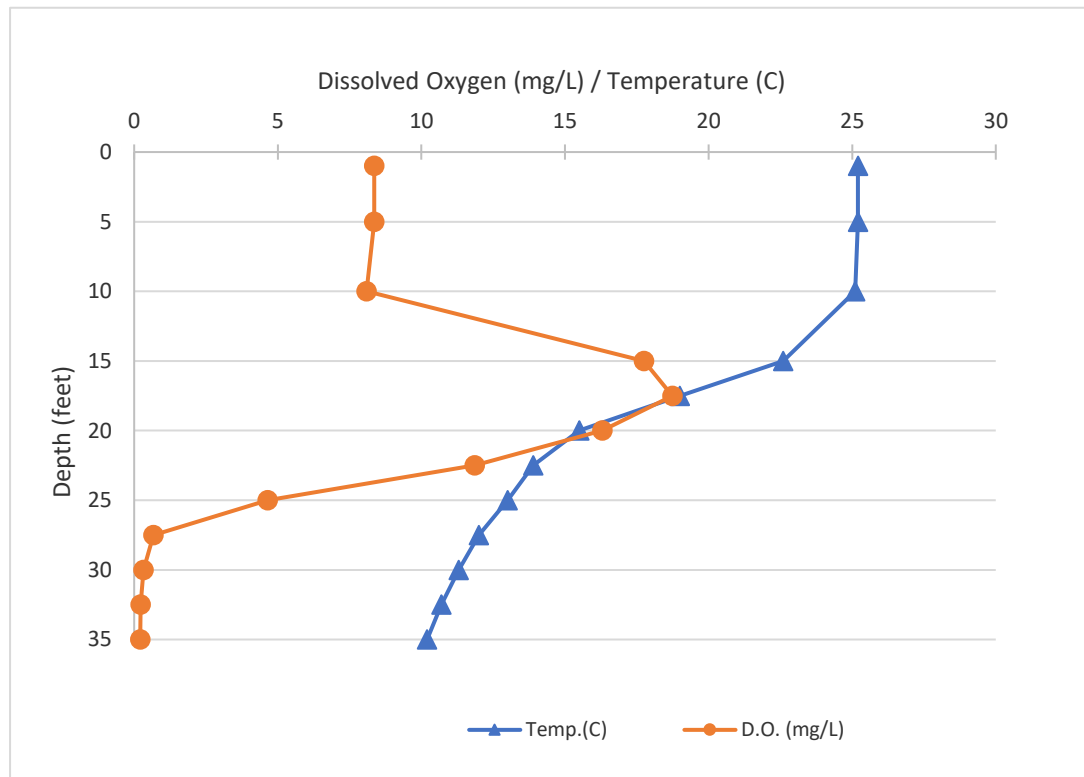
7/29/2022

Dissolved Oxygen and Temperature Profile

Depth (ft)	Temp.(C)	D.O. (mg/L)
1	25.2	8.36
5	25.2	8.36
10	25.1	8.09
15	22.6	17.75
17.5	19	18.74
20	15.5	16.3
22.5	13.9	11.86
25	13	4.65
27.5	12	0.67
30	11.3	0.32
32.5	10.7	0.23
35	10.2	0.21

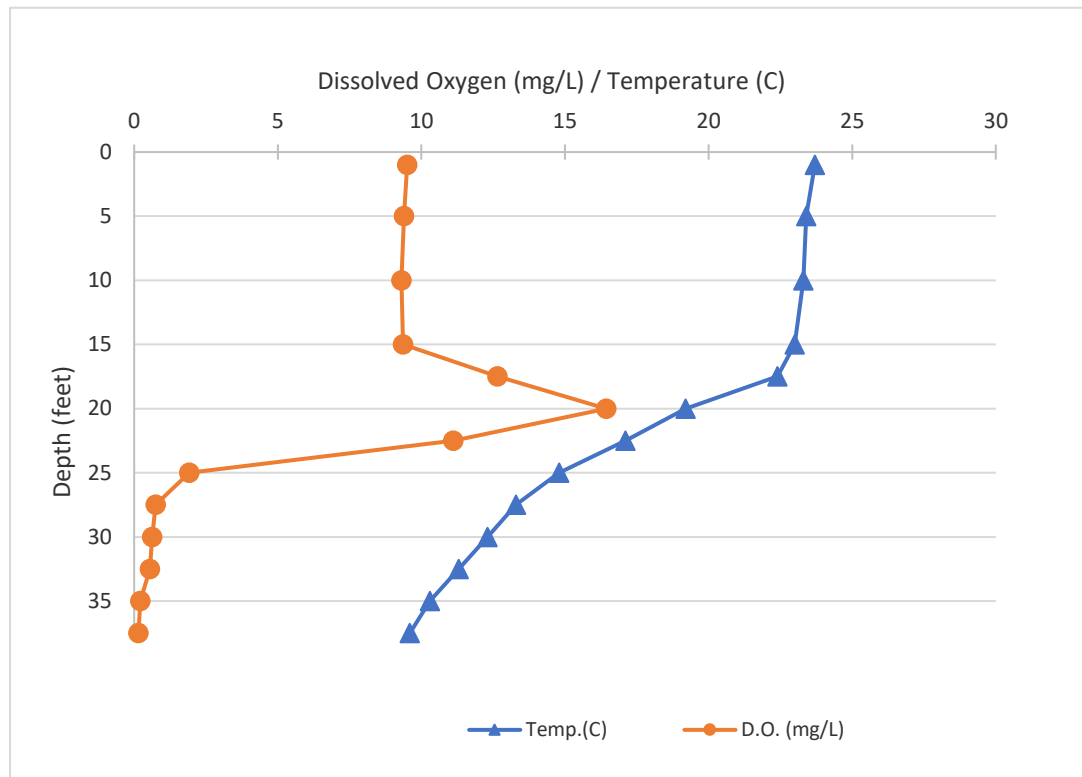
9/9/2022

Dissolved Oxygen and Temperature Profile

Depth (ft)	Temp.(C)	D.O. (mg/L)
1	23.7	9.51
5	23.4	9.4
10	23.3	9.31
15	23	9.36
17.5	22.4	12.65
20	19.2	16.44
22.5	17.1	11.11
25	14.8	1.92
27.5	13.3	0.75
30	12.3	0.63
32.5	11.3	0.55
35	10.3	0.21
37.5	9.6	0.15

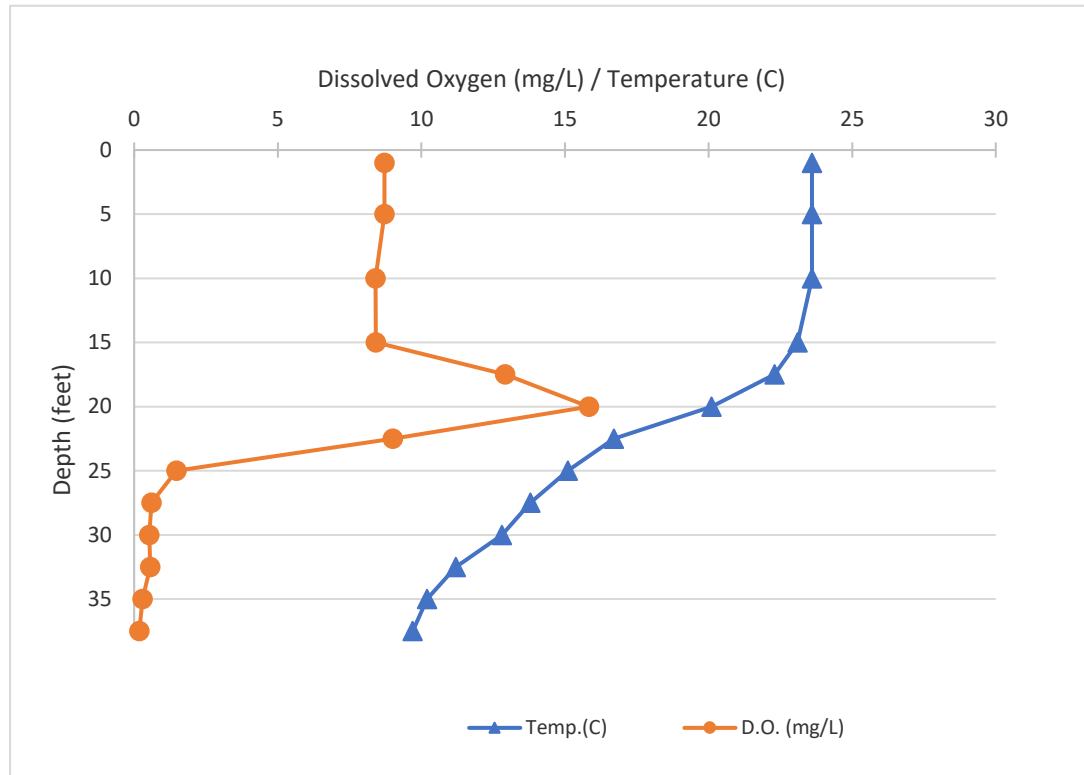
9/11/2022

Dissolved Oxygen and Temperature Profile

Depth (ft)	Temp.(C)	D.O. (mg/L)
1	23.6	8.71
5	23.6	8.71
10	23.6	8.4
15	23.1	8.41
17.5	22.3	12.92
20	20.1	15.83
22.5	16.7	9.01
25	15.1	1.47
27.5	13.8	0.6
30	12.8	0.53
32.5	11.2	0.56
35	10.2	0.29
37.5	9.7	0.18
