2022 Data Report for Beaver Lake, Alpena County

Site ID: 040097

Beaver Lake, Alpena County 2022 CLMP Results

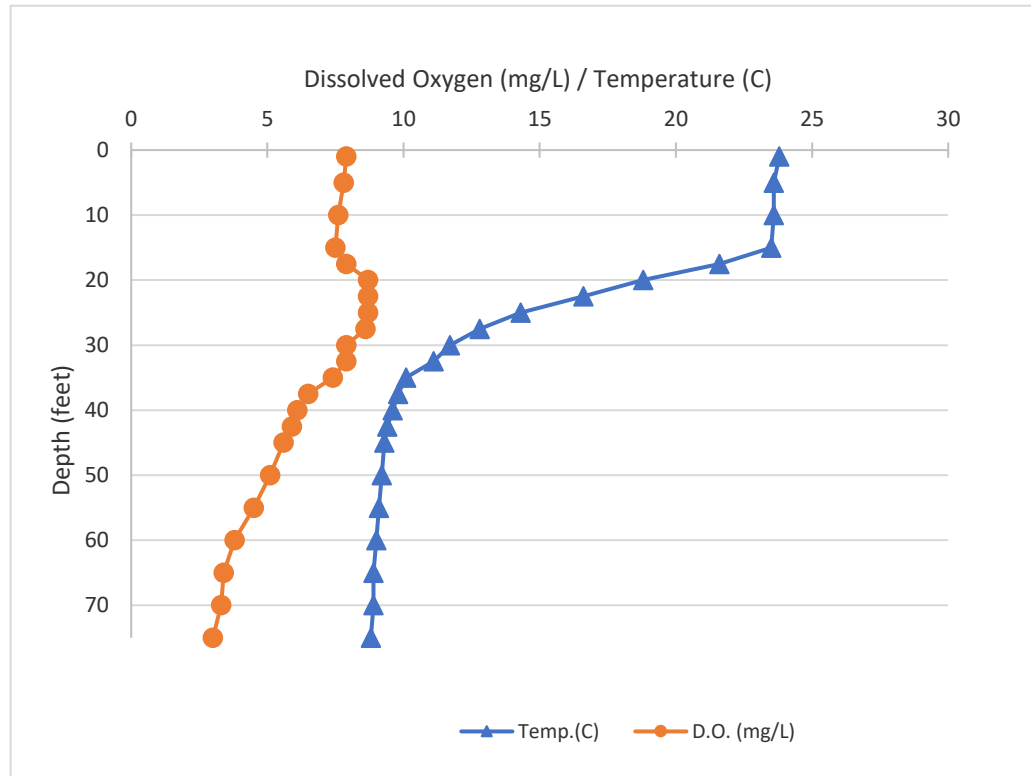
6/23/2012

Dissolved Oxygen and Temperature Profile

Depth (ft)	Temp.(C)	D.O. (mg/L)
1	23.8	7.9
5	23.6	7.8
10	23.6	7.6
15	23.5	7.5
17.5	21.6	7.9
20	18.8	8.7
22.5	16.6	8.7
25	14.3	8.7
27.5	12.8	8.6
30	11.7	7.9
32.5	11.1	7.9
35	10.1	7.4
37.5	9.8	6.5
40	9.6	6.1
42.5	9.4	5.9
45	9.3	5.6
50	9.2	5.1
55	9.1	4.5
60	9	3.8
65	8.9	3.4
70	8.9	3.3
75	8.8	3
