# 2022 Data Report for

# Crystal Lake, Hillsdale County

Site ID: 300269

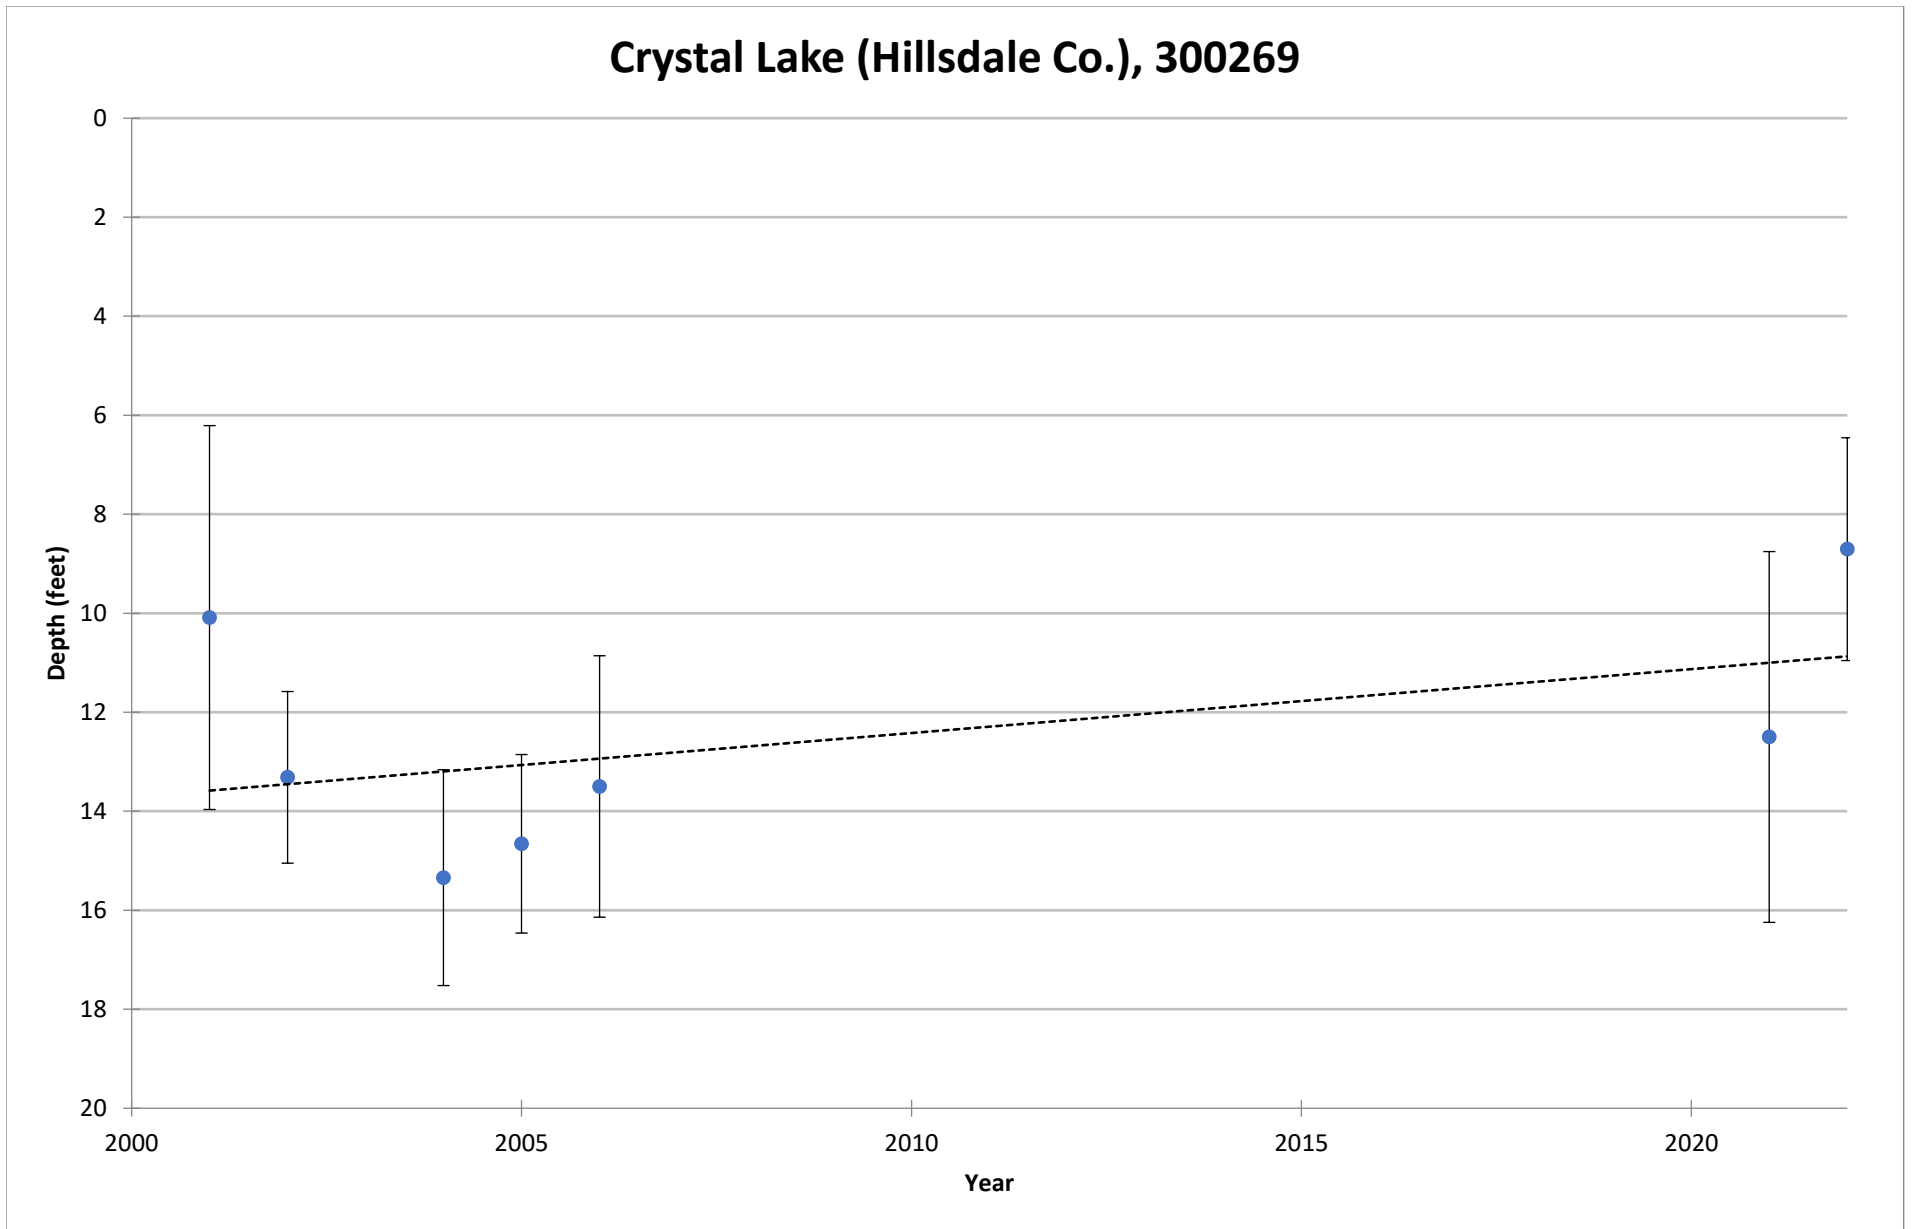
COOPERATIVE LAKES MONITORING PROGRAM  
SUMMER MEAN TRANSPARENCY

Vertical bars indicate standard deviation

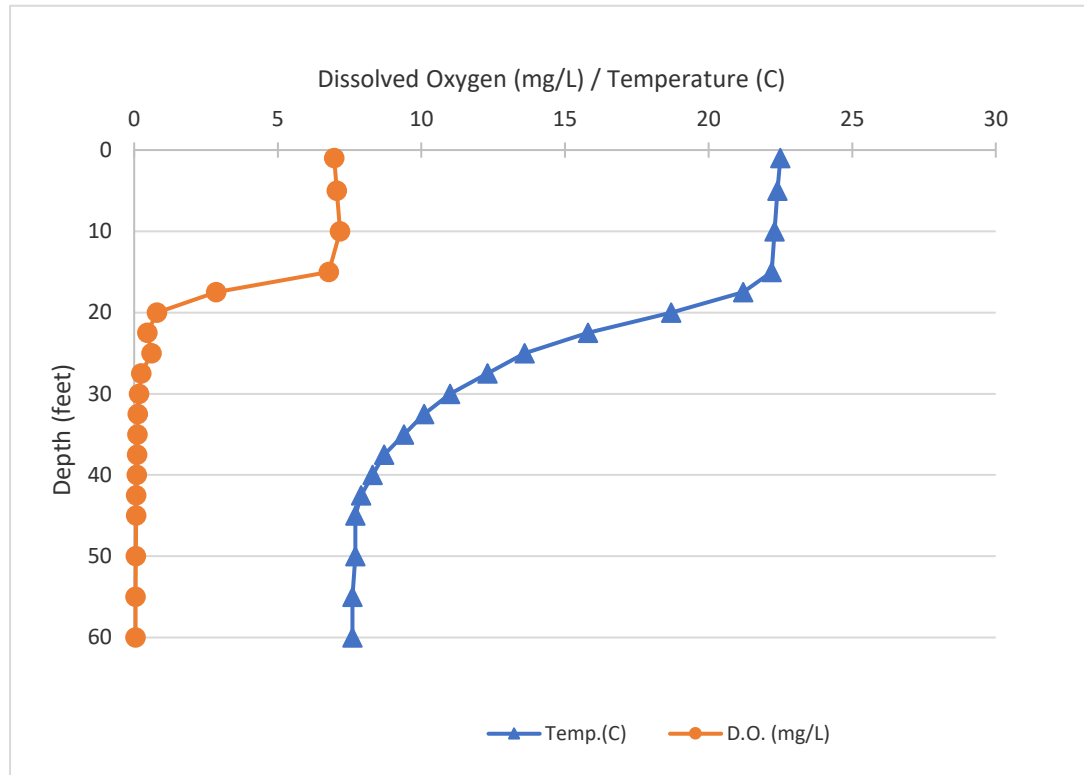
### Dissolved Oxygen and Temperature Profile

Depth (ft)	Temp.(C)	D.O. (mg/L)
1	22.5	6.97
5	22.4	7.06
10	22.3	7.17
15	22.2	6.78
17.5	21.2	2.85
20	18.7	0.79
22.5	15.8	0.46
25	13.6	0.6
27.5	12.3	0.25
30	11	0.17
32.5	10.1	0.13
35	9.4	0.11
37.5	8.7	0.1
40	8.3	0.09
42.5	7.9	0.07
45	7.7	0.07
50	7.7	0.06
55	7.6	0.05
60	7.6	0.05
