2022 Data Report for

First Fortune Lake, Iron County

Site ID: 360080

First Fortune Lake, Iron County 2022 CLMP Results

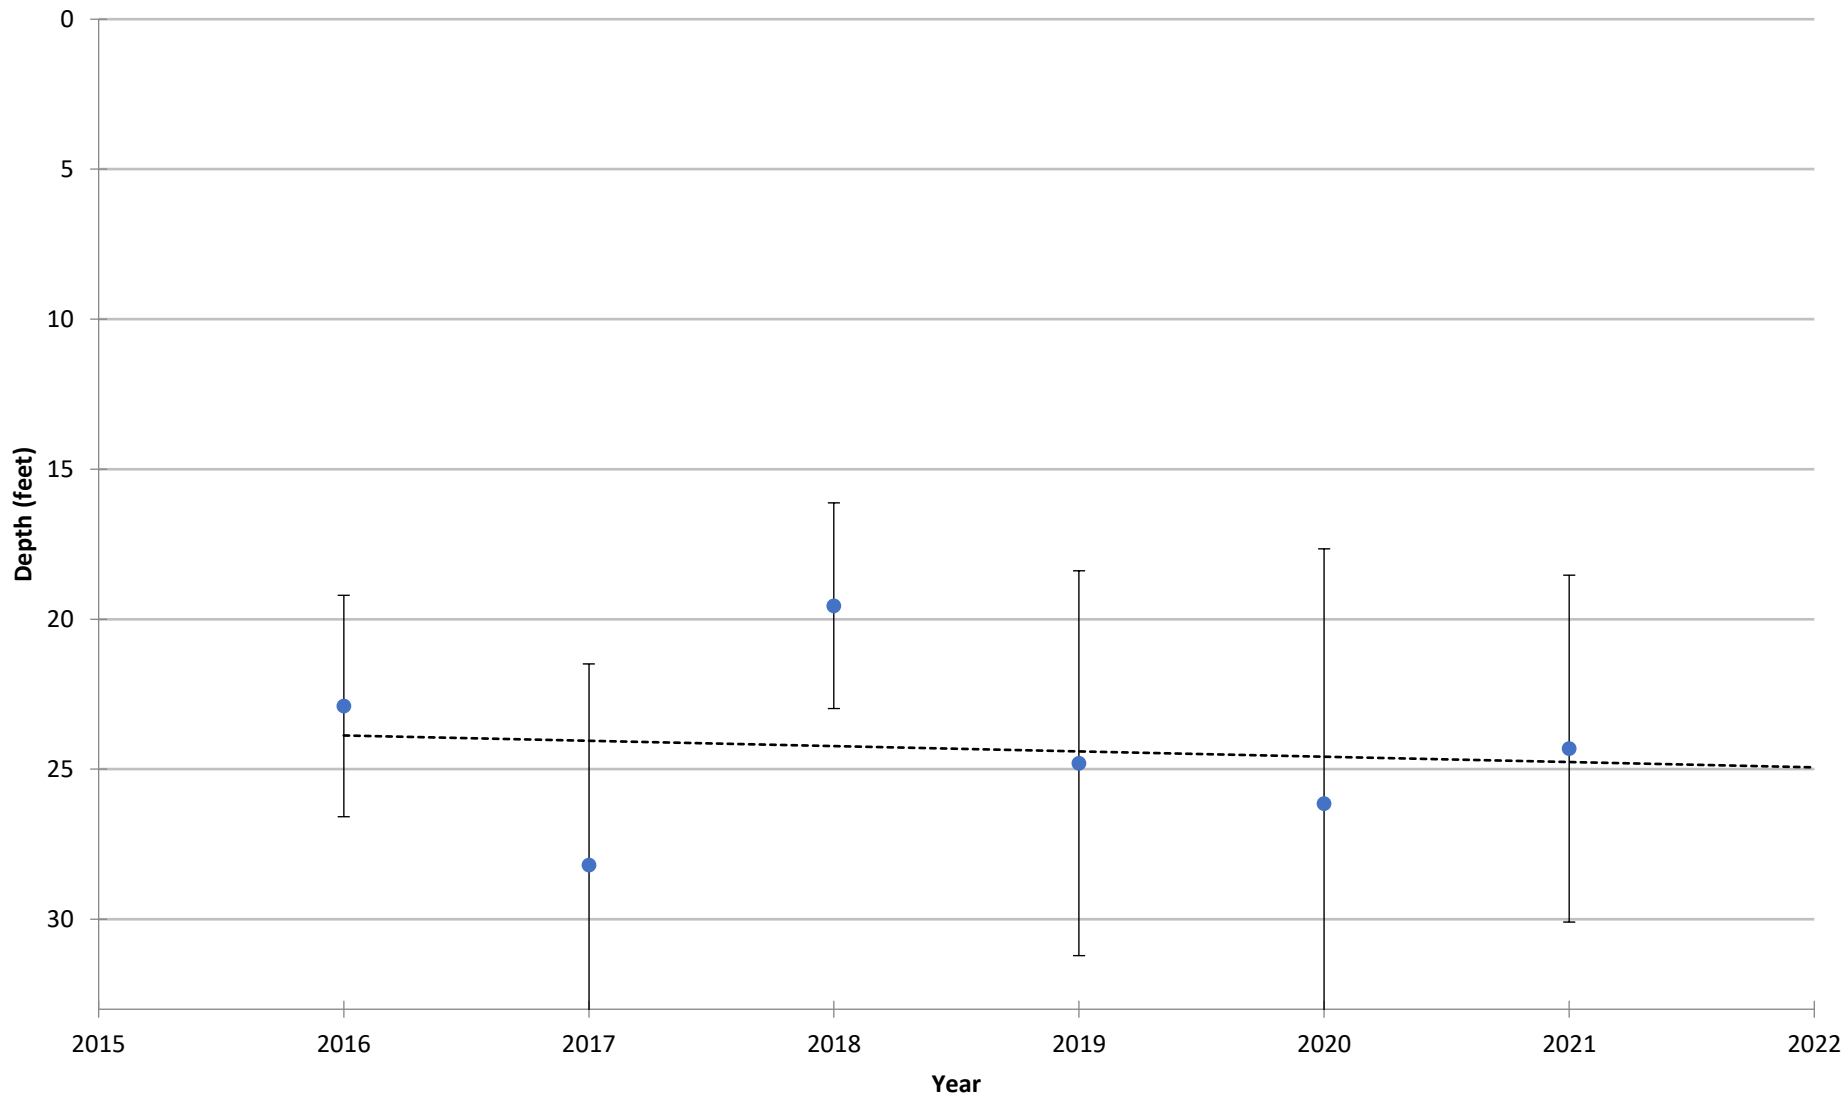
COOPERATIVE LAKES MONITORING PROGRAM
SUMMER MEAN TRANSPARENCY

First Fortune Lake (Iron Co.), 360080

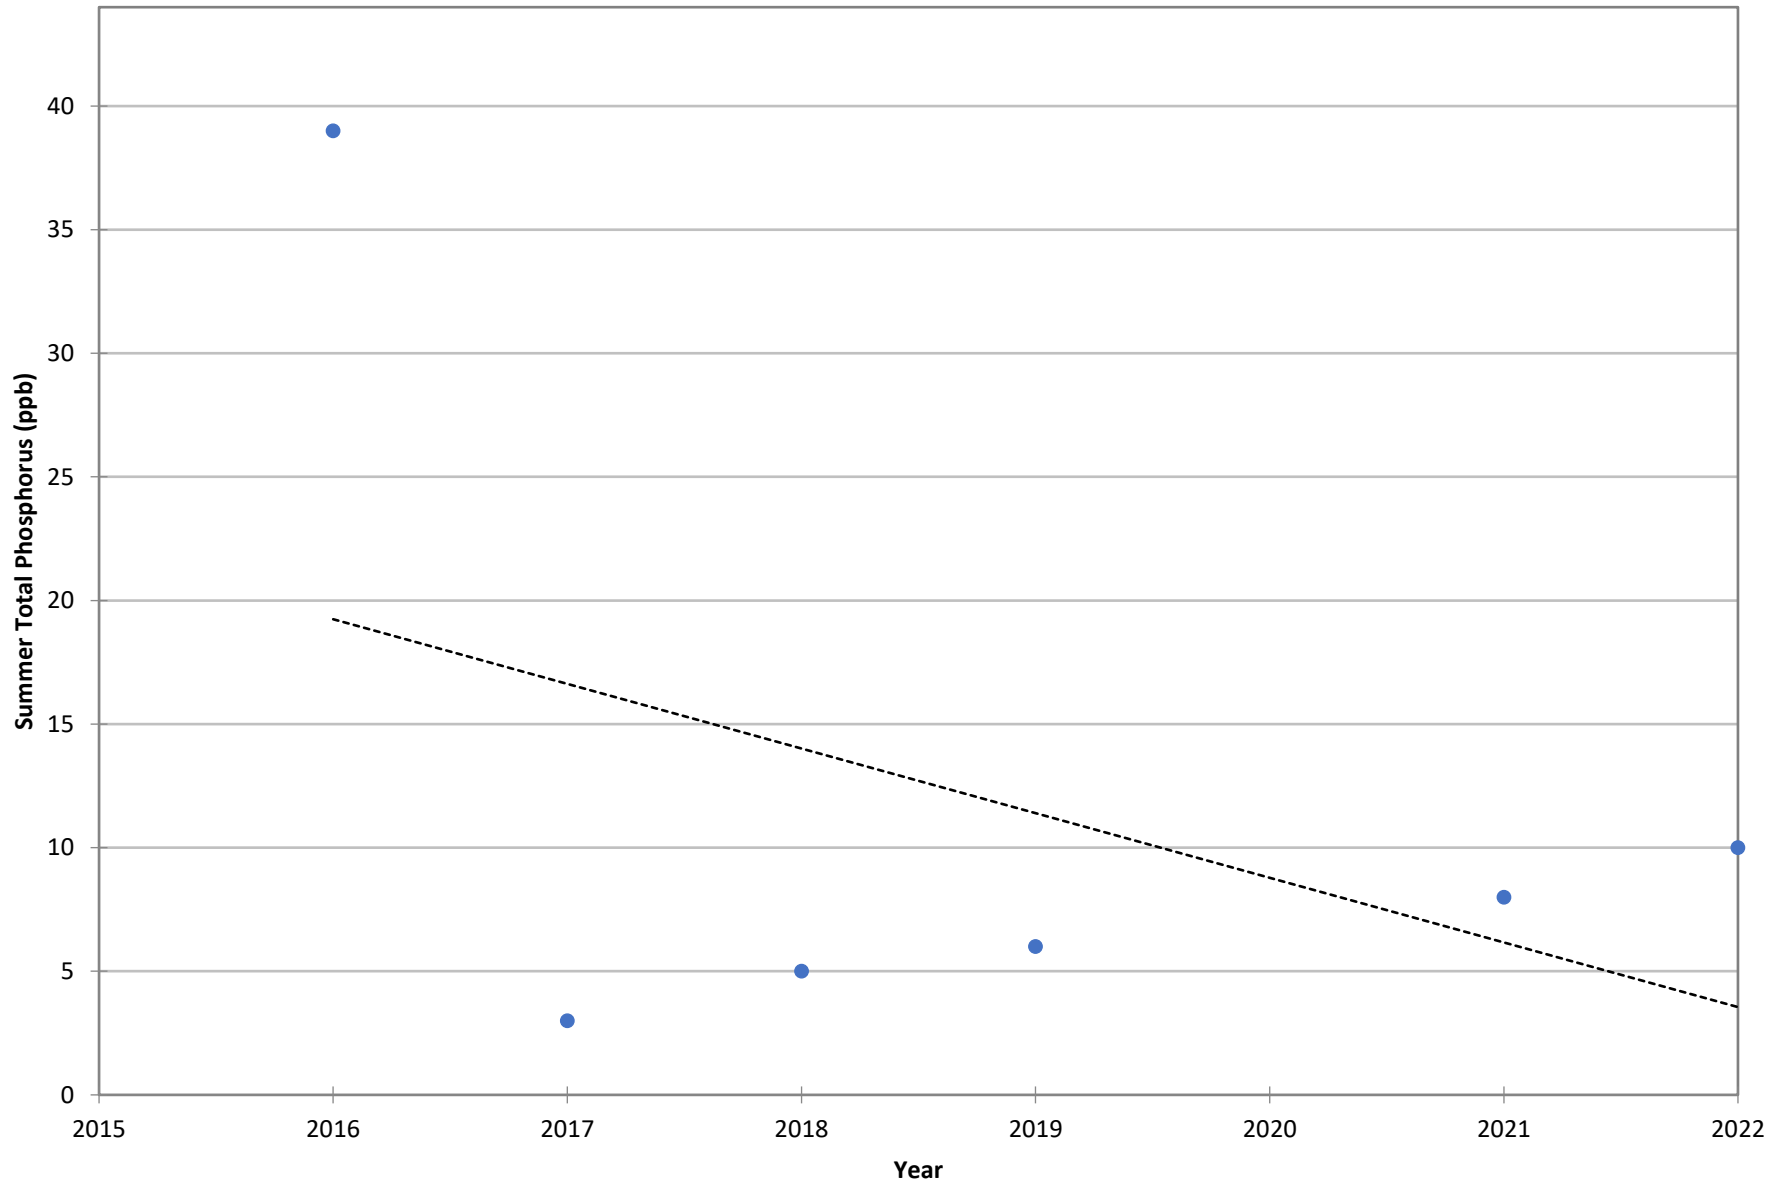
COOPERATIVE LAKES MONITORING PROGRAM
SUMMER TOTAL PHOSPHORUS

First Fortune Lake (Iron Co.), 360080
