2022 Data Report for

Second Fortune Lake, Iron County

Site ID: 360177

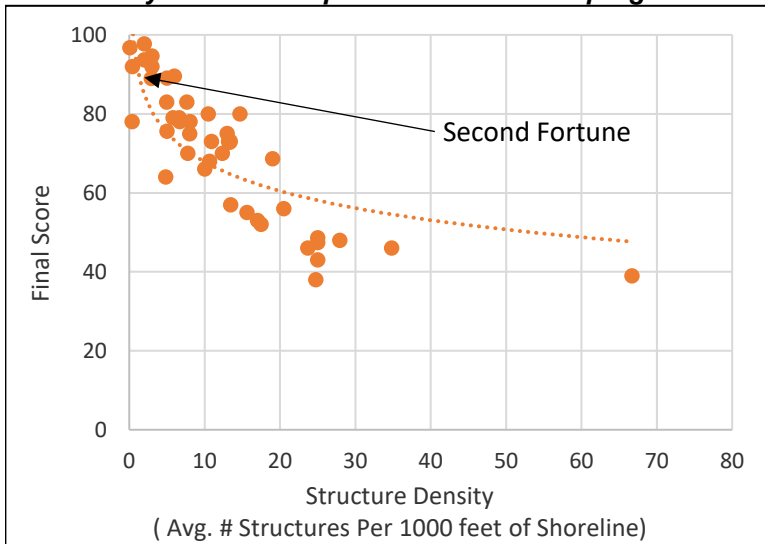
How does your lake compare to others in the program?

Second Fortune Lake:	
Number of Sections:	10
Number of Structures:	53
Structure Density:	5.3
Final Score:	89

All 31 Participating Lakes from 2015-2017:	
Avg. Number of Sections:	16
Avg. Number of Structures:	233
Avg. Structure Density:	14.6
Avg. Final Score:	66

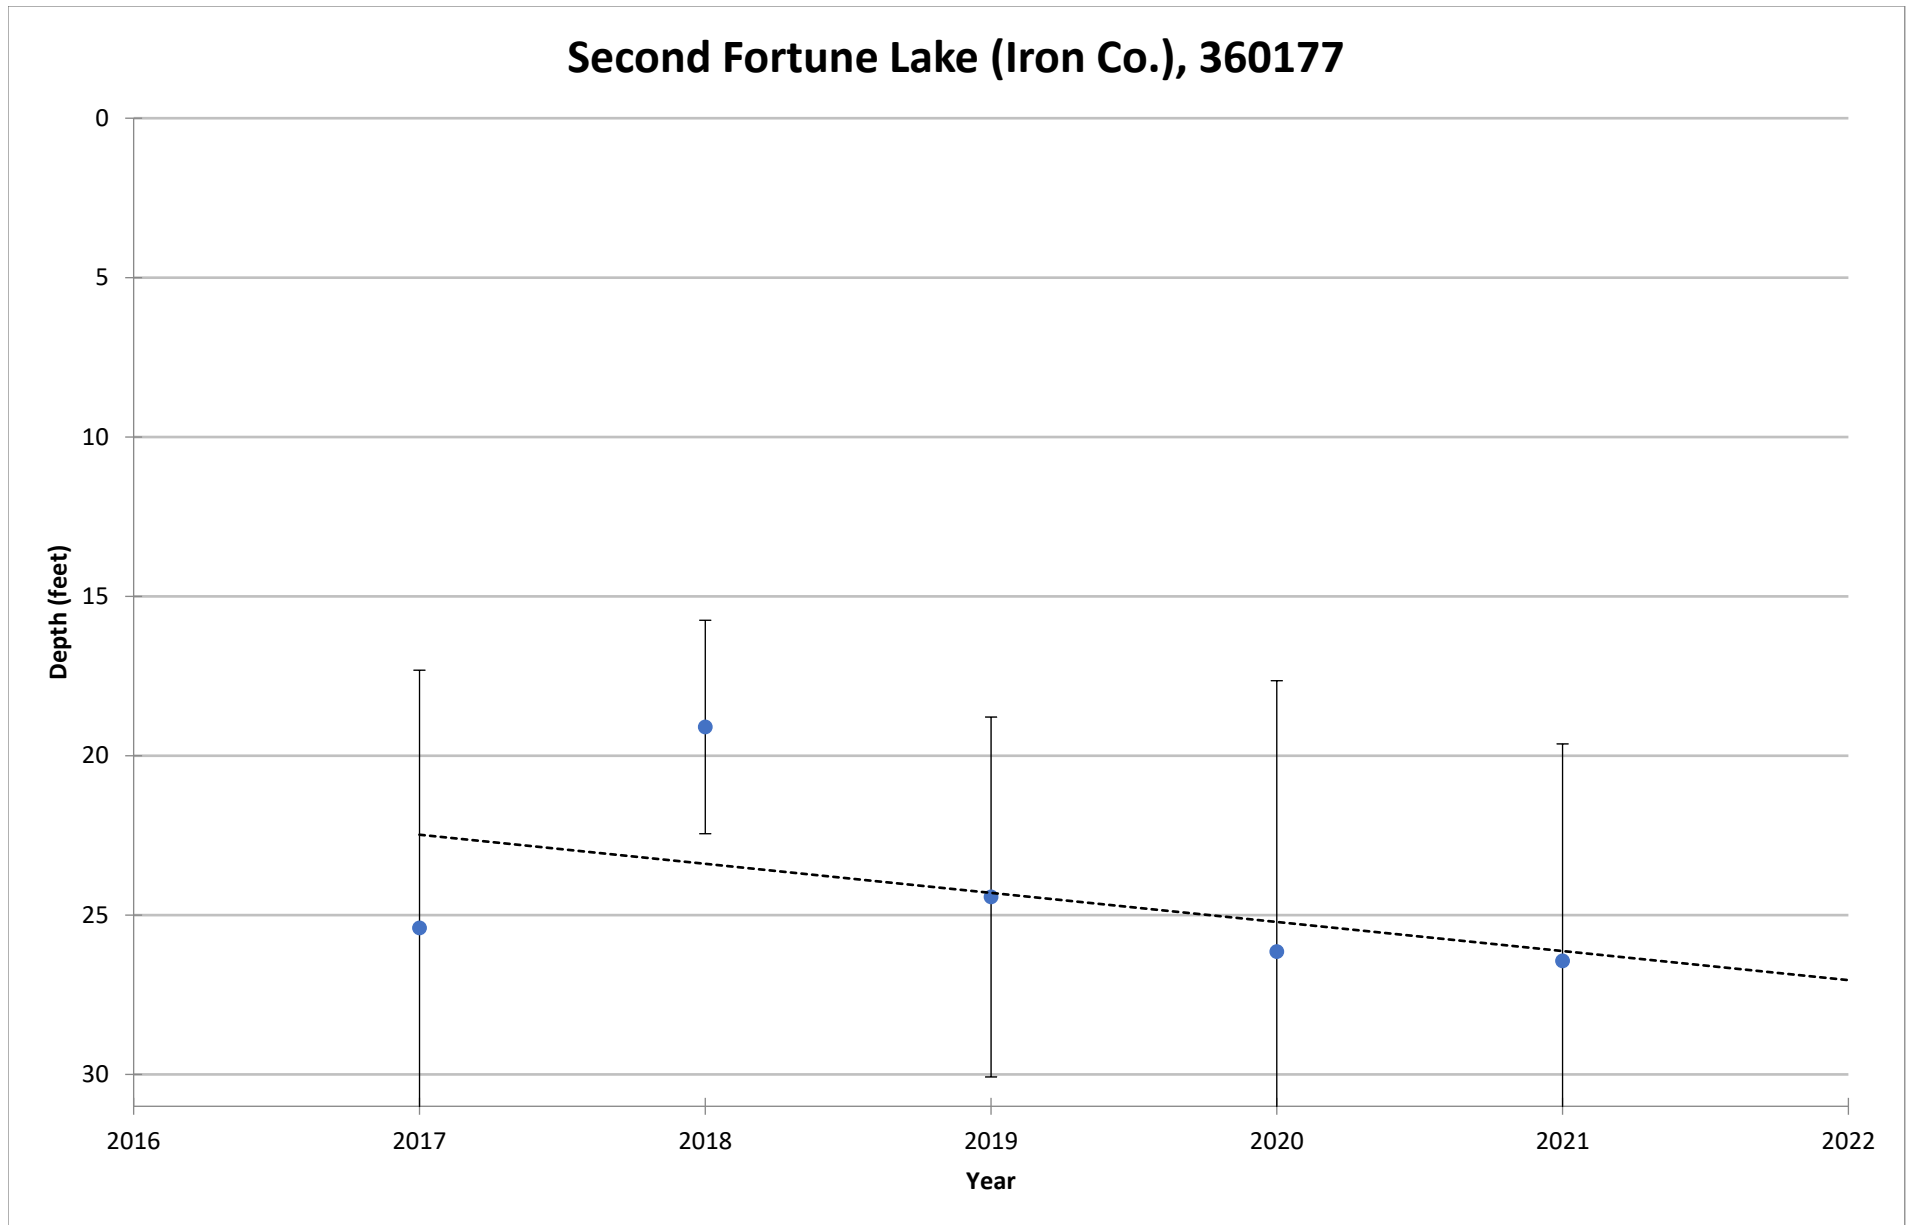
COOPERATIVE LAKES MONITORING PROGRAM
SUMMER MEAN TRANSPARENCY

Second Fortune Lake (Iron Co.), 360177

Vertical bars indicate standard deviation

Secchi Disk Transparency (feet)

Year	# Readings	Min	Max	Average	Std. Dev	Carlson TSI
2022	3*	21.5	26.5			
2017-2021	53	14.5	43.0	24.3	6.5	31
2022 All CLMP Lakes	3178	1.0	63.0	11.6	2.5	43

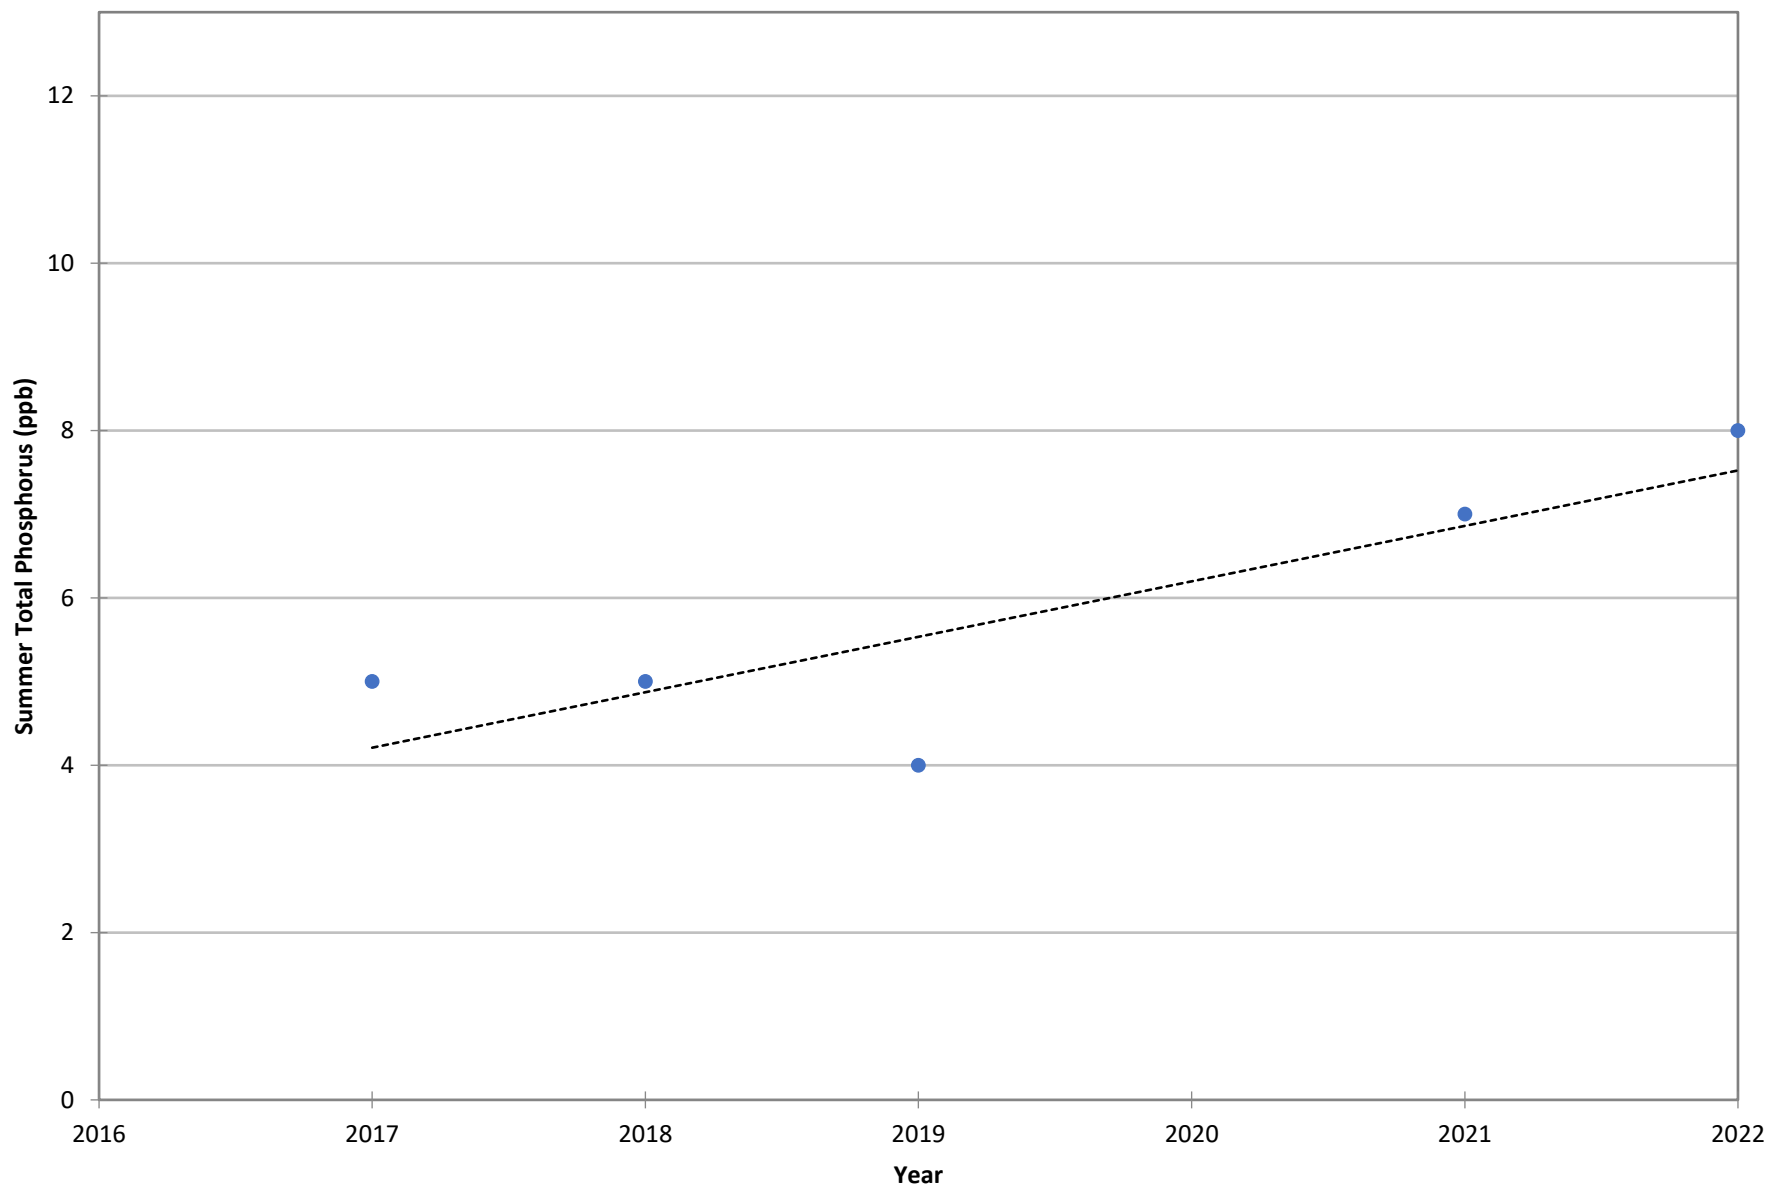
COOPERATIVE LAKES MONITORING PROGRAM
SUMMER TOTAL PHOSPHORUS

Second Fortune Lake (Iron Co.), 360177

Summer Phosphorus (parts per billion)

Year	# Samples	Min	Max	Average	Std. Dev	Carlson TSI
2022	1	8.0	8.0	8.0	NA	34
2017-2021	4	<5 T	7.0	5.3	1.3	28
2022 All CLMP Lakes	234	<= 3	150.0	17.4	15.3	45
