2022 Data Report for Fremont Lake, Newaygo County

Site ID: 620029

Fremont Lake, Newaygo County 2022 CLMP Results

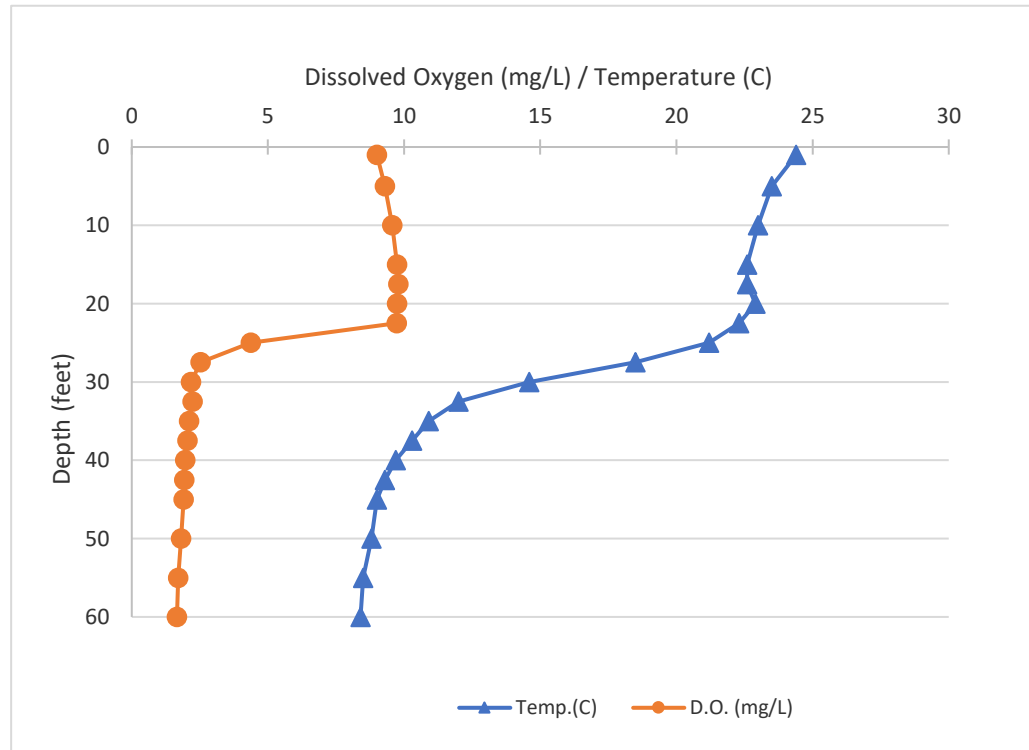
9/8/2022

Dissolved Oxygen and Temperature Profile

Depth (ft)	Temp.(C)	D.O. (mg/L)
1	24.4	9
5	23.5	9.3
10	23	9.57
15	22.6	9.74
17.5	22.6	9.79
20	22.9	9.74
22.5	22.3	9.73
25	21.2	4.37
27.5	18.5	2.53
30	14.6	2.17
32.5	12	2.23
35	10.9	2.11
37.5	10.3	2.04
40	9.7	1.96
42.5	9.3	1.93
45	9	1.9
50	8.8	1.81
55	8.5	1.71
60	8.4	1.66
