2022 Data Report for

Gravel Lake, Van Buren County

Site ID: 800271

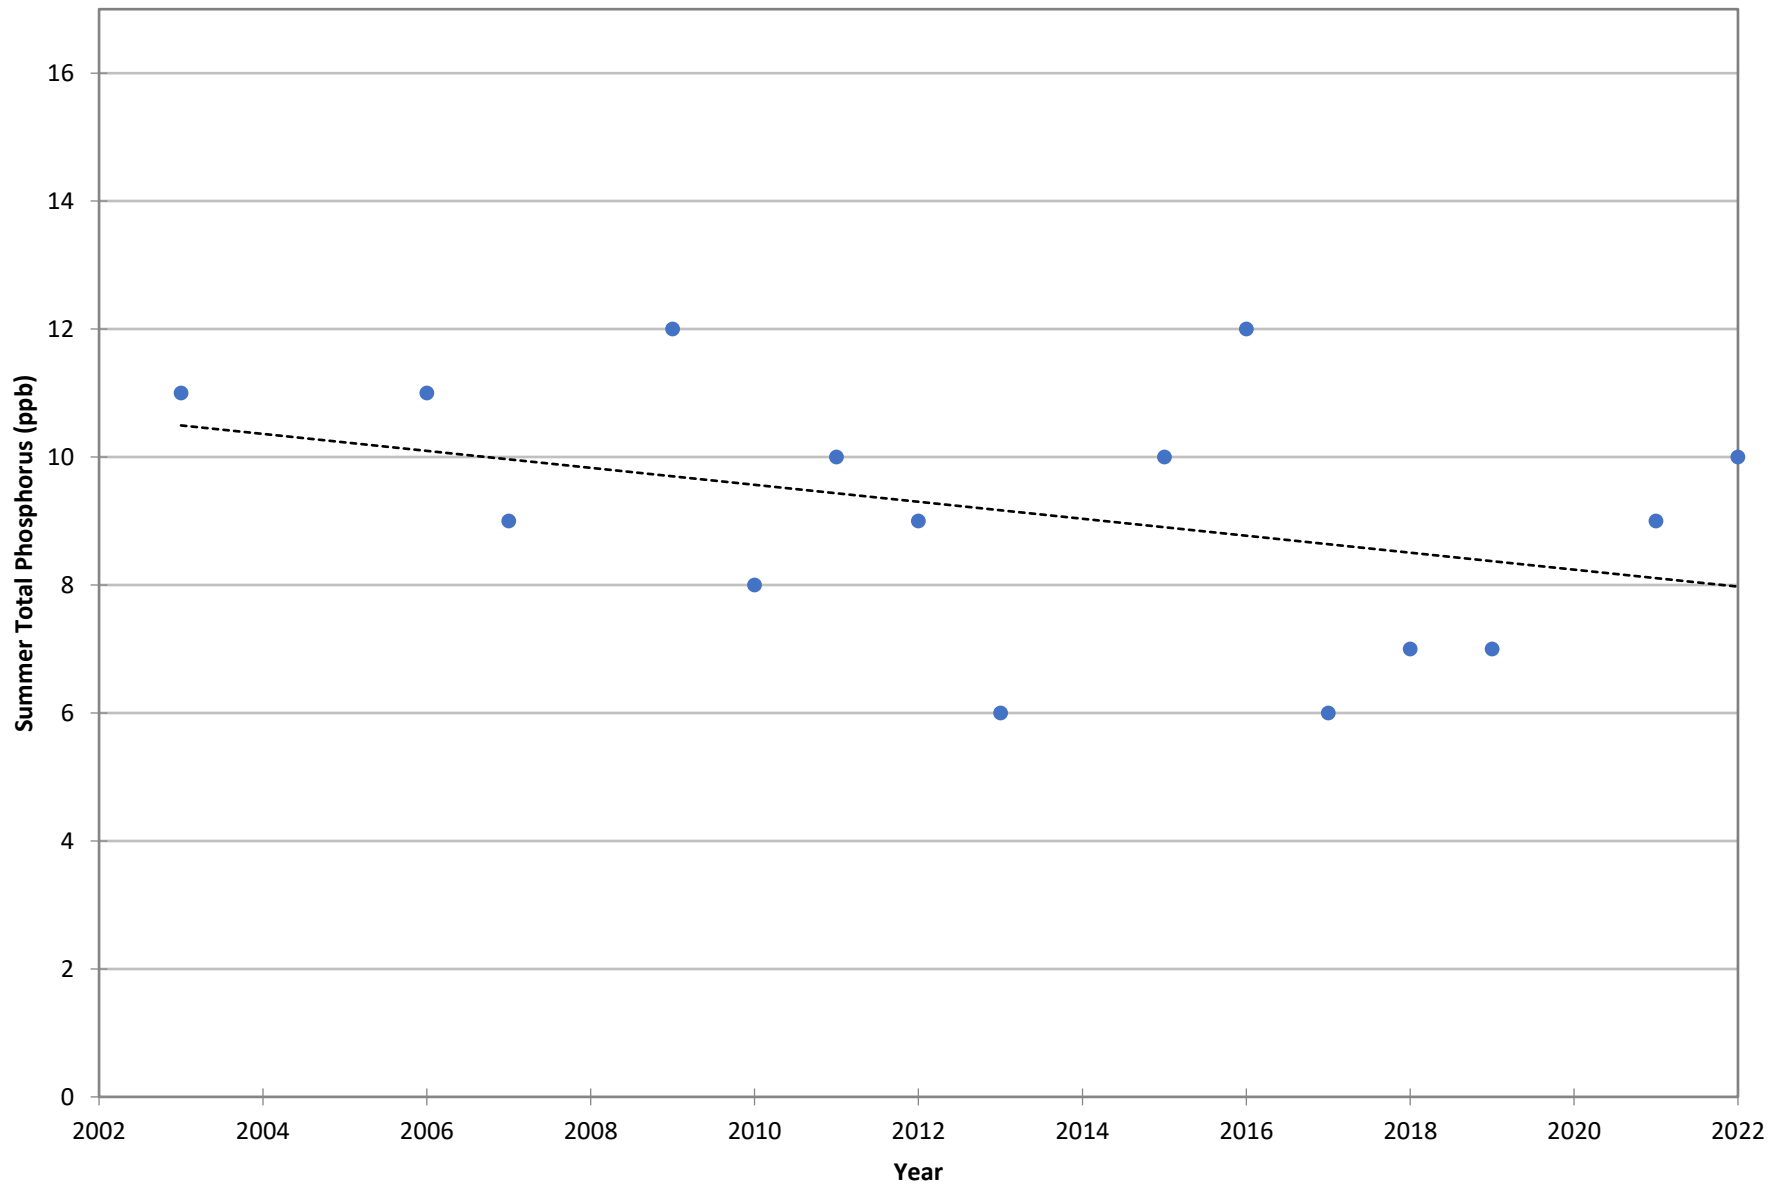
COOPERATIVE LAKES MONITORING PROGRAM
SUMMER TOTAL PHOSPHORUS

Gravel Lake (Van Buren Co.), 800271
