2022 Data Report for Hunter Lake, Gladwin County

Site ID: 260119

Hunter Lake, Gladwin County 2022 CLMP Results

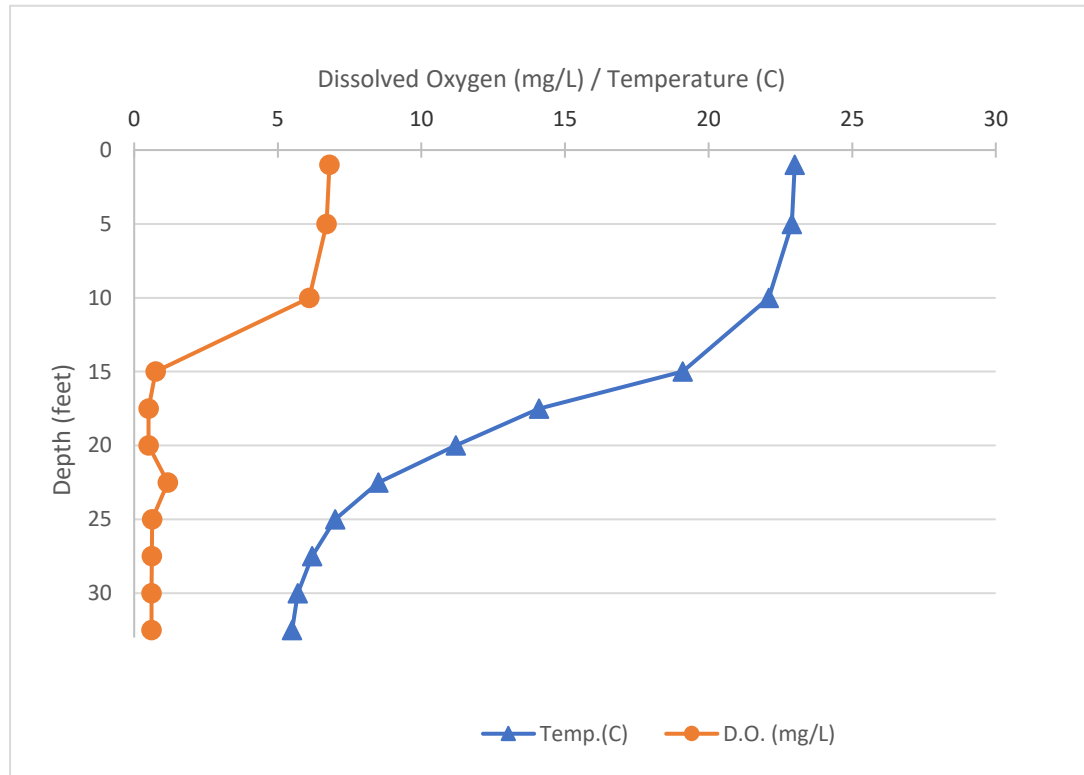
Name: Hunter Lake
County: Gladwin
Site ID: 260119
Date: 9/12/2016

Dissolved Oxygen and Temperature Profile

Depth (ft)	Temp.(C)	D.O. (mg/L)
1	23	6.8
5	22.9	6.7
10	22.1	6.1
15	19.1	0.75
17.5	14.1	0.5
20	11.2	0.5
22.5	8.5	1.17
25	7	0.63
27.5	6.2	0.61
30	5.7	0.6
32.5	5.5	0.6
