2022 Data Report for Juno Lake, Cass County

Site ID: 140058

Juno Lake, Cass County 2022 CLMP Results

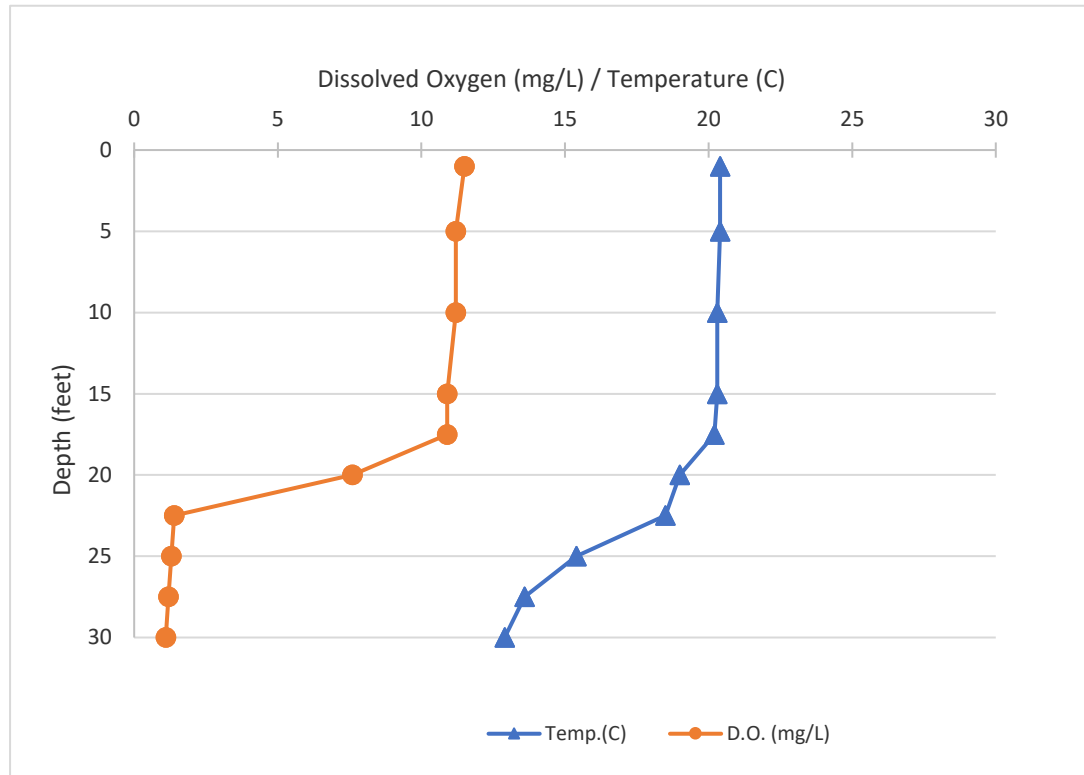
Name: Juno Lake
 County: Cass
 Site ID: 140058
 Date: 9/24/2022

Depth (ft)	Temp.(C)	D.O. (mg/L)
1	20.4	11.5
1	20.4	11.5
5	20.4	11.2
5	20.4	11.2
10	20.3	11.2
10	20.3	11.2
15	20.3	10.9
15	20.3	10.9
17.5	20.2	10.9
17.5	20.2	10.9
20	19	7.6
20	19	7.6
22.5	18.5	1.4
22.5	18.5	1.4
25	15.4	1.3
25	15.4	1.3
27.5	13.6	1.2
27.5	13.6	1.2
30	12.9	1.1
30	12.9	1.1
