# 2022 Data Report for

# Kimball Lake, Newaygo County

Site ID: 620276

# Kimball Lake, Newaygo County 2022 CLMP Results

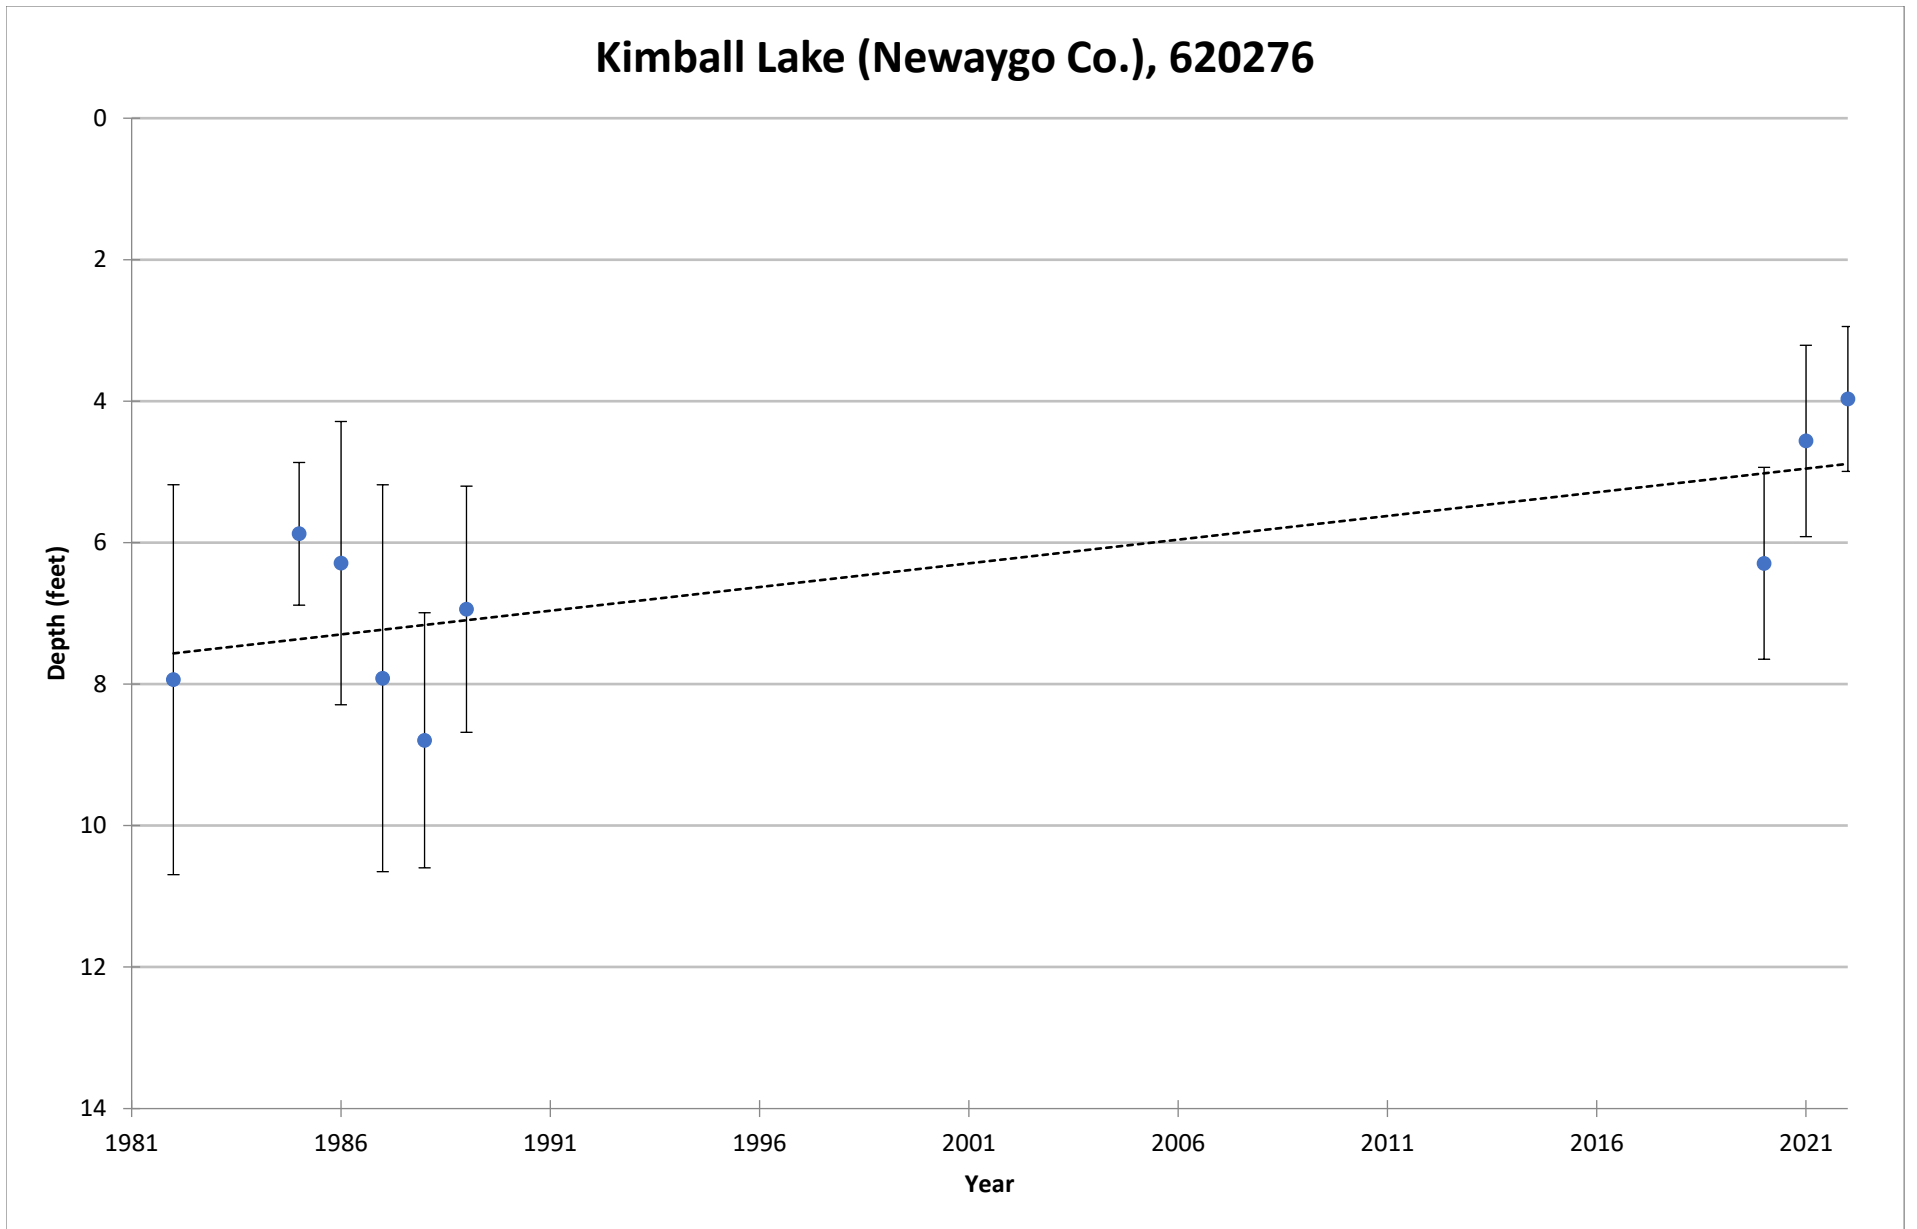
COOPERATIVE LAKES MONITORING PROGRAM  
SUMMER MEAN TRANSPARENCY

**Kimball Lake (Newaygo Co.), 620276**

Vertical bars indicate standard deviation

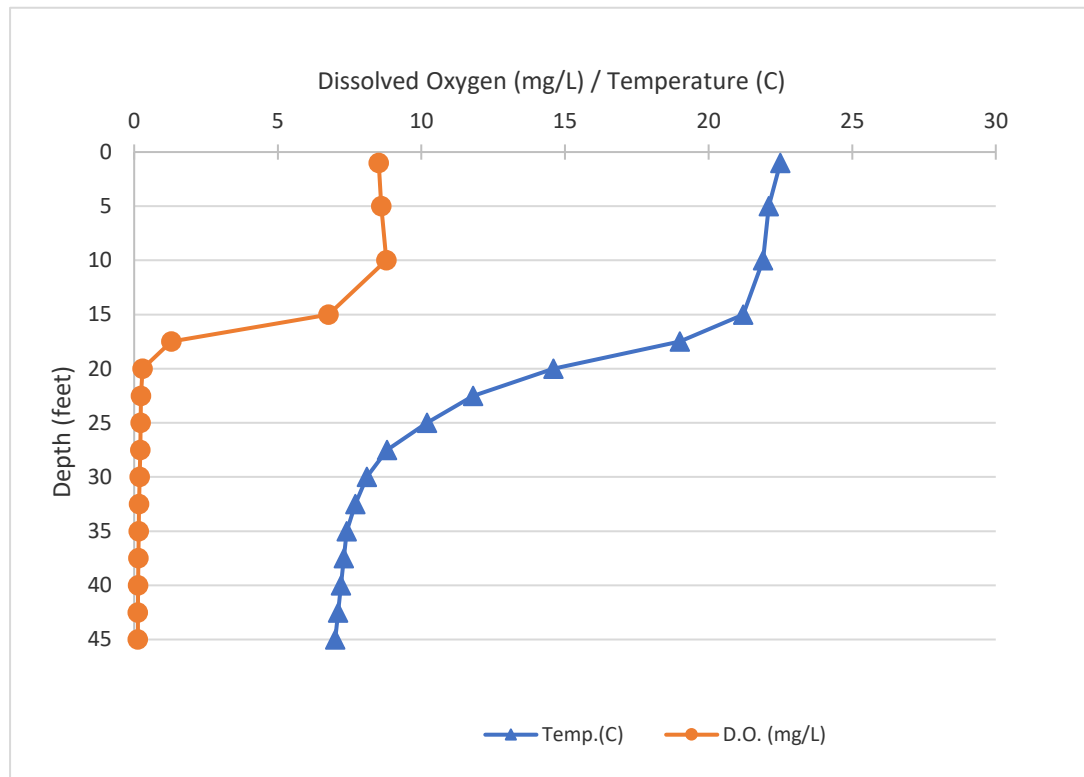
9/17/2022

Depth (ft)	Temp.(C)	D.O. (mg/L)
1	22.5	8.52
5	22.1	8.6
10	21.9	8.78
15	21.2	6.77
17.5	19	1.29
20	14.6	0.29
22.5	11.8	0.24
25	10.2	0.22
27.5	8.8	0.21
30	8.1	0.19
32.5	7.7	0.17
35	7.4	0.16
37.5	7.3	0.15
40	7.2	0.14
42.5	7.1	0.13
45	7	0.13
