2022 Data Report for

Lake Lancelot, Gladwin County

Site ID: 260104

Lake Lancelot, Gladwin County 2022 CLMP Results

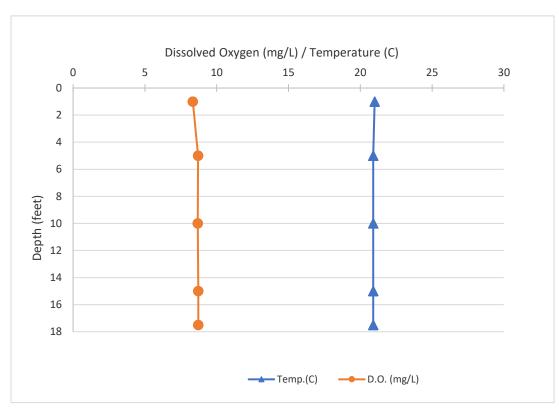
County: Gladwin Site ID: 260104 Date: 9/13/2021

Depth (ft)	Temp.(C)	D.O. (mg/L)
1	21	8.34
1	21	8.34
1	21	8.34
1	21	8.34
5	20.9	8.7
5	20.9	8.7
5	20.9	8.7
5	20.9	8.7
10	20.9	8.68
10	20.9	8.68
10	20.9	8.68
10	20.9	8.68
15	20.9	8.72
15	20.9	8.72
15	20.9	8.72
15	20.9	8.72
17.5	20.9	8.72
17.5	20.9	8.72
17.5	20.9	8.72
17.5	20.9	8.72
