# 2022 Data Report for

# Lake Lancer, Gladwin County

# Lake Lancer, Gladwin County 2022 CLMP Results

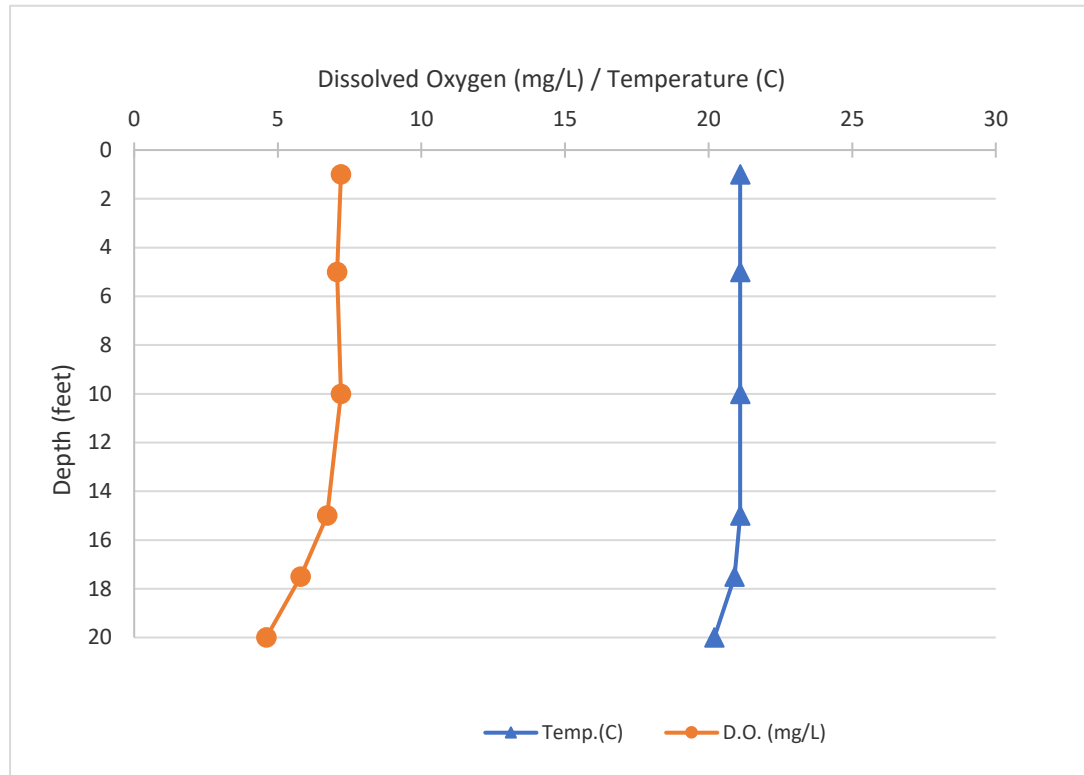
9/12/2021

Depth (ft)	Temp.(C)	D.O. (mg/L)
1	21.1	7.2
5	21.1	7.07
10	21.1	7.2
15	21.1	6.72
17.5	20.9	5.8
20	20.2	4.6
