# 2022 Data Report for West Maggie Lake, Iron County

Site ID: 360172

# West Maggie Lake, Iron County 2022 CLMP Results

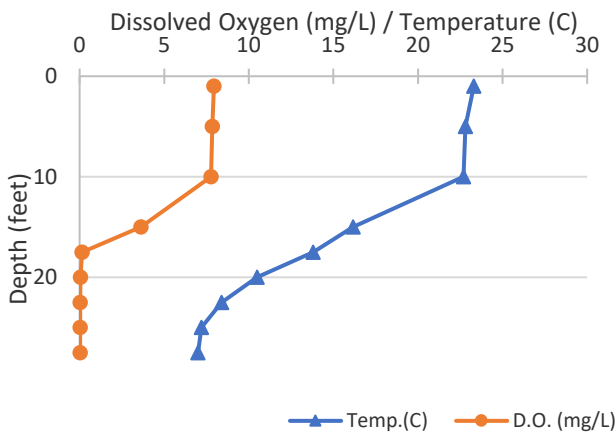
7/16/2016

## Dissolved Oxygen and Temp Profile

The lake is anoxic on the bottom from the first sampling in the spring; as the summer continues, it continues to stratify into distinct layers. Based on the monitoring, it is not clear if the bottom waters ever have oxygen.

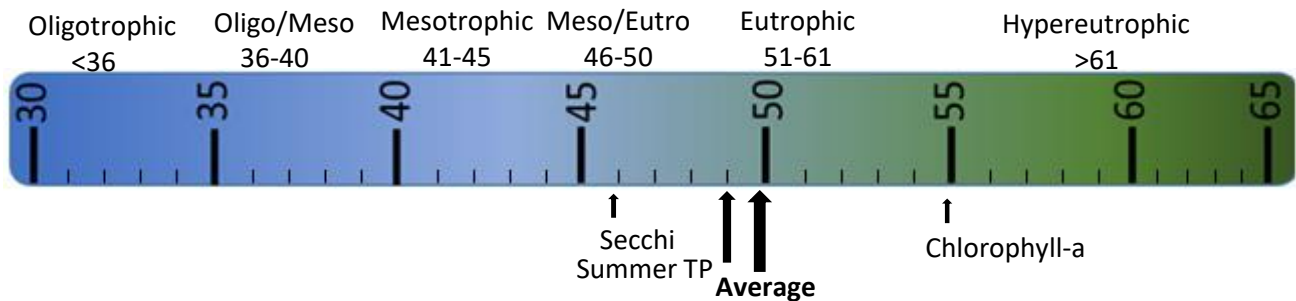
In 1977, limnologist Dr. Robert Carlson developed a numerical scale (0-100) where the numbers indicate the level of nutrient enrichment. Using the proper equations, we can convert results from Summer Total Phosphorus, Secchi Depth, and Chlorophyll-a to this Trophic Status Index (TSI). The TSI numbers are furthermore grouped into general categories (oligotrophic, mesotrophic, eutrophic, and hypereutrophic), to quickly give us a way to understand the general nutrient level of any lake.

TSI for West Maggie Lake in 2022	
Average	50
Secchi Disk	46
Summer TP	49
Chlorophyll-a	55

With an average TSI score of 50 based on 2022 Secchi transparency, chlorophyll-a, and summer total phosphorus data, this lake is rated between the mesotrophic and eutrophic lake classification. The lake leans slightly more eutrophic than mesotrophic.

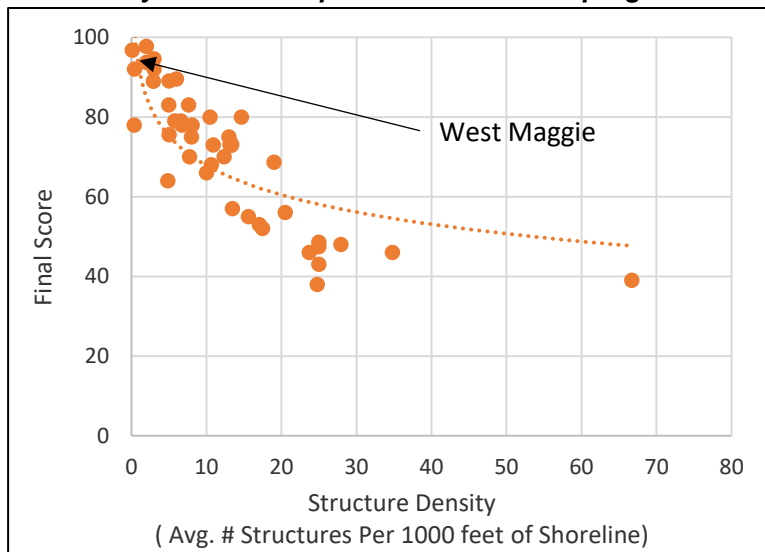
### How does your lake compare to others in the program?

<b>West Maggie Lake:</b>	
Number of Sections:	8
Number of Structures:	25
Structure Density:	3.1
Final Score:	95

<b>All 42 Participating Lakes from 2015-2018:</b>	
Avg. Number of Sections:	16.3
Avg. Number of Structures:	248.5
Avg. Structure Density:	15.2
Avg. Final Score:	70.5

Overall, the lakeshore habitat of West Maggie Lake is doing excellent and scored much higher than average when compared to other lakes in the program. All of the 1000 foot sections scored Good. Several had perfect scores (sections 2,7,8)

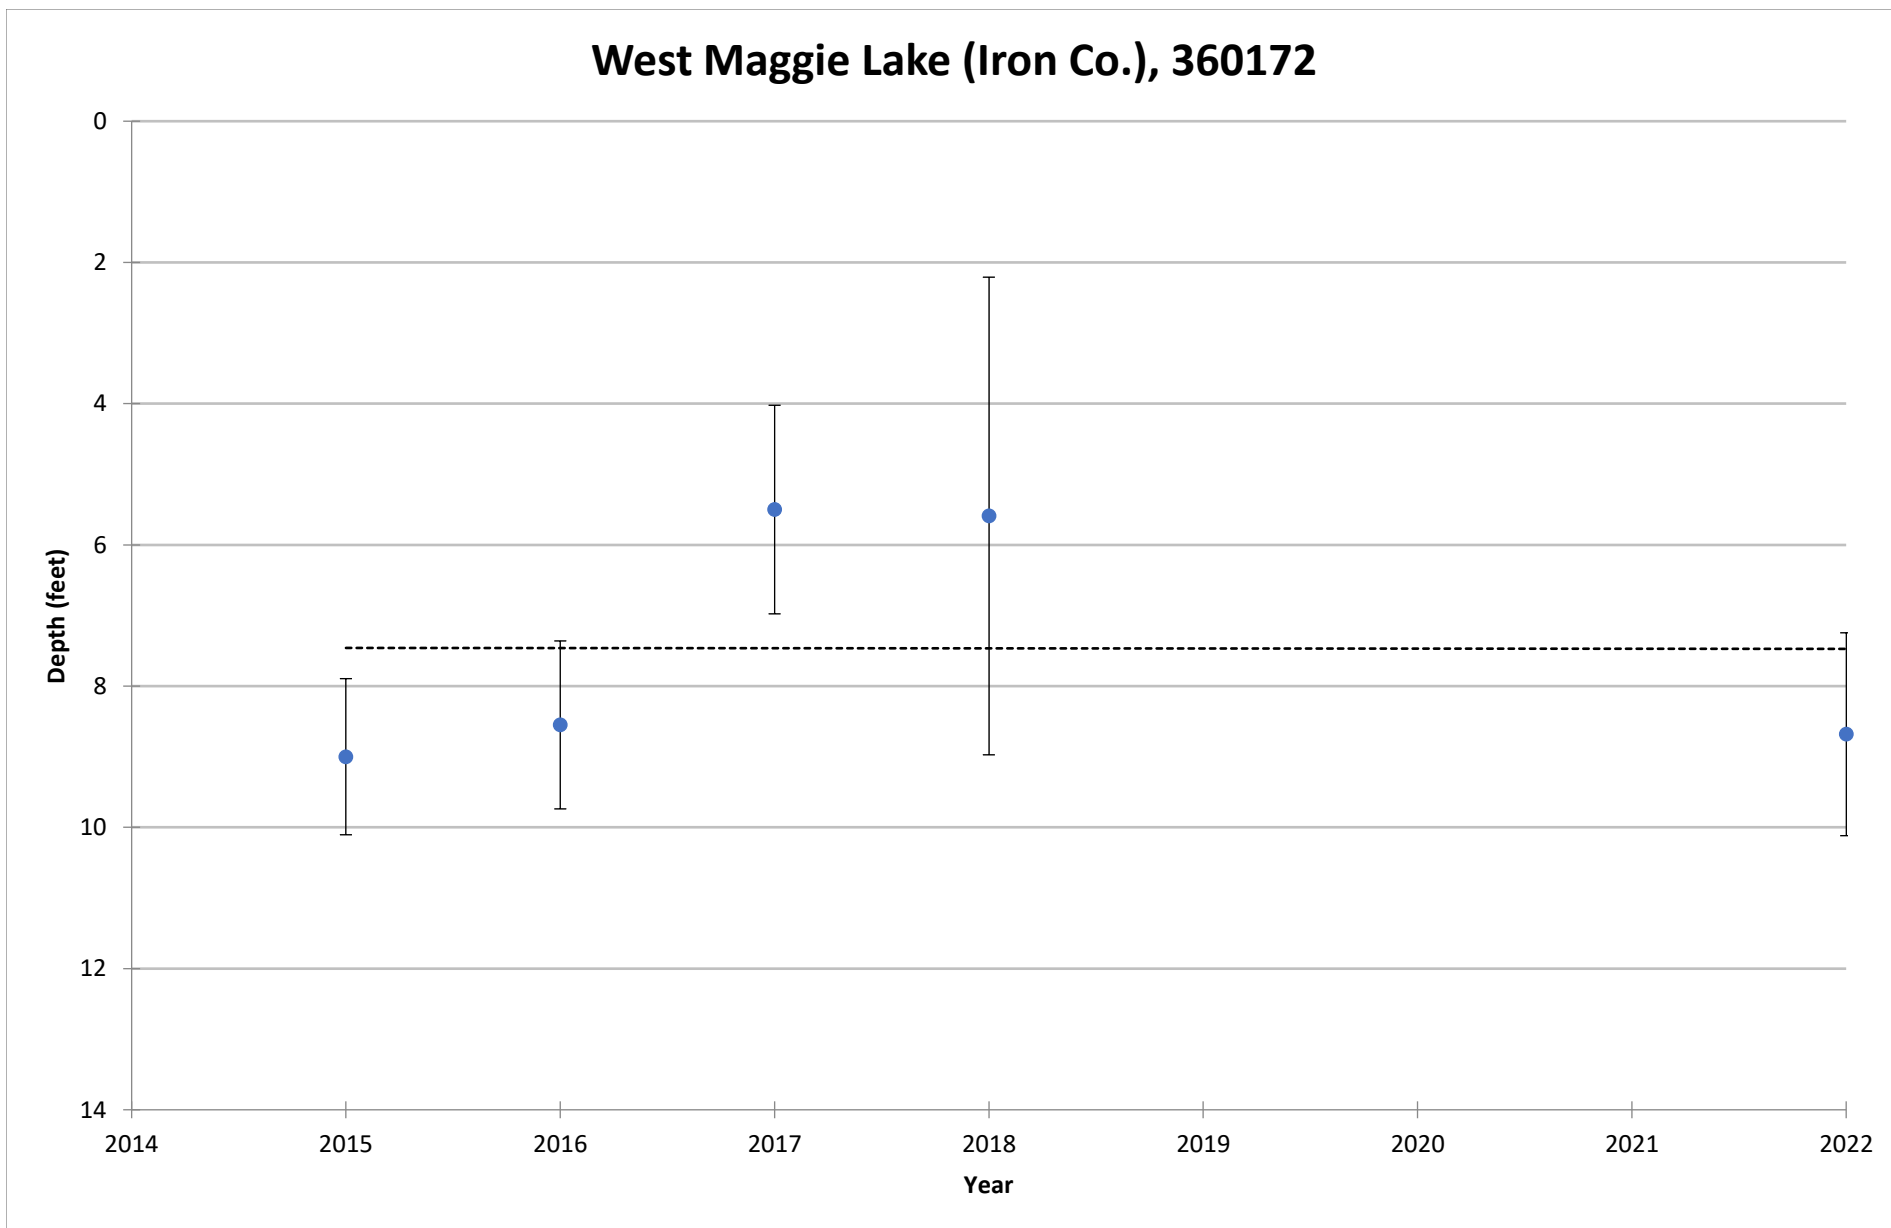
COOPERATIVE LAKES MONITORING PROGRAM  
SUMMER MEAN TRANSPARENCY

**West Maggie Lake (Iron Co.), 360172**

Vertical bars indicate standard deviation

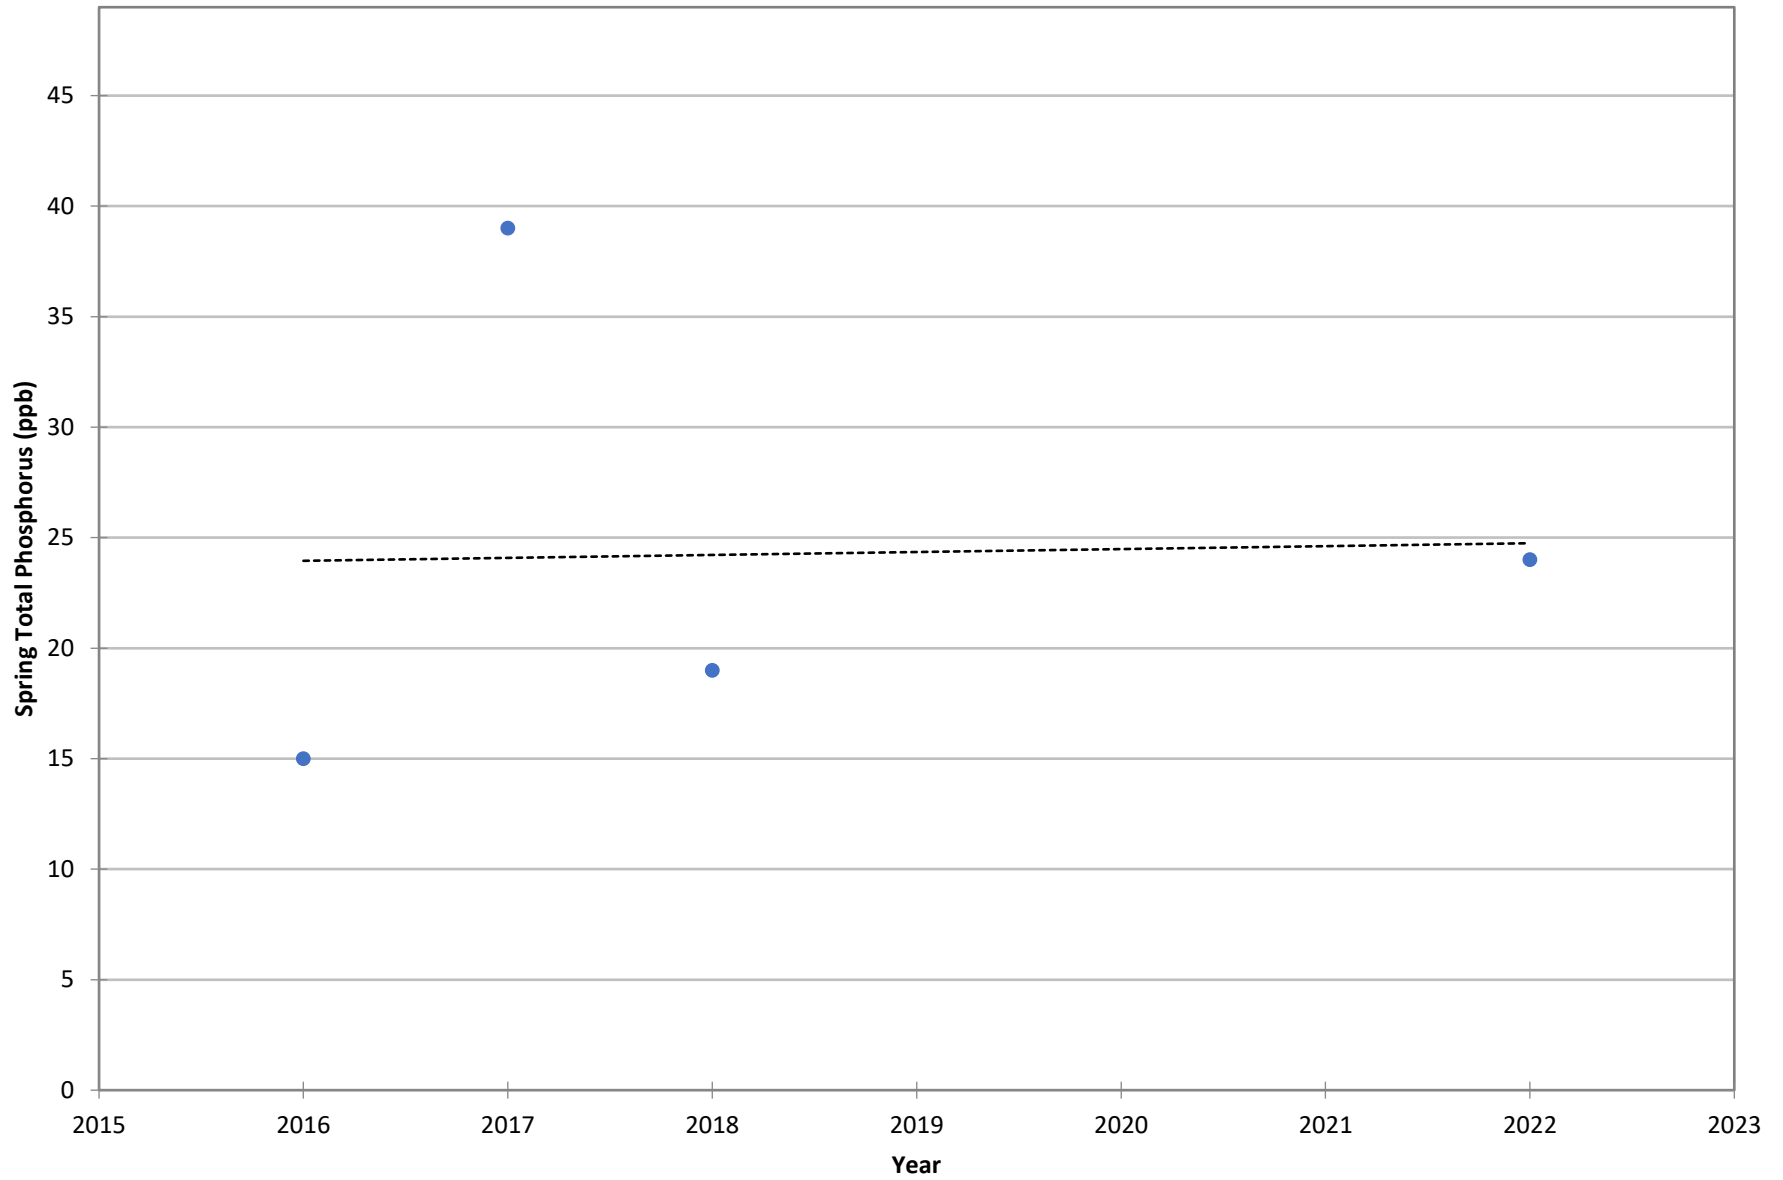
COOPERATIVE LAKES MONITORING PROGRAM  
SPRING TOTAL PHOSPHORUS

**West Maggie Lake (Iron Co.), 360172**

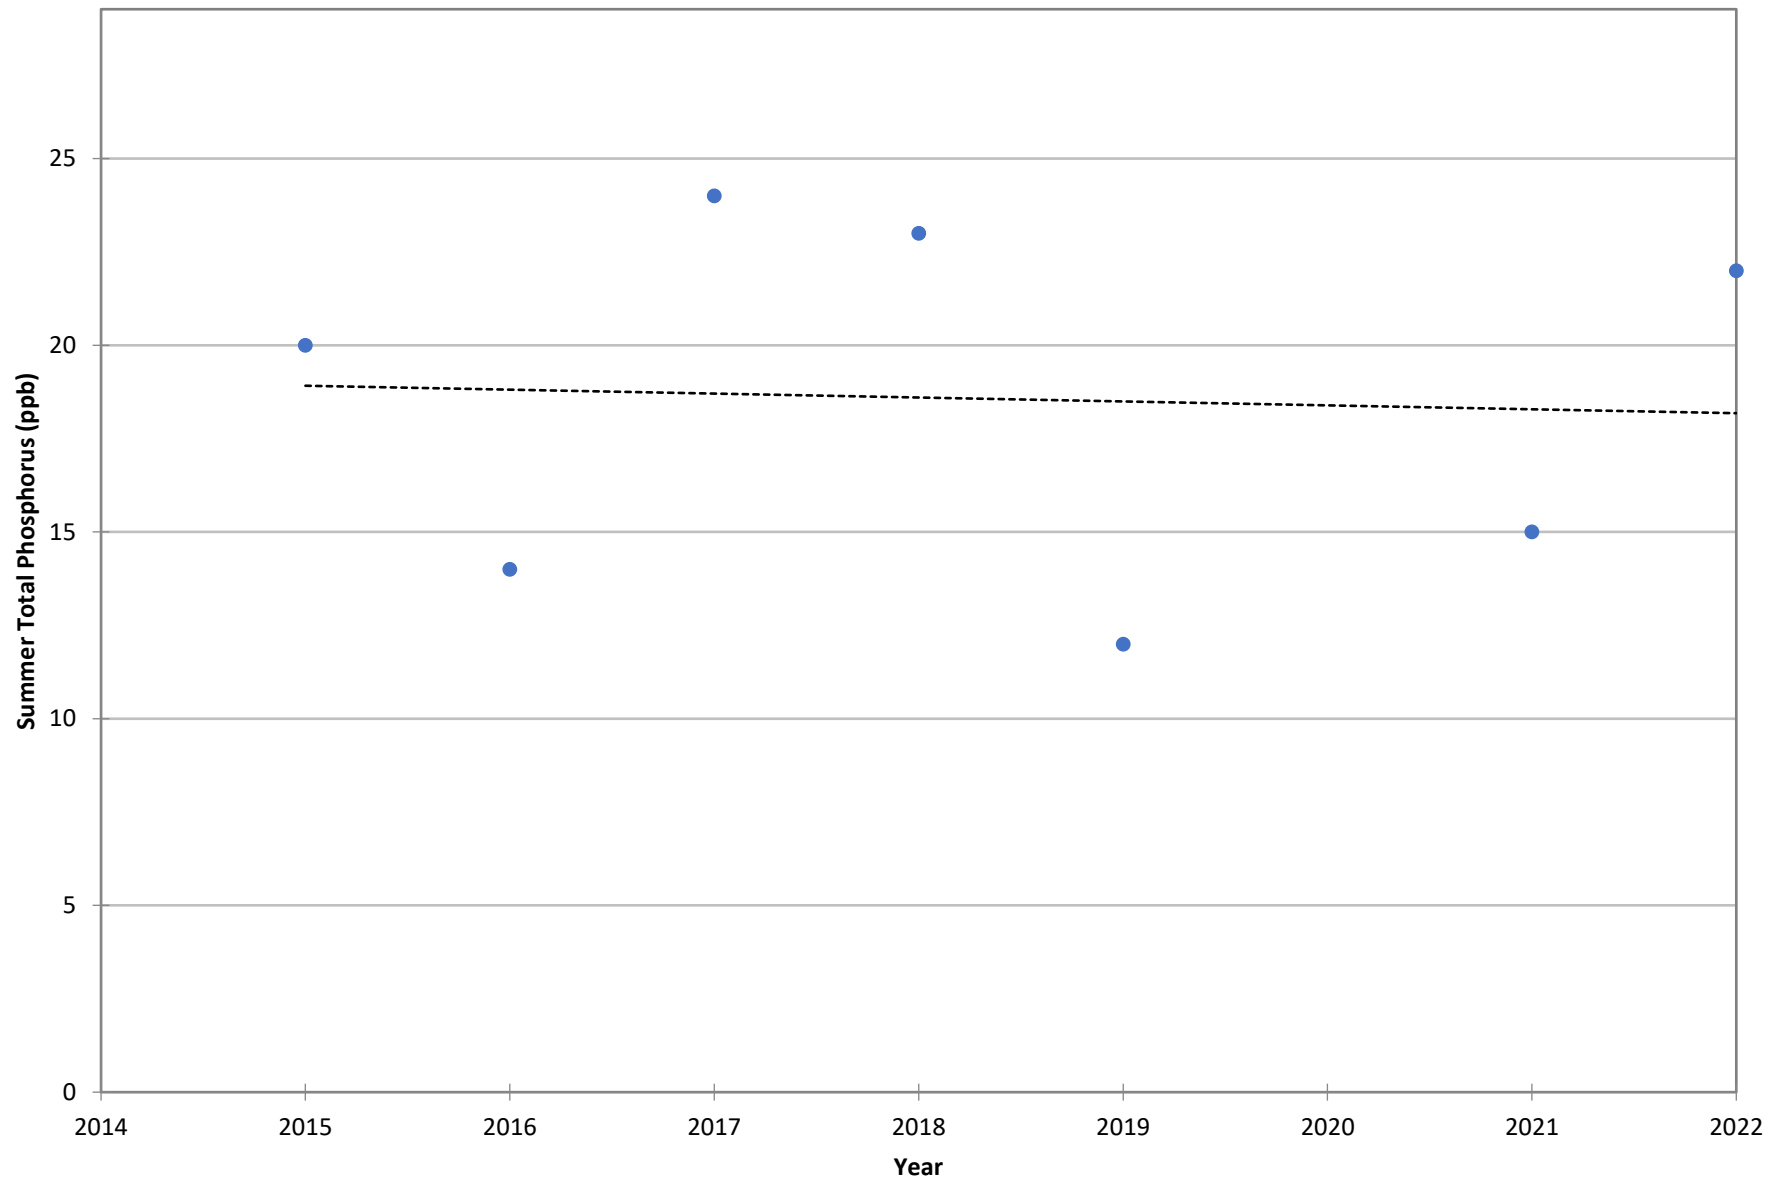
COOPERATIVE LAKES MONITORING PROGRAM  
SUMMER TOTAL PHOSPHORUS

**West Maggie Lake (Iron Co.), 360172**

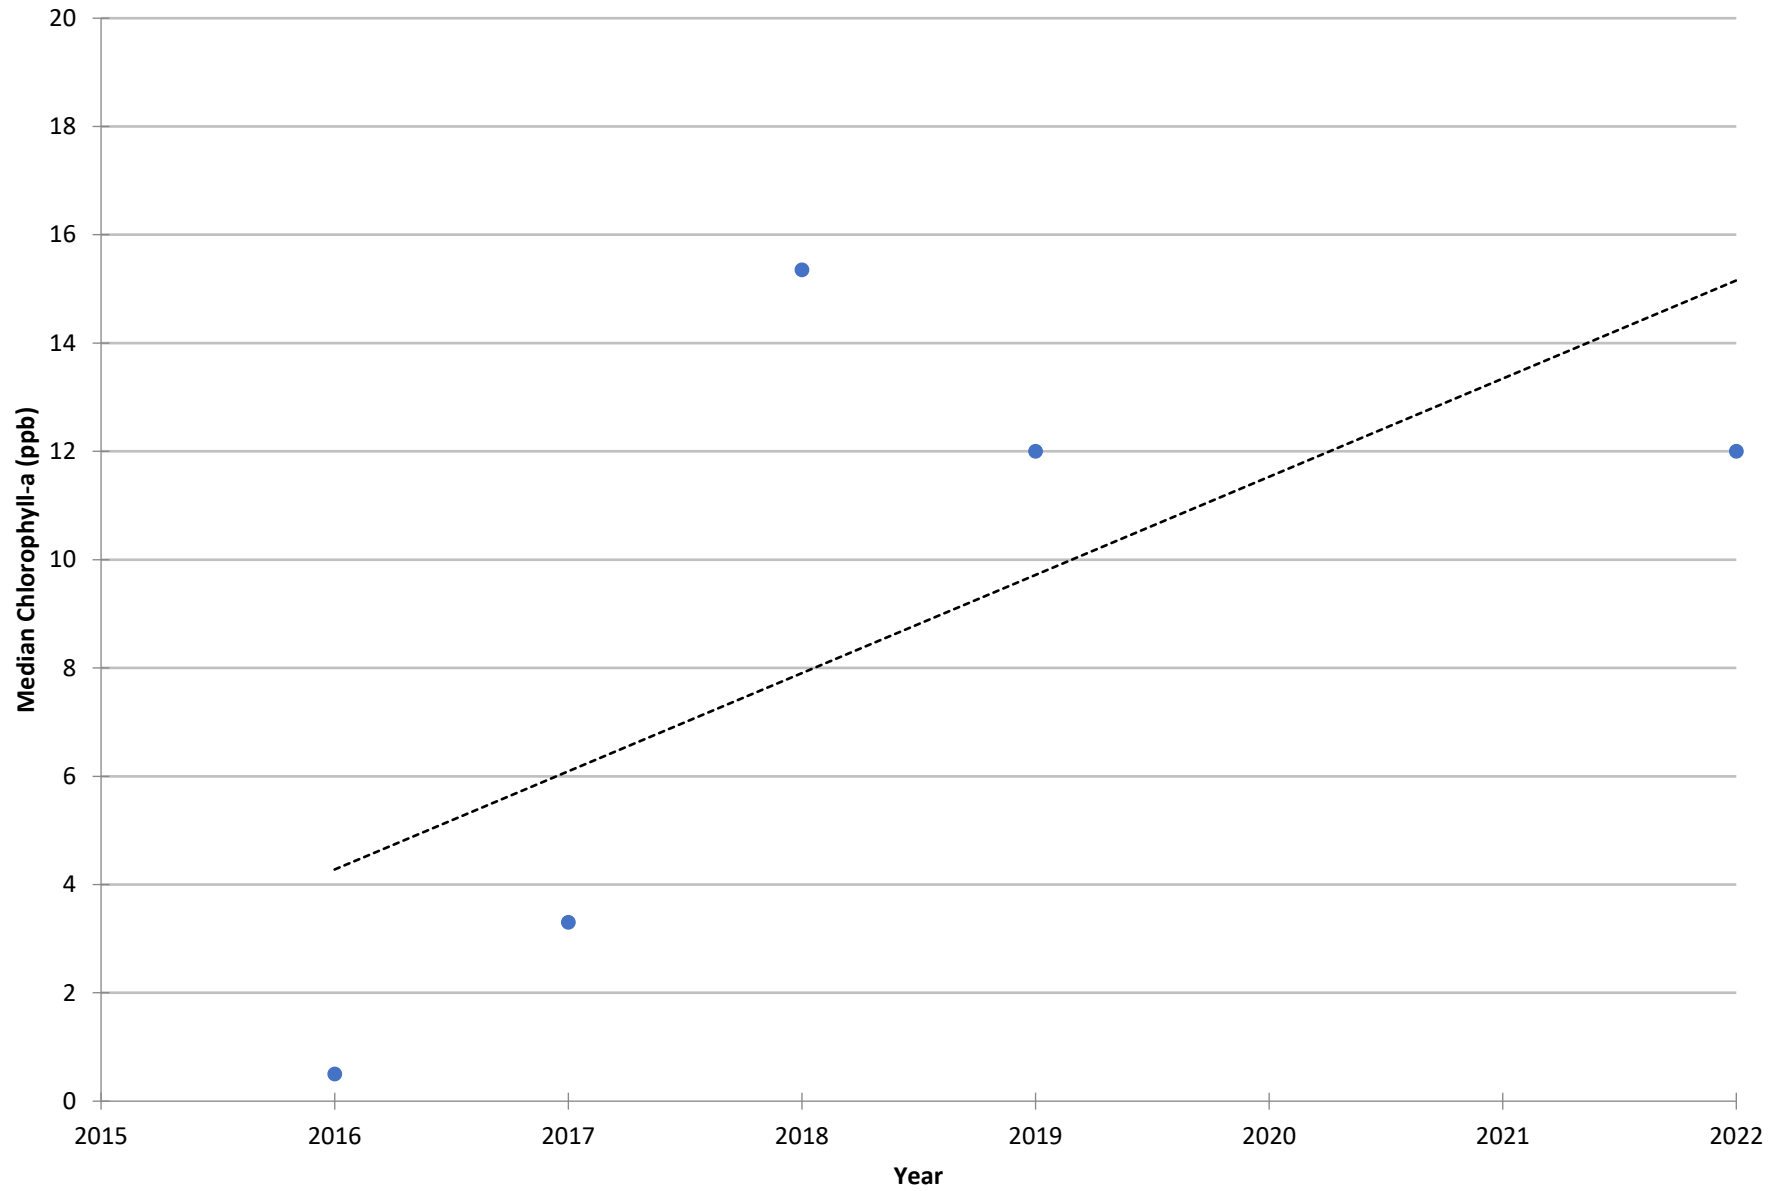
COOPERATIVE LAKES MONITORING PROGRAM  
SUMMER MEDIAN CHLOROPHYLL-A

### West Maggie Lake (Iron Co.)

Vertical bars indicate standard deviation

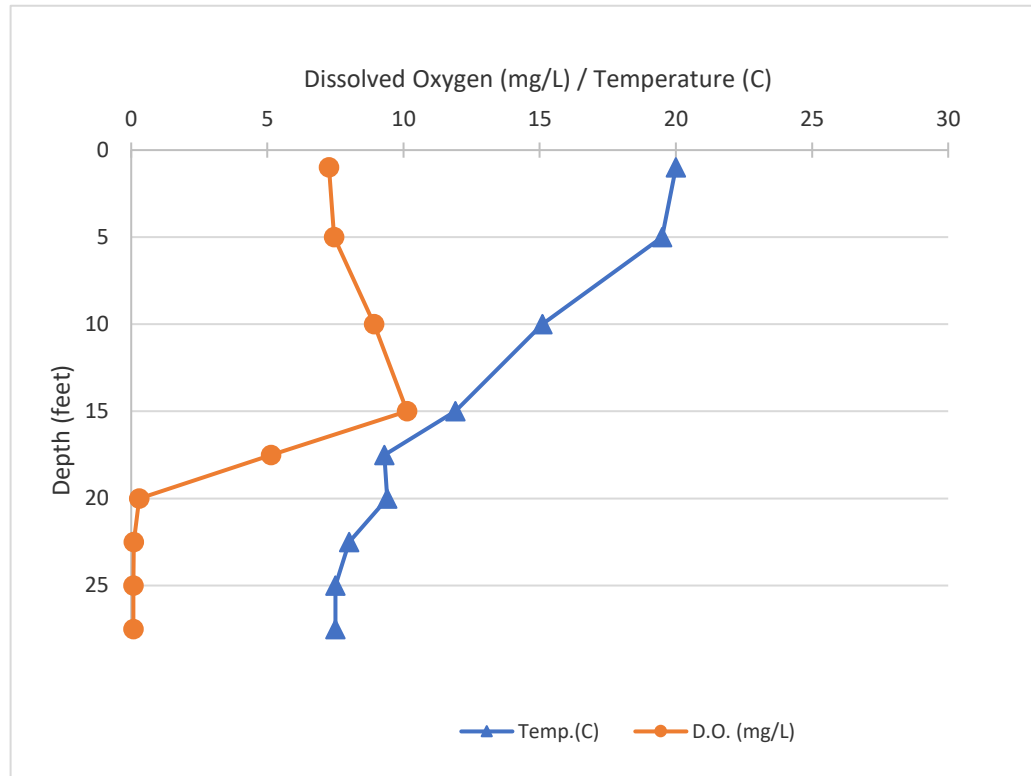
5/26/2016

### Dissolved Oxygen and Temperature Profile

Depth (ft)	Temp.(C)	D.O. (mg/L)
1	20	7.26
5	19.5	7.45
10	15.1	8.92
15	11.9	10.13
17.5	9.3	5.14
20	9.4	0.3
22.5	8	0.1
25	7.5	0.08
27.5	7.5	0.08

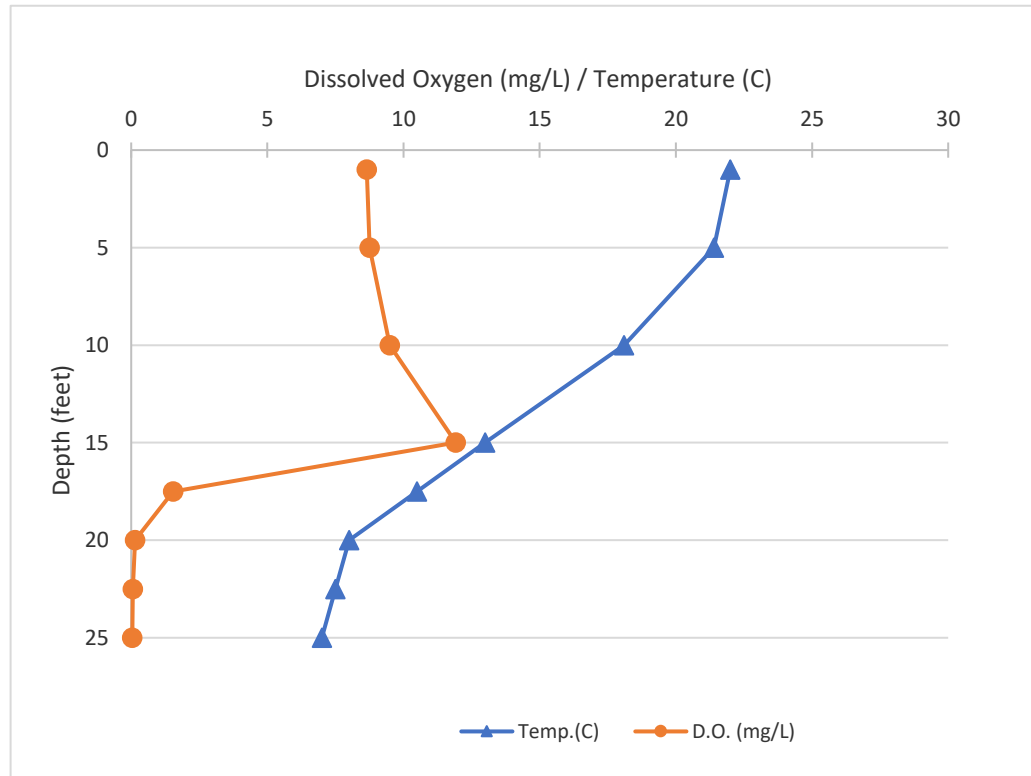
6/12/2016

### Dissolved Oxygen and Temperature Profile

Depth (ft)	Temp.(C)	D.O. (mg/L)
1	22	8.65
5	21.4	8.75
10	18.1	9.5
15	13	11.92
17.5	10.5	1.54
20	8	0.14
22.5	7.5	0.06
25	7	0.04

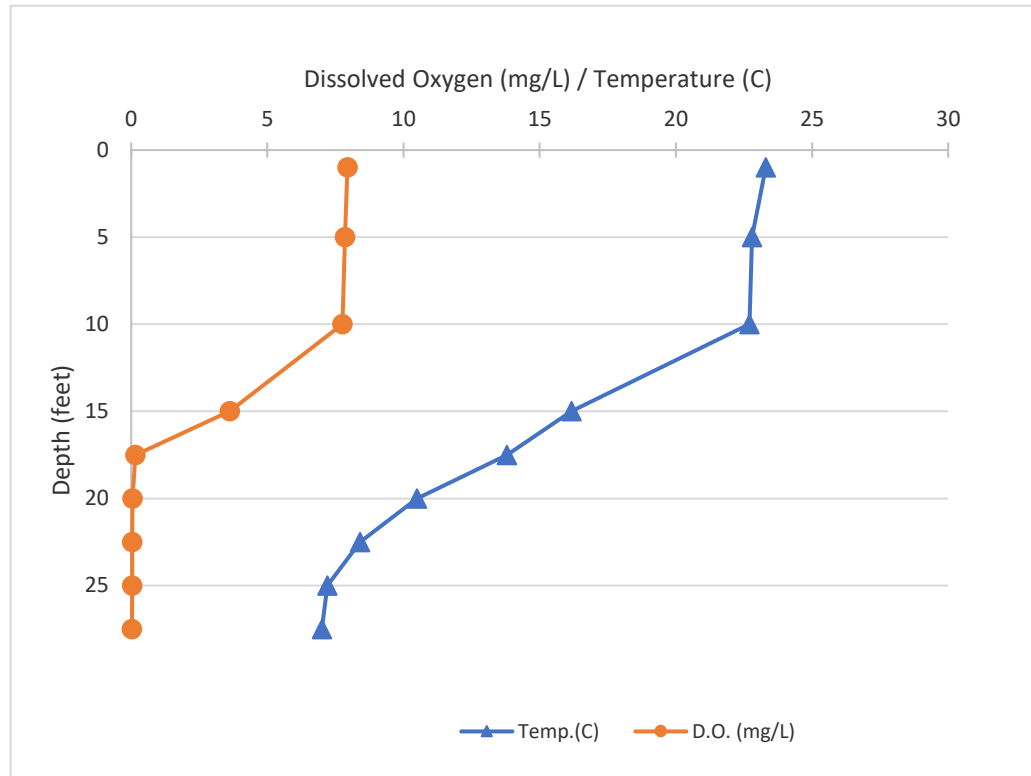
7/16/2016

### Dissolved Oxygen and Temperature Profile

Depth (ft)	Temp.(C)	D.O. (mg/L)
1	23.3	7.94
5	22.8	7.85
10	22.7	7.76
15	16.17	3.62
17.5	13.8	0.15
20	10.5	0.05
22.5	8.4	0.04
25	7.2	0.04
27.5	7	0.03

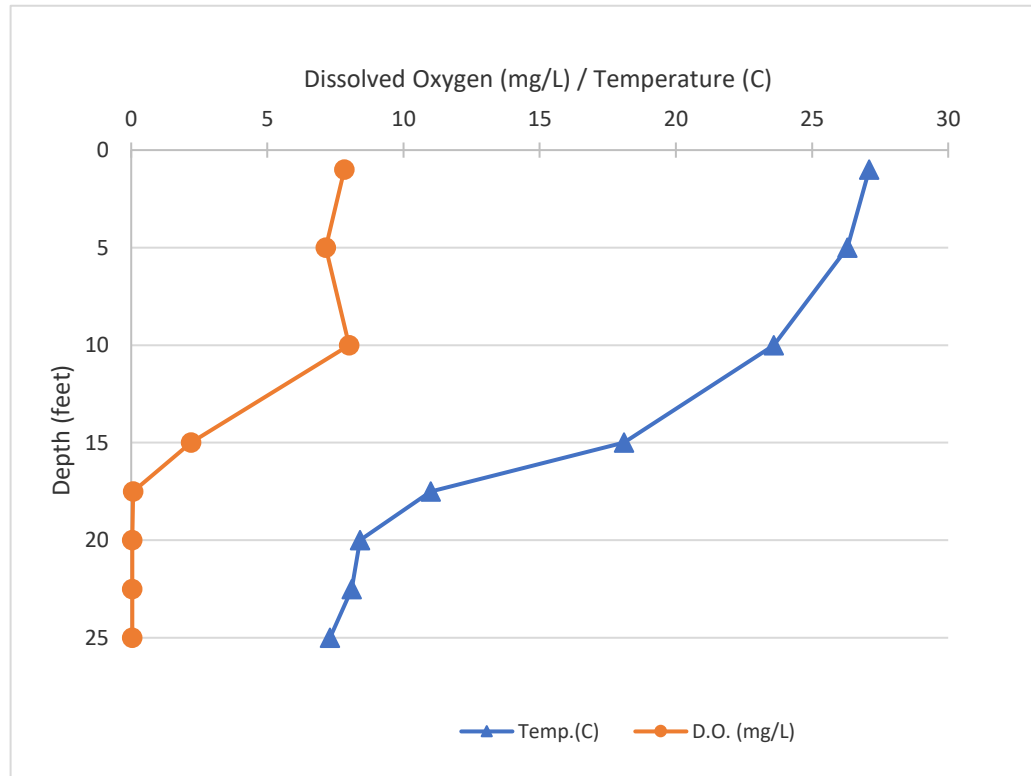
7/23/2016

### Dissolved Oxygen and Temperature Profile

Depth (ft)	Temp.(C)	D.O. (mg/L)
1	27.1	7.83
5	26.3	7.15
10	23.6	8
15	18.1	2.2
17.5	11	0.07
20	8.4	0.04
22.5	8.1	0.04
25	7.3	0.04

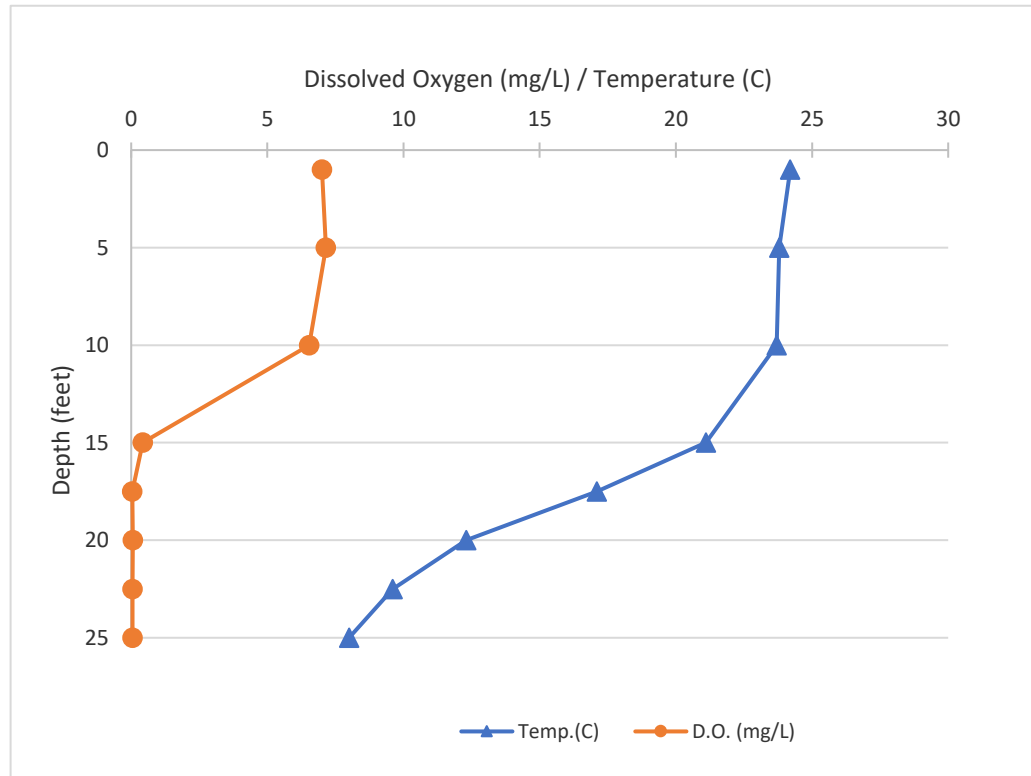
8/14/2016

### Dissolved Oxygen and Temperature Profile

Depth (ft)	Temp.(C)	D.O. (mg/L)
1	24.2	7
5	23.8	7.15
10	23.7	6.53
15	21.1	0.42
17.5	17.1	0.04
20	12.3	0.06
22.5	9.6	0.05
25	8	0.05

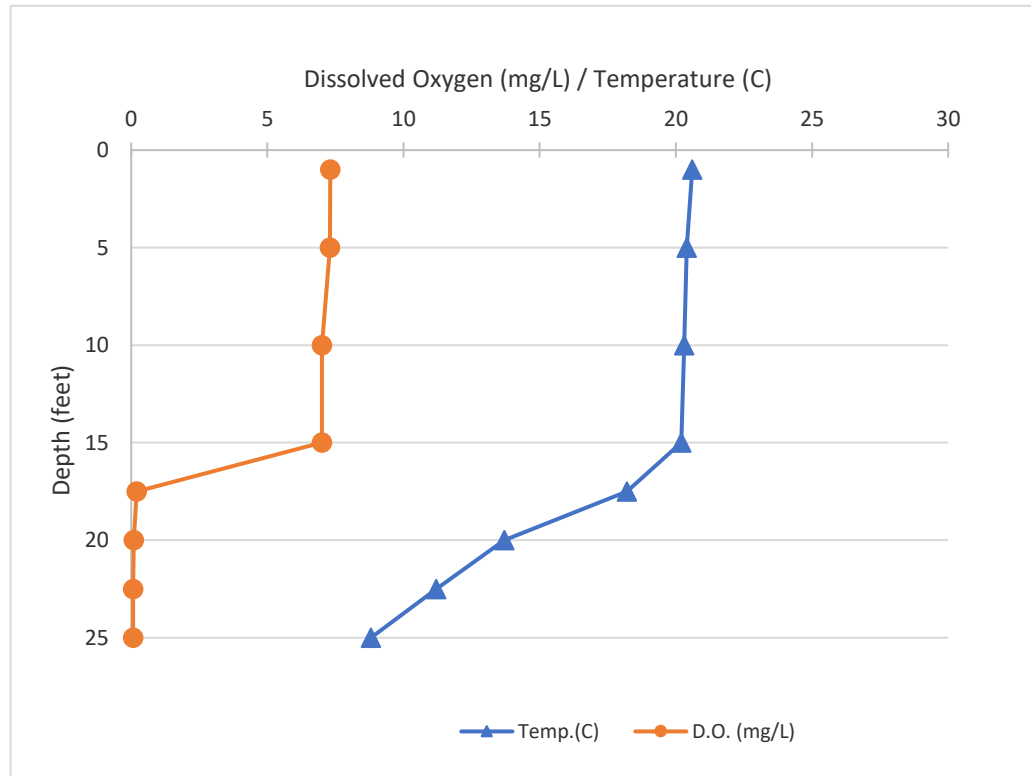
9/11/2016

### Dissolved Oxygen and Temperature Profile

Depth (ft)	Temp.(C)	D.O. (mg/L)
1	20.6	7.31
5	20.4	7.3
10	20.3	7
15	20.2	7
17.5	18.2	0.2
20	13.7	0.1
22.5	11.2	0.07
25	8.8	0.07
