2022 Data Report for

Rose Lake, Shiawassee County

Site ID: 780276

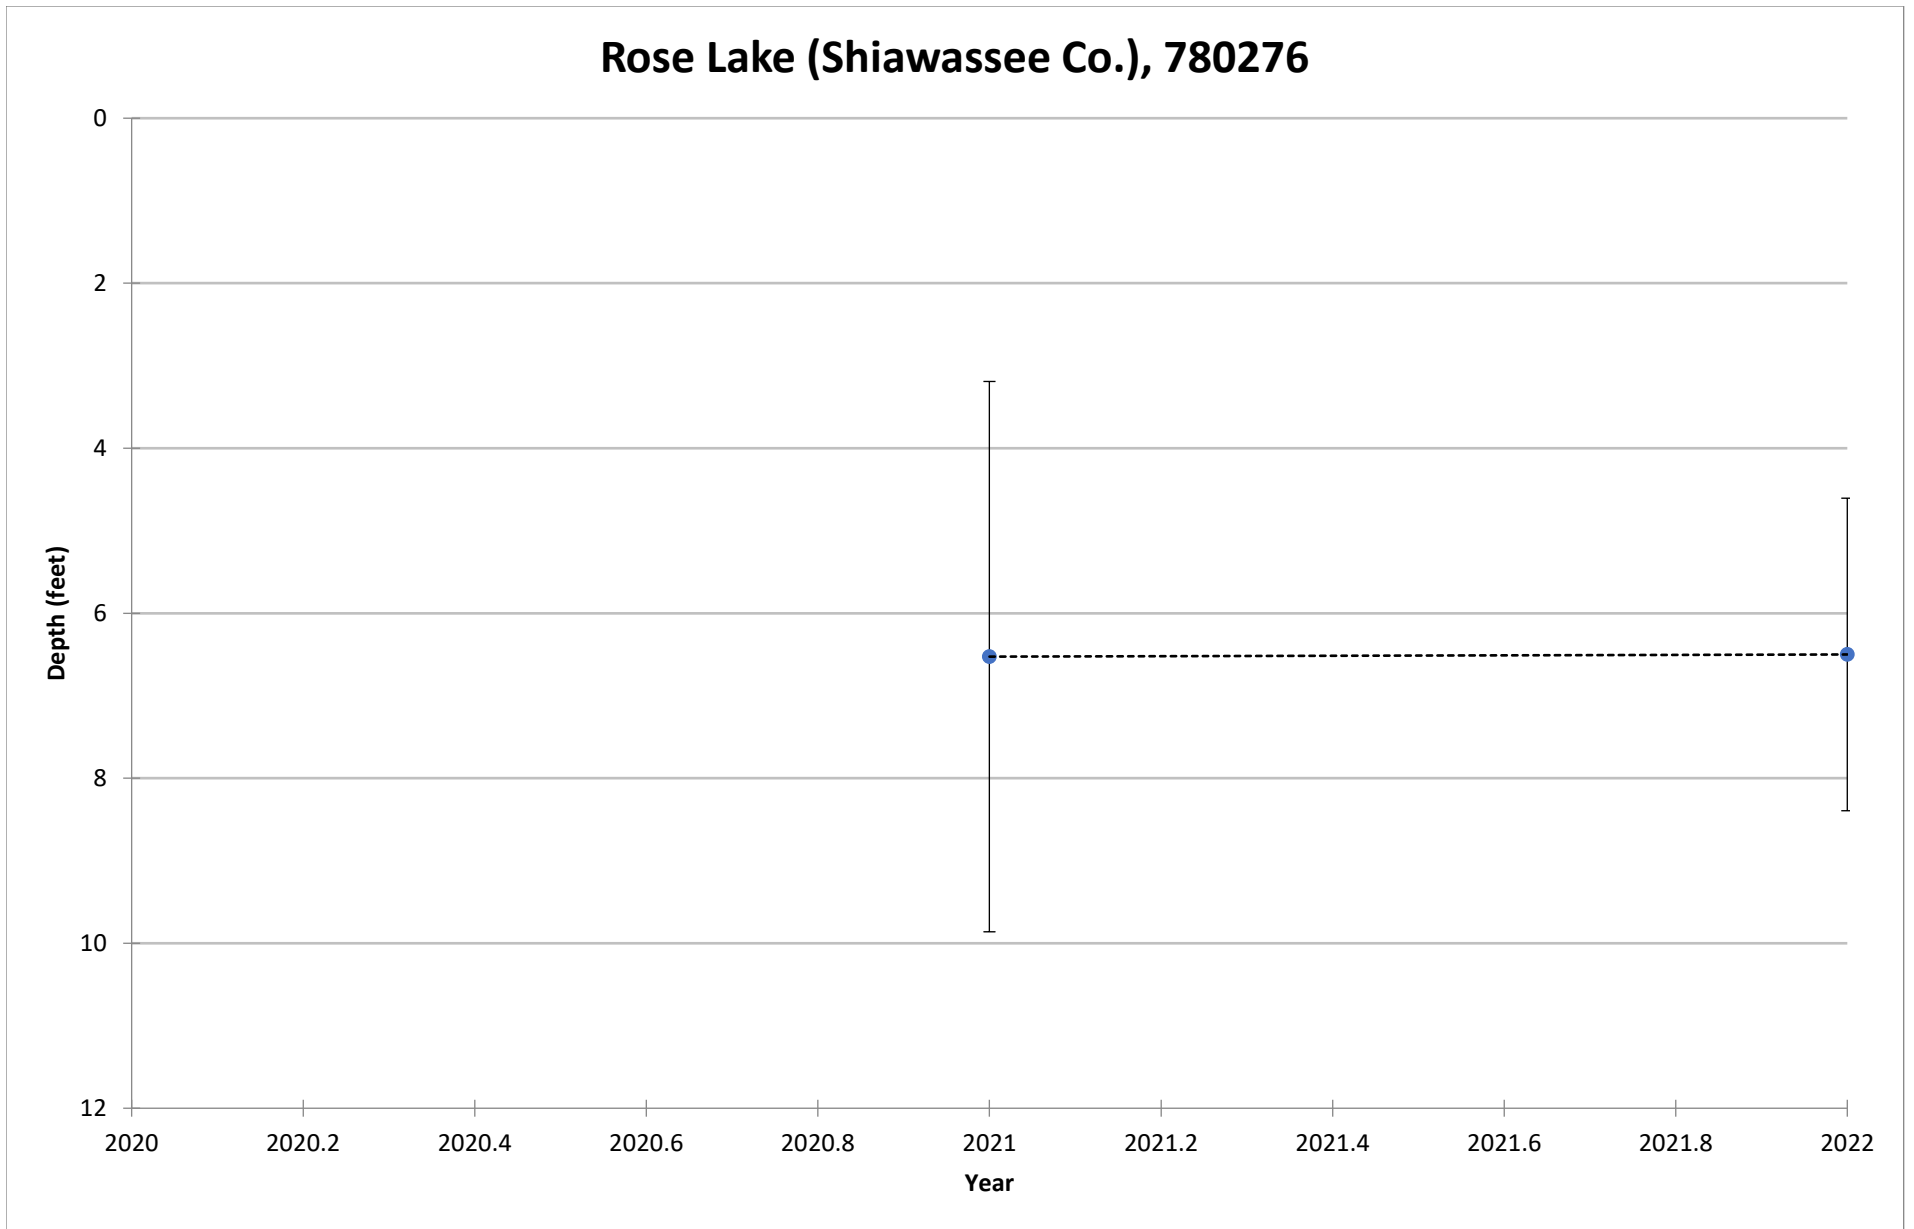
Rose Lake (Shiawassee Co.), 780276

COOPERATIVE LAKES MONITORING PROGRAM
SUMMER MEAN TRANSPARENCY

Vertical bars indicate standard deviation

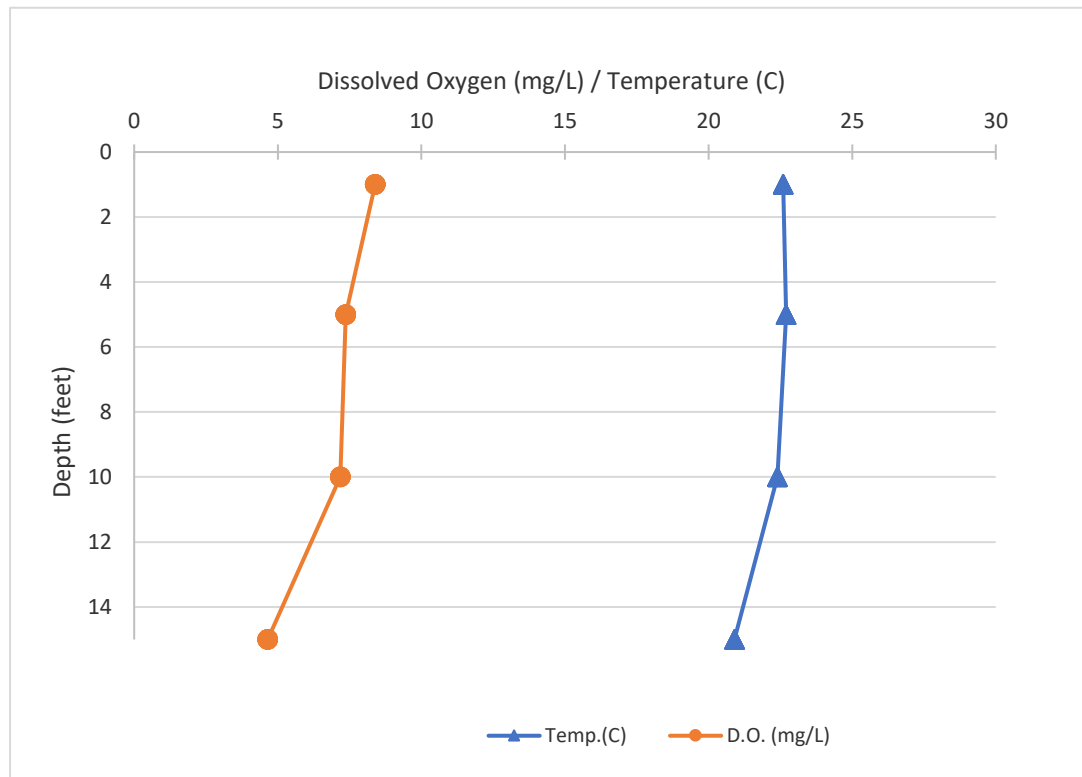
9/7/2022

Dissolved Oxygen and Temperature Profile

Depth (ft)	Temp.(C)	D.O. (mg/L)
1	22.6	8.39
1	22.6	8.39
1	22.6	8.39
1	22.6	8.39
1	22.6	8.39
5	22.7	7.37
5	22.7	7.37
5	22.7	7.37
5	22.7	7.37
5	22.7	7.37
10	22.4	7.18
10	22.4	7.18
10	22.4	7.18
10	22.4	7.18
10	22.4	7.18
15	20.9	4.65
15	20.9	4.65
15	20.9	4.65
15	20.9	4.65
15	20.9	4.65
