**2022 Data Report
for
Spider Lake, Grand Traverse County**

Site ID: 280395

Spider Lake, Grand Traverse County 2022 CLMP Results

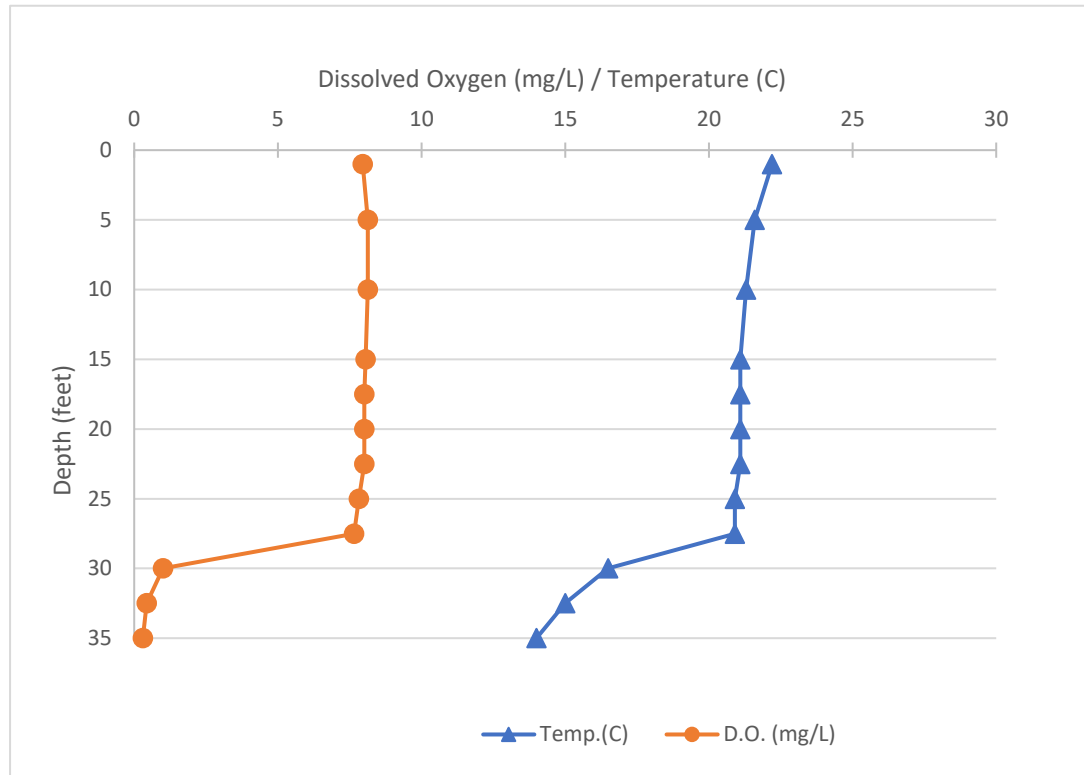
9/10/2021

Depth (ft)	Temp.(C)	D.O. (mg/L)
1	22.2	7.95
5	21.6	8.13
10	21.3	8.13
15	21.1	8.05
17.5	21.1	8.01
20	21.1	8.01
22.5	21.1	8.01
25	20.9	7.82
27.5	20.9	7.65
30	16.5	1
32.5	15	0.44
35	14	0.3
