# 2022 Data Report for Big Star Lake, Lake County

Site ID: 430022

# Big Star Lake, Lake County 2022 CLMP Results

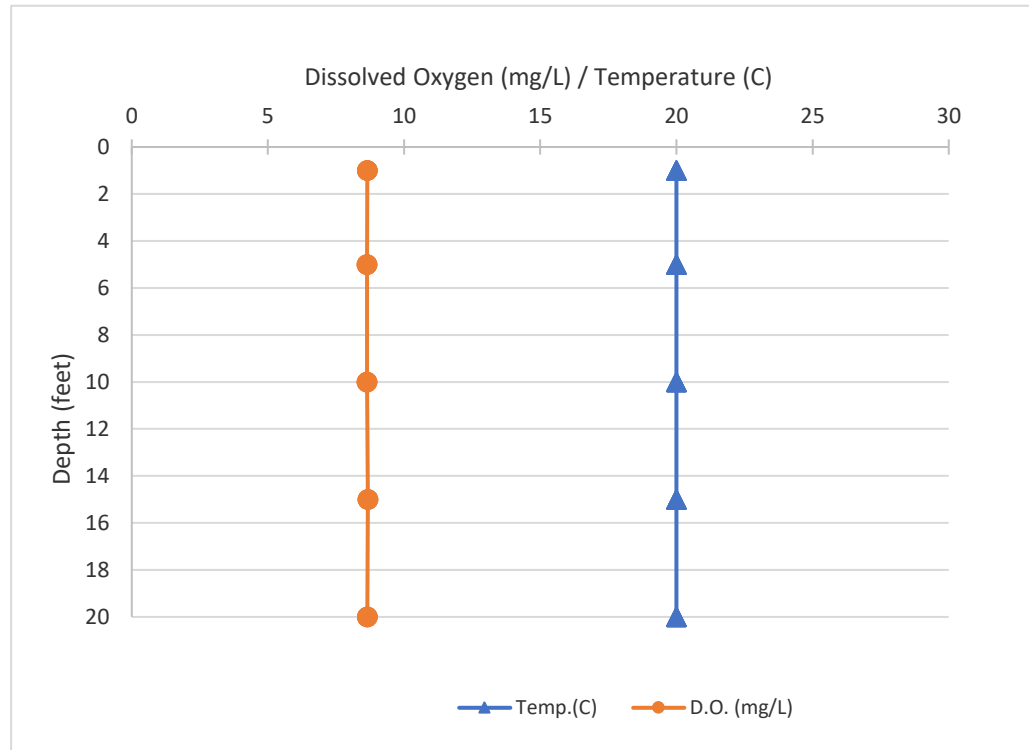
Name: Big Star Lake  
 County: Lake  
 Site ID: 430022  
 Date: 9/7/2017

Depth (ft)	Temp.(C)	D.O. (mg/L)
1	20	8.65
1	20	8.65
1	20	8.65
1	20	8.65
5	20	8.64
5	20	8.64
5	20	8.64
5	20	8.64
10	20	8.64
10	20	8.64
10	20	8.64
10	20	8.64
15	20	8.67
15	20	8.67
15	20	8.67
15	20	8.67
20	20	8.65
20	20	8.65
20	20	8.65
20	20	8.65
