2022 Data Report for

Thread Lake, Genesee County

Site ID: 250417

Thread Lake, Genesee County 2022 CLMP Results

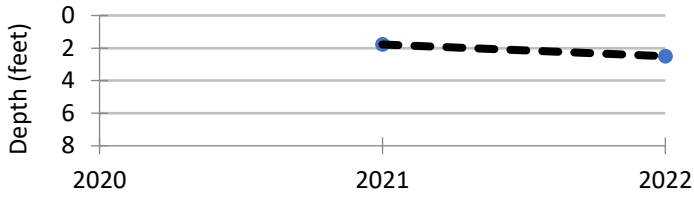
Secchi Disk Transparency (feet)

Year	# Readings	Min	Max	Average	Std. Dev	Carlson TSI
2022	8	1.5	4.5	2.5	1.0	64
2021	9	1.0	5.0	2.5	1.3	69
2022 All CLMP Lakes	3178	1.0	63.0	11.6	2.5	43

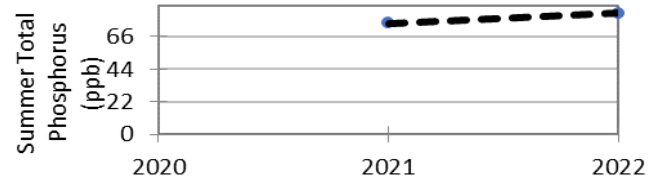
Summer Phosphorus (parts per billion)

Year	# Samples	Min	Max	Average	Std. Dev	Carlson TSI
2022	1	82.0	82.0	82.0	NA	68
2021	1	75.0	75.0	75.0	NA	66
2022 All CLMP Lakes	234	<= 3	150.0	17.4	15.3	45

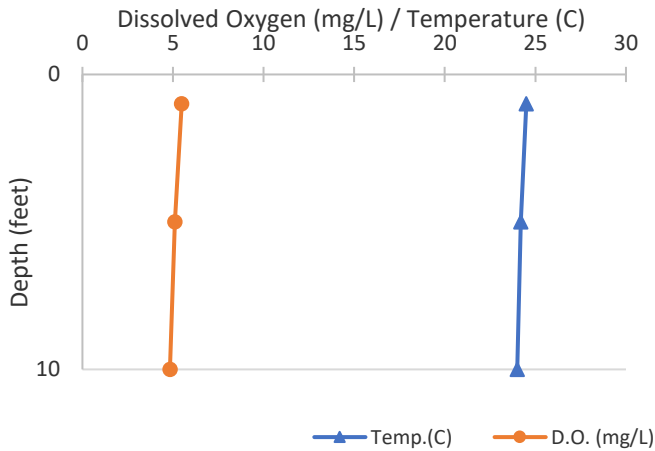
8/3/2022

Dissolved Oxygen and Temperature Profile

Due to its low depth, the lake is able to maintain dissolved oxygen throughout the water column for the entire summer.

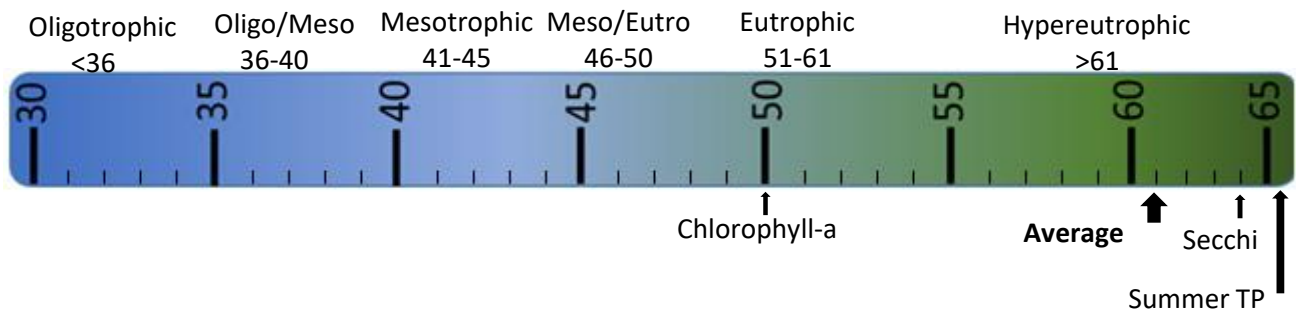
TSI for Thread Lake in 2022	
Average	61
Secchi Disk	64
Summer TP	68
Chlorophyll-a	50

With an average TSI score of 61 based on 2022 Secchi transparency, chlorophyll-a, and summer total phosphorus data, this lake is rated as a hypereutrophic lake.

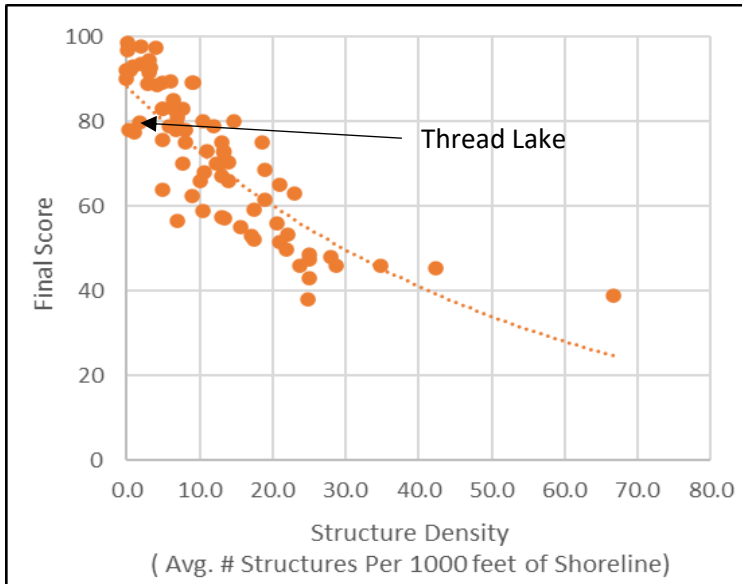
Thread Lake:	
Number of Sections:	26
Number of Structures:	48
Structure Density:	1.85
Final Score:	80

All 78 Participating Lakes from 2015-2021:	
Avg. Number of Sections:	16
Avg. Number of Structures:	214
Avg. Structure Density:	12.2
Avg. Final Score:	72

Note about graph to the left: The dotted line sets your average expectation of the score of your lake. If your lake is lower than the dotted line, then your shoreline health is lower than average compared to lakes with similar amount of shoreline development. And vice-versa in regards to a lake above the dotted line.

Overall, the lakeshore habitat of Thread Lake is doing well and scored higher than average when compared to other lakes in the program. All of the 1000 foot sections scored either Fair or Good: 9 fair, and 17 good.

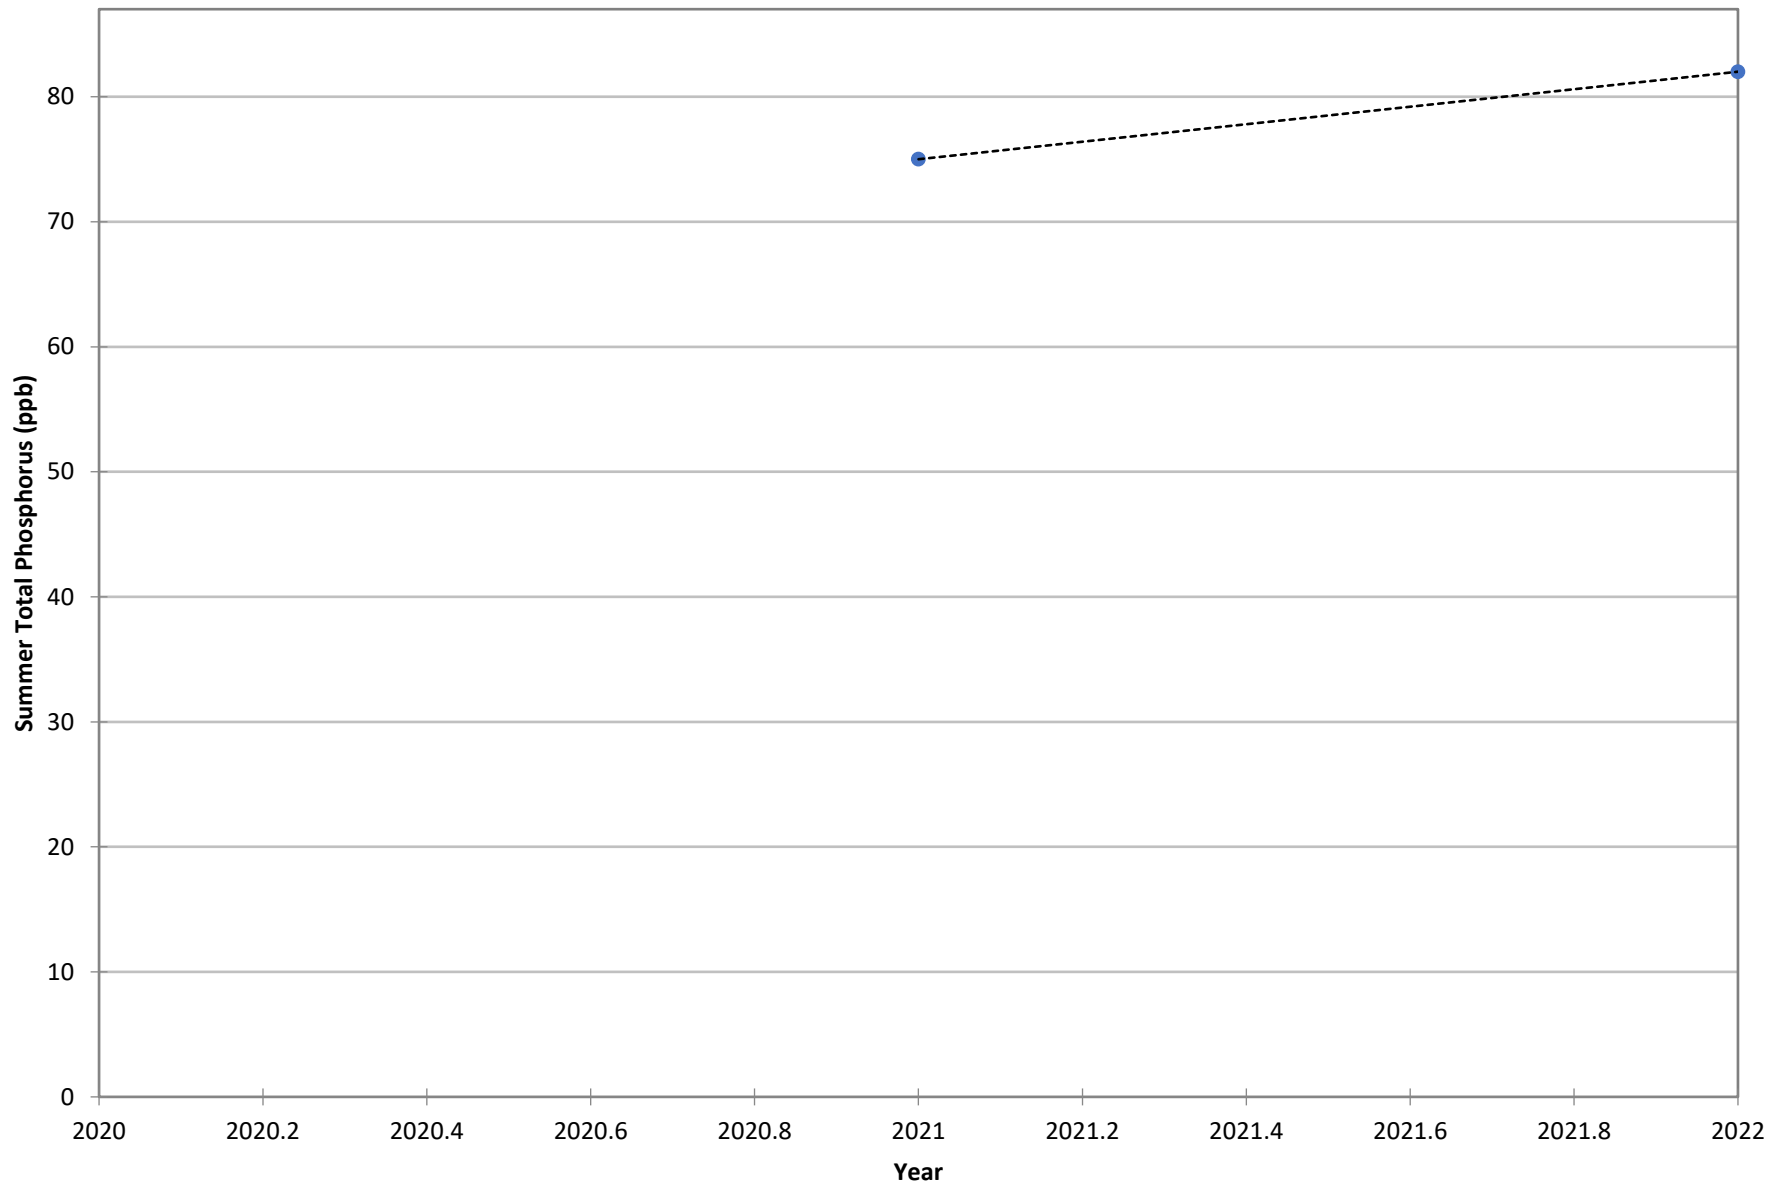
Thread Lake (Genesee Co.), 250417

Vertical bars indicate standard deviation

COOPERATIVE LAKES MONITORING PROGRAM
SUMMER TOTAL PHOSPHORUS

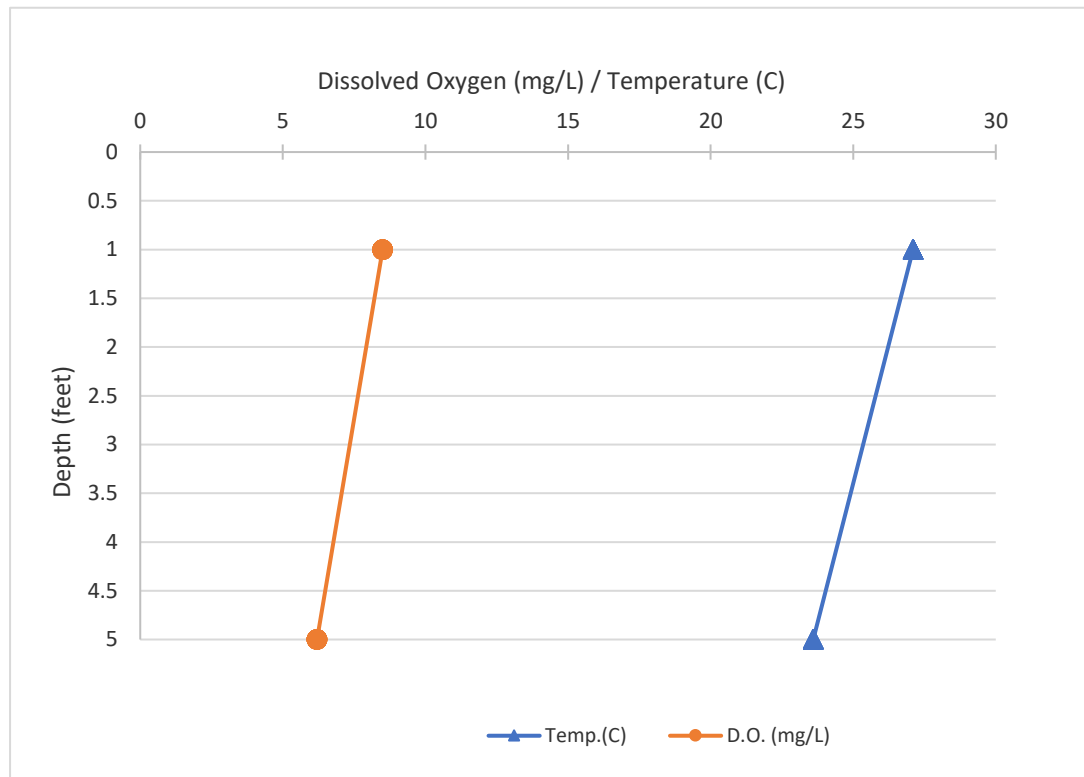
Name: Thread Lake
County: Genesee
Site ID: 250417
Date: 6/29/2022

Dissolved Oxygen and Temperature Profile

Depth (ft)	Temp.(C)	D.O. (mg/L)
1	27.1	8.5
1	27.1	8.5
1	27.1	8.5
1	27.1	8.5
1	27.1	8.5
1	27.1	8.5
1	27.1	8.5
1	27.1	8.5
1	27.1	8.5
1	27.1	8.5
1	27.1	8.5
5	23.6	6.2
5	23.6	6.2
5	23.6	6.2
5	23.6	6.2
5	23.6	6.2
5	23.6	6.2
5	23.6	6.2
5	23.6	6.2
5	23.6	6.2
5	23.6	6.2
5	23.6	6.2

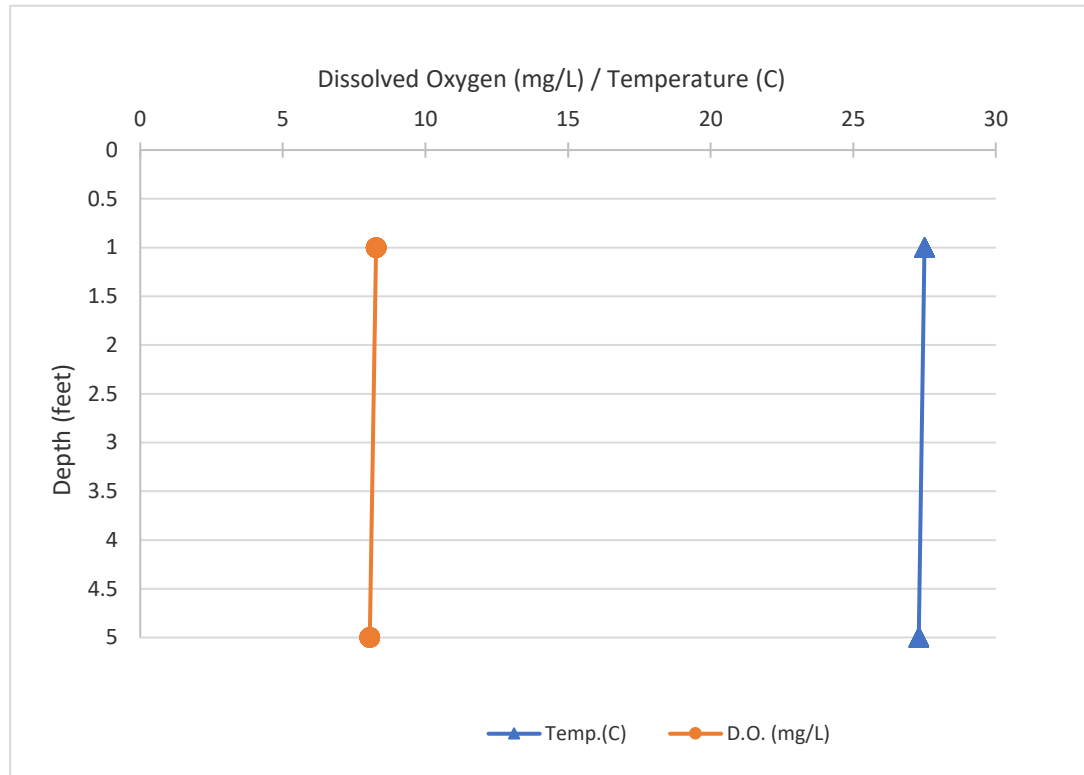
Name: Thread Lake
County: Genesee
Site ID: 250417
Date: 7/19/2022

Dissolved Oxygen and Temperature Profile

Depth (ft)	Temp.(C)	D.O. (mg/L)
1	27.5	8.27
1	27.5	8.27
1	27.5	8.27
1	27.5	8.27
1	27.5	8.27
1	27.5	8.27
1	27.5	8.27
1	27.5	8.27
1	27.5	8.27
1	27.5	8.27
5	27.3	8.05
5	27.3	8.05
5	27.3	8.05
5	27.3	8.05
5	27.3	8.05
5	27.3	8.05
5	27.3	8.05
5	27.3	8.05
5	27.3	8.05
5	27.3	8.05
5	27.3	8.05

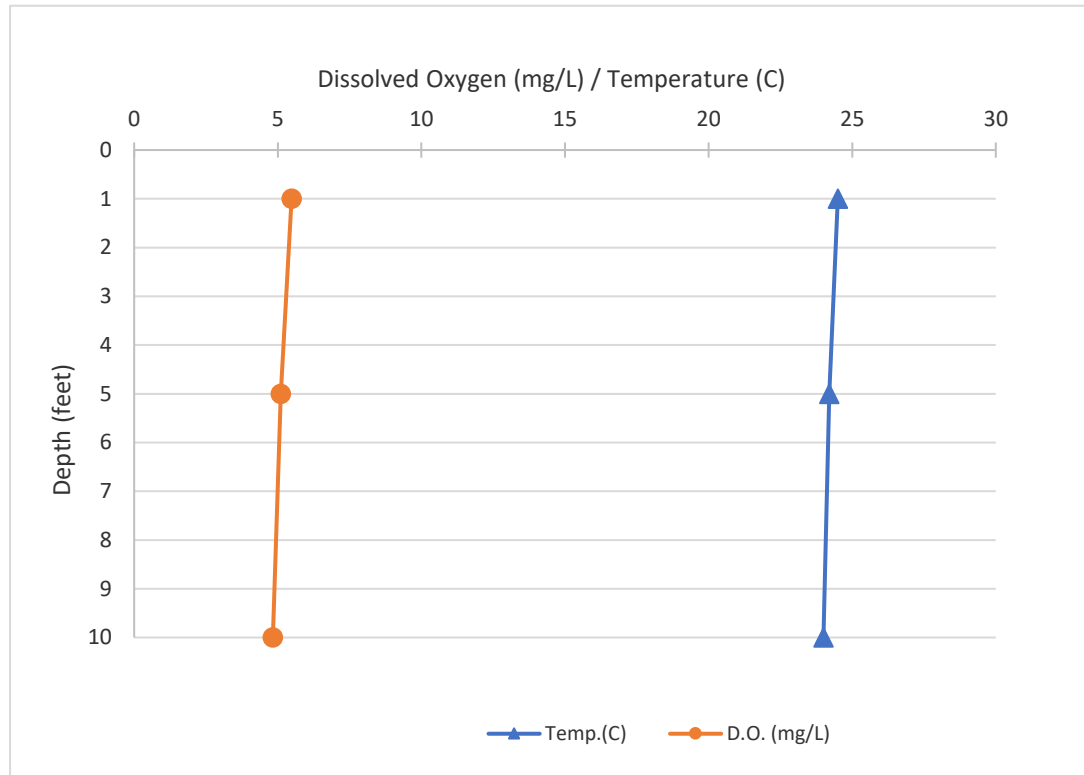
Name: Thread Lake
County: Genesee
Site ID: 250417
Date: 8/3/2022

Dissolved Oxygen and Temperature Profile

Depth (ft)	Temp.(C)	D.O. (mg/L)
1	24.5	5.48
5	24.2	5.11
10	24	4.83

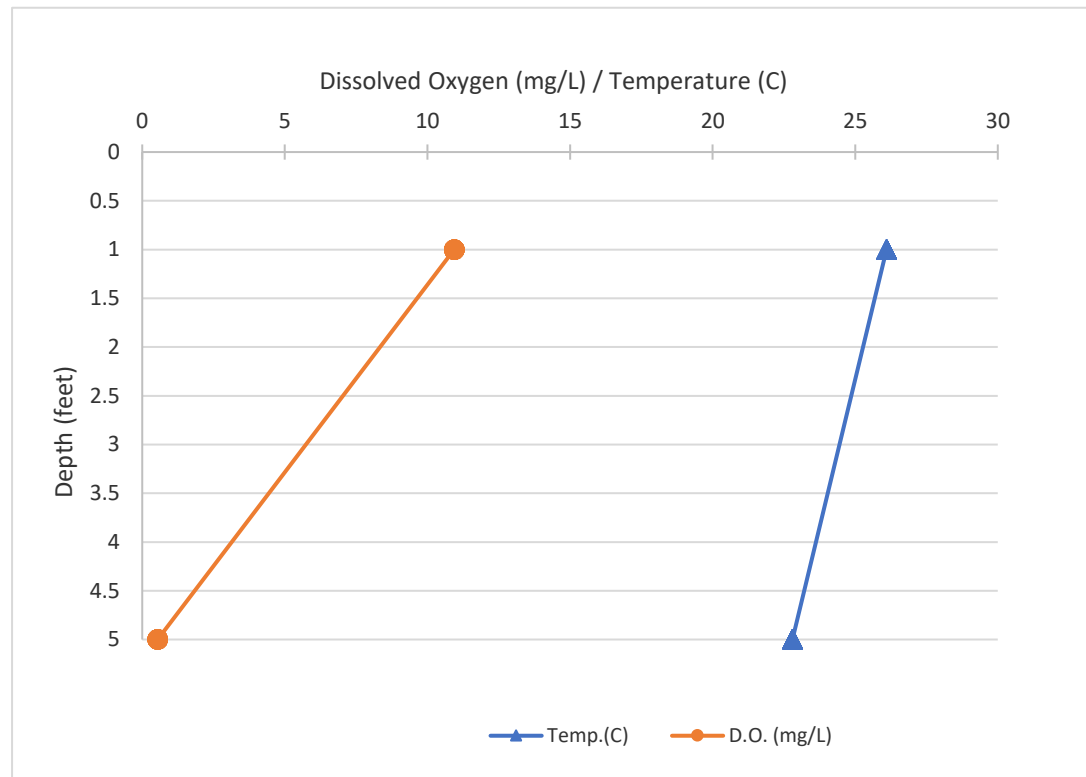
Name: Thread Lake
County: Genesee
Site ID: 250417
Date: 8/19/2022

Dissolved Oxygen and Temperature Profile

Depth (ft)	Temp.(C)	D.O. (mg/L)
1	26.1	10.94
1	26.1	10.94
1	26.1	10.94
1	26.1	10.94
1	26.1	10.94
1	26.1	10.94
1	26.1	10.94
1	26.1	10.94
1	26.1	10.94
1	26.1	10.94
1	26.1	10.94
5	22.8	0.54
5	22.8	0.54
5	22.8	0.54
5	22.8	0.54
5	22.8	0.54
5	22.8	0.54
5	22.8	0.54
5	22.8	0.54
5	22.8	0.54
5	22.8	0.54

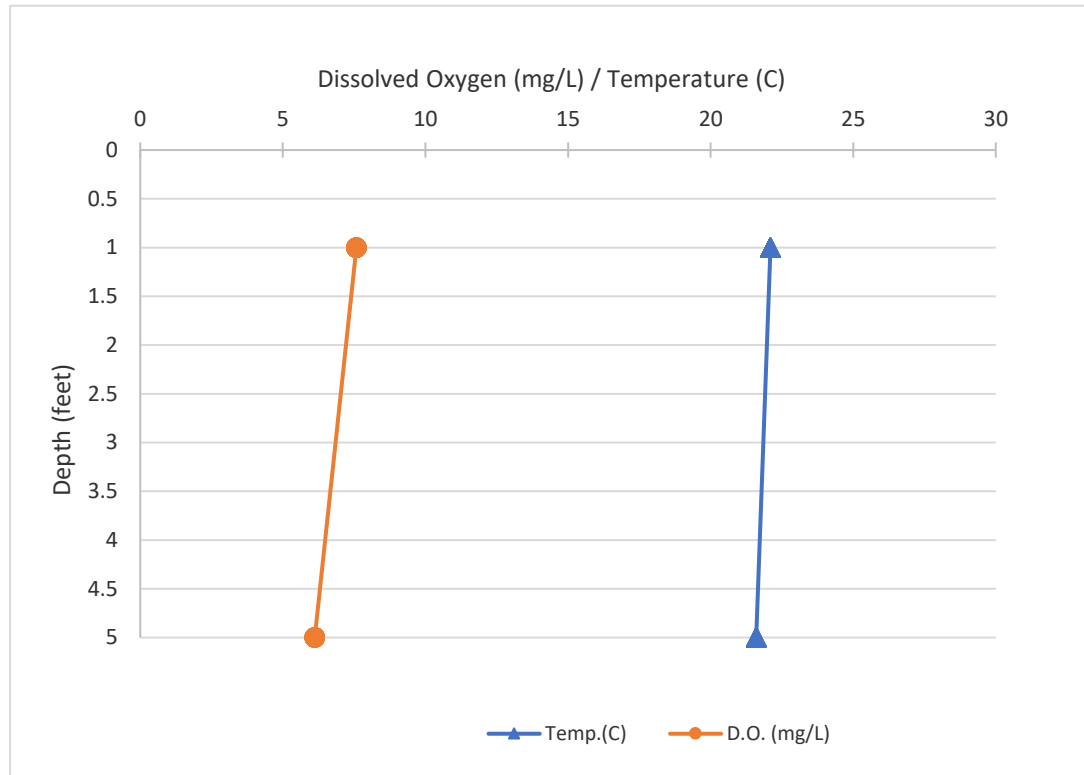
Name: Thread Lake
County: Genesee
Site ID: 250417
Date: 9/17/2022

Dissolved Oxygen and Temperature Profile

Depth (ft)	Temp.(C)	D.O. (mg/L)
1	22.1	7.58
1	22.1	7.58
1	22.1	7.58
1	22.1	7.58
1	22.1	7.58
1	22.1	7.58
1	22.1	7.58
1	22.1	7.58
1	22.1	7.58
1	22.1	7.58
1	22.1	7.58
5	21.6	6.12
5	21.6	6.12
5	21.6	6.12
5	21.6	6.12
5	21.6	6.12
5	21.6	6.12
5	21.6	6.12
5	21.6	6.12
5	21.6	6.12
5	21.6	6.12
5	21.6	6.12
