2022 Data Report for

Twin Lake, Crawford County

Site ID: 200184

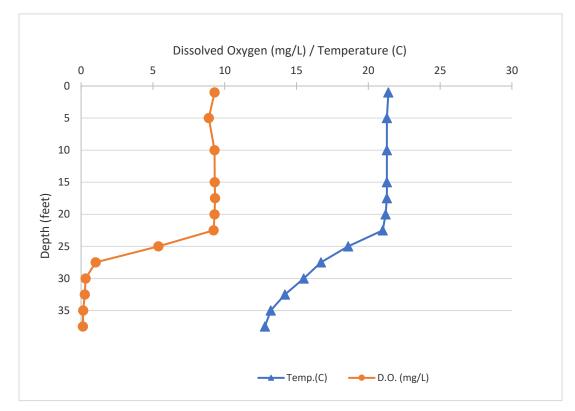
Name: Twin Lake County: Crawford Site ID: 200184 Date: 9/9/2022

Temp.(C)	D.O. (mg/L)
21.4	9.3
21.3	8.89
21.3	9.29
21.3	9.31
21.3	9.33
21.2	9.3
21	9.23
18.6	5.38
16.7	1.02
15.5	0.31
14.2	0.26
13.2	0.15
12.8	0.12
	21.4 21.3 21.3 21.3 21.2 21.2 21 18.6 16.7 15.5 14.2
