2022 Data Report for

White Lake (East), Muskegon County

Site ID: 610330

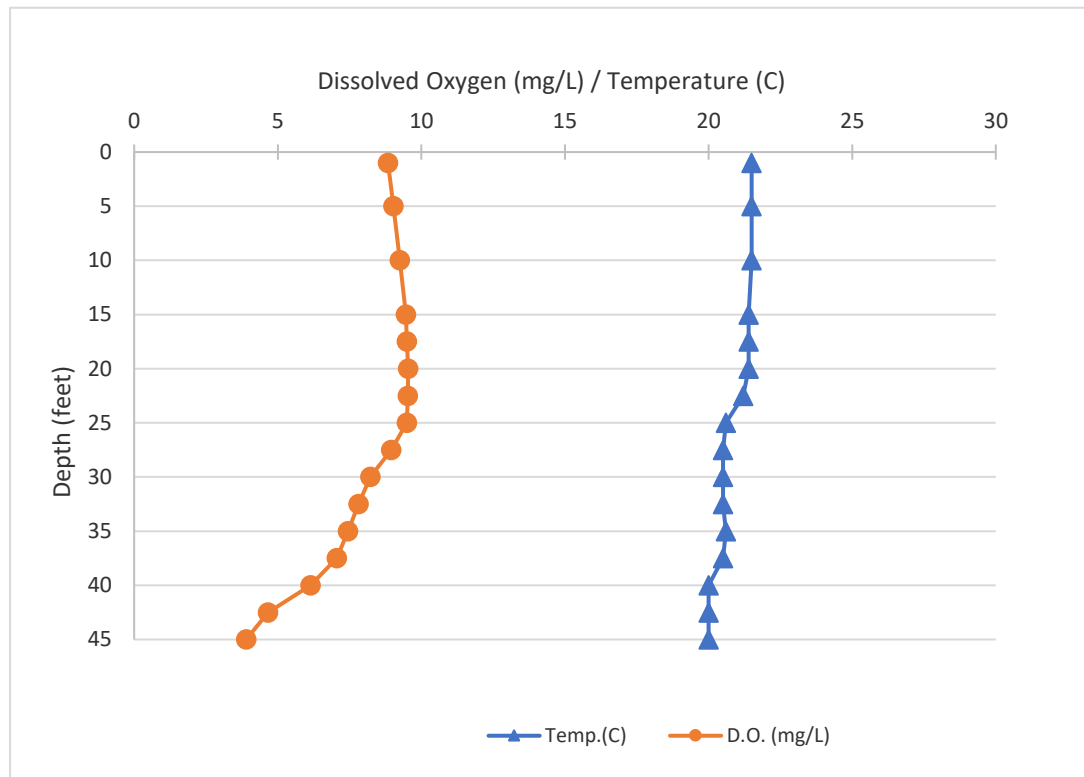
9/17/2022

Dissolved Oxygen and Temperature Profile

Depth (ft)	Temp.(C)	D.O. (mg/L)
1	21.5	8.84
5	21.5	9.03
10	21.5	9.25
15	21.4	9.46
17.5	21.4	9.5
20	21.4	9.54
22.5	21.2	9.53
25	20.6	9.49
27.5	20.5	8.95
30	20.5	8.22
32.5	20.5	7.81
35	20.6	7.44
37.5	20.5	7.06
40	20	6.14
42.5	20	4.66
45	20	3.9
