2022 Data Report for Rennie Lake, Grand Traverse County

Site ID: 280430

Rennie Lake, Grand Traverse County 2022 CLMP Results

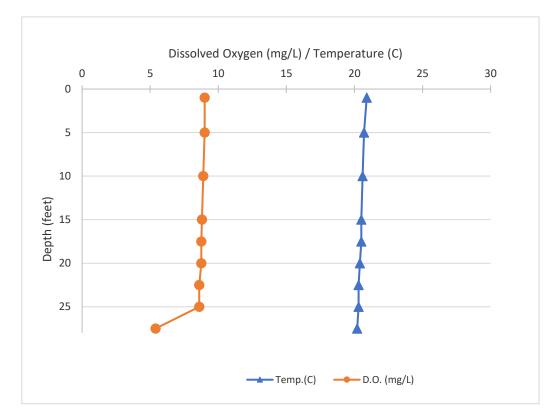
Site ID: 280430 Date: 9/13/2021

Depth (ft)	Temp.(C)	D.O. (mg/L)
1	20.9	9
5	20.7	9
10	20.6	8.9
15	20.5	8.8
17.5	20.5	8.75
20	20.4	8.75
22.5	20.3	8.6
25	20.3	8.6
27.5	20.2	5.4
