# **2022 Data Report for Lake View, Benzie County**

Site ID: 100274

# Lake View, Benzie County 2022 CLMP Results

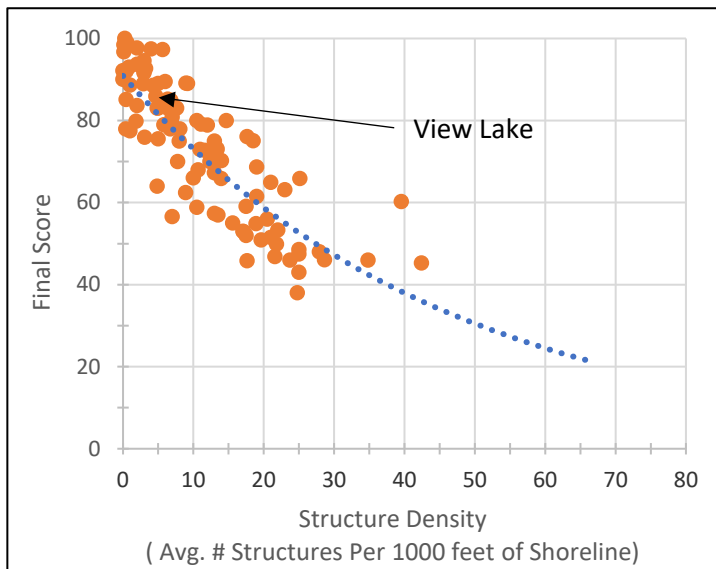
Lake View	
Number of Sections:	9
Number of Structures:	61
Structure Density:	6.8
Final Score:	84.9

All 95 Participating Lakes from 2015-2022:	
Avg. Number of Sections:	16
Avg. Number of Structures:	228
Avg. Structure Density:	12
Avg. Final Score:	73

Note about graph to the left: The dotted line sets your average expectation of the score of your lake. If your lake is lower than the dotted line, then your shoreline health is lower than average compared to lakes with similar amount of shoreline development. And vice-versa in regards to a lake above the dotted line.

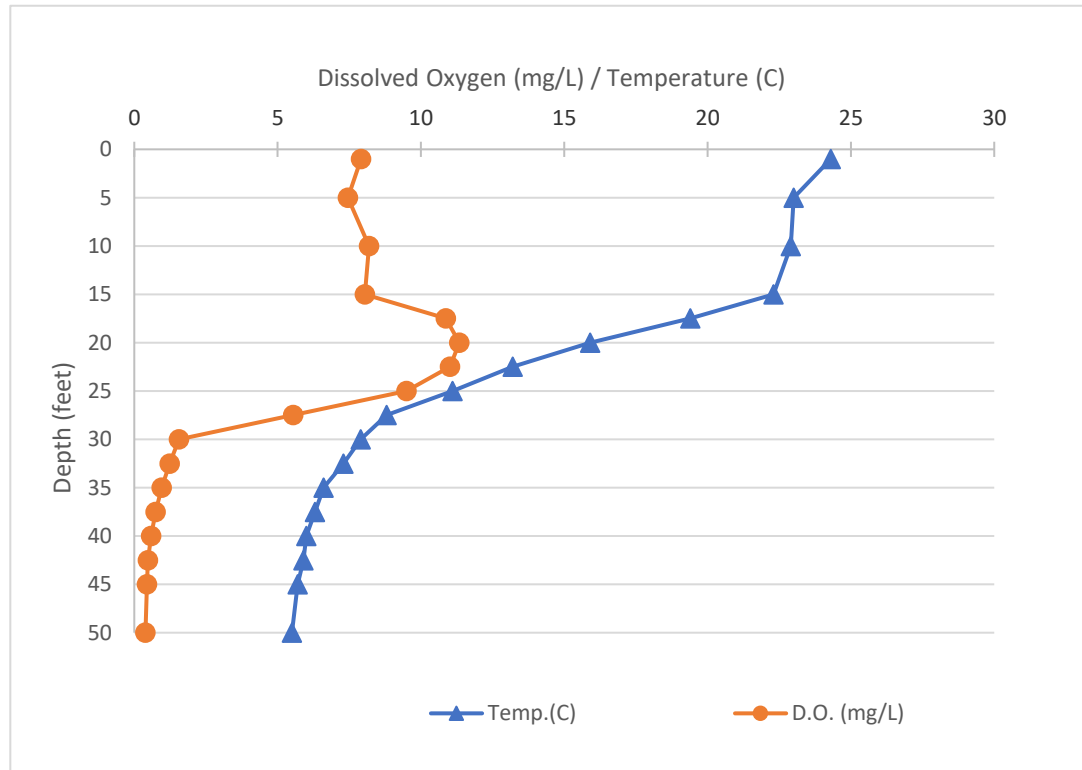
9/8/2022

### Dissolved Oxygen and Temperature Profile

Depth (ft)	Temp.(C)	D.O. (mg/L)
1	24.3	7.91
5	23	7.45
10	22.9	8.19
15	22.3	8.04
17.5	19.4	10.87
20	15.9	11.34
22.5	13.2	11.01
25	11.1	9.5
27.5	8.8	5.54
30	7.9	1.56
32.5	7.3	1.24
35	6.6	0.96
37.5	6.3	0.74
40	6	0.59
42.5	5.9	0.48
45	5.7	0.44
50	5.5	0.39
