2023 Data Report for Beaver Lake, Alpena County

Site ID: 040097

Beaver Lake, Alpena County 2023 CLMP Results

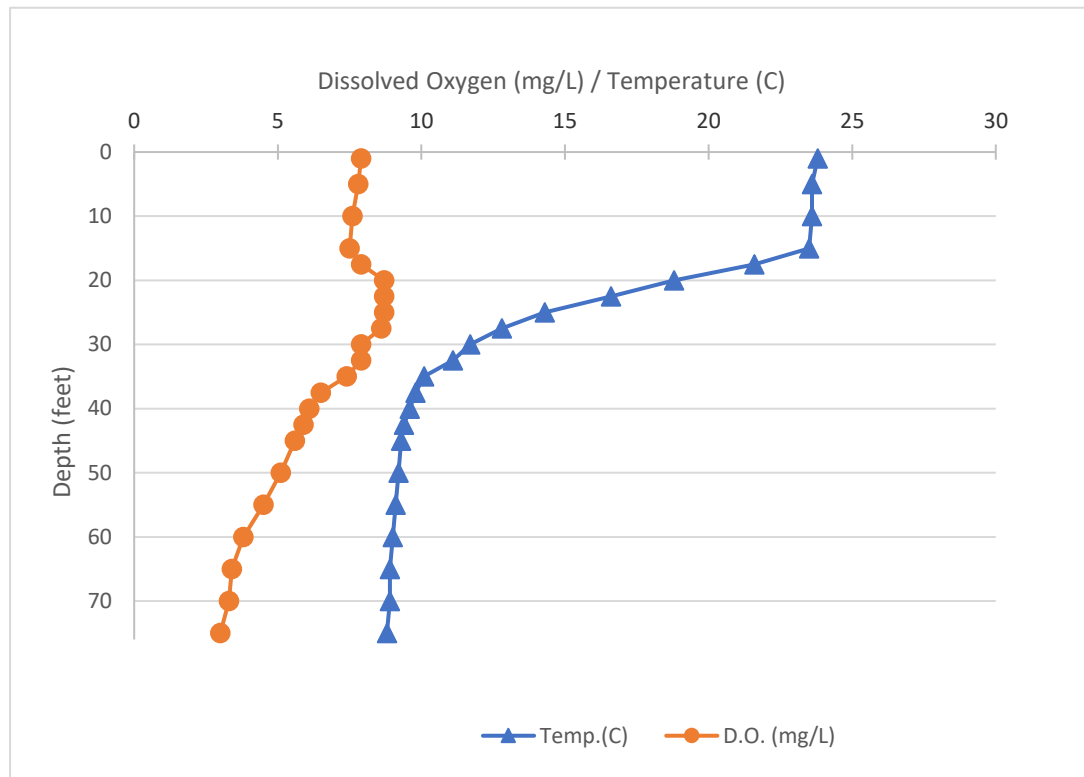
6/23/2012

Dissolved Oxygen and Temperature Profile

Depth (ft)	Temp.(C)	D.O. (mg/L)
1	23.8	7.9
5	23.6	7.8
10	23.6	7.6
15	23.5	7.5
17.5	21.6	7.9
20	18.8	8.7
22.5	16.6	8.7
25	14.3	8.7
27.5	12.8	8.6
30	11.7	7.9
32.5	11.1	7.9
35	10.1	7.4
37.5	9.8	6.5
40	9.6	6.1
42.5	9.4	5.9
45	9.3	5.6
50	9.2	5.1
55	9.1	4.5
60	9	3.8
65	8.9	3.4
70	8.9	3.3
75	8.8	3

Lake: Beaver Lake (Alpena Co.)
