2023 Data Report for

First Fortune Lake, Iron County

Site ID: 360080

First Fortune Lake, Iron County 2023 CLMP Results

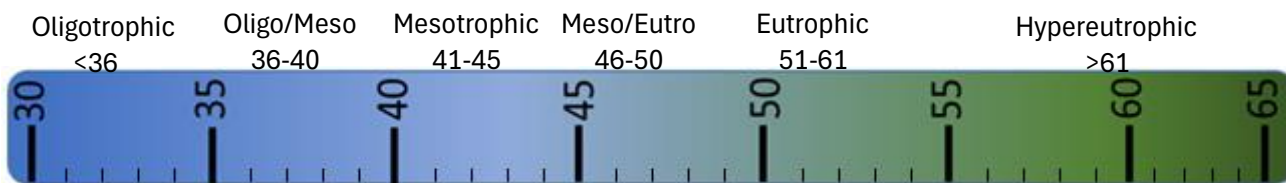
TSI for First Fortune Lake in 2023	
Average	27
Secchi Disk	
Summer TP	27
Chlorophyll-a

^ Average

^ Total Phosphorus

With a TSI score of 29 based on 2023 summer total phosphorus, this lake is rated as oligotrophic.

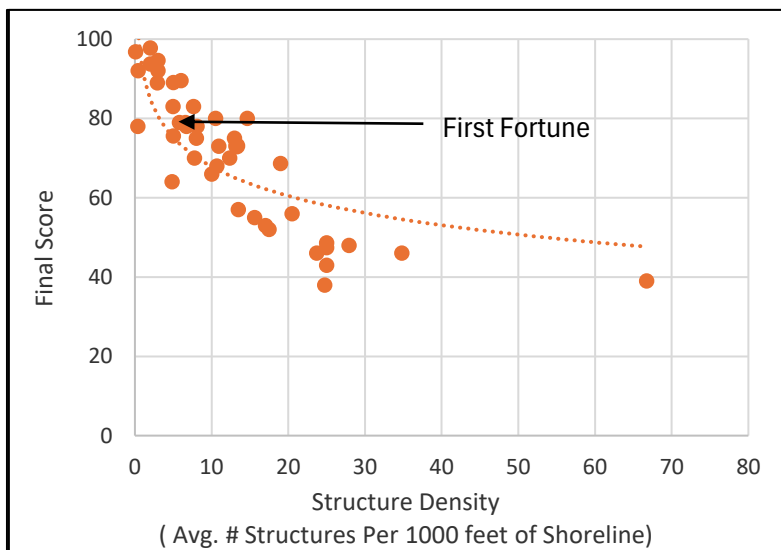
How does your lake compare to others in the program?

First Fortune Lake:	
Number of Sections:	18
Number of Structures:	121
Structure Density:	6.7
Final Score:	78

All 42 Participating Lakes from 2015-2018:	
Avg. Number of Sections:	16.3
Avg. Number of Structures:	248.5
Avg. Structure Density:	15.2
Avg. Final Score:	70.5

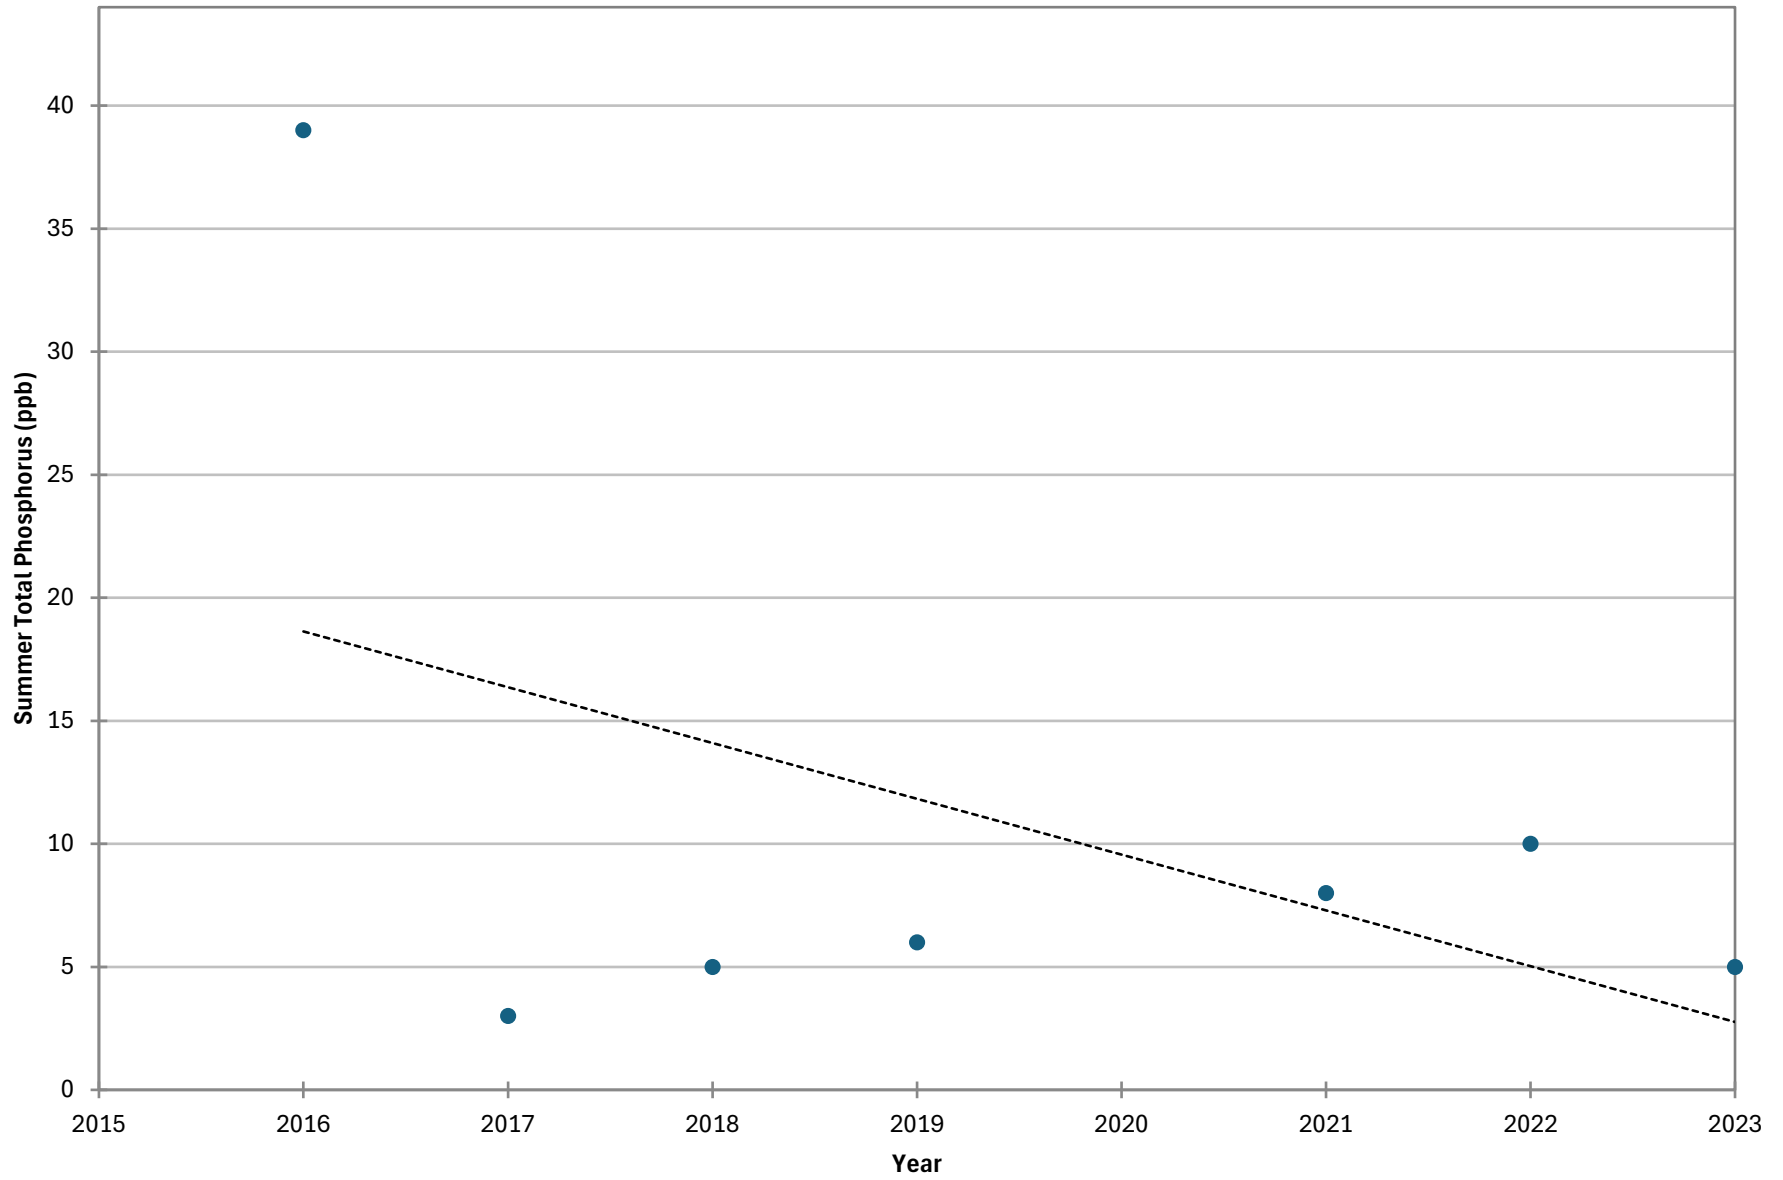
COOPERATIVE LAKES MONITORING PROGRAM
SUMMER TOTAL PHOSPHORUS

First Fortune Lake (Iron Co.), 360080
