2023 Data Report for Hunter Lake, Gladwin County

Site ID: 260119

Hunter Lake, Gladwin County 2023 CLMP Results

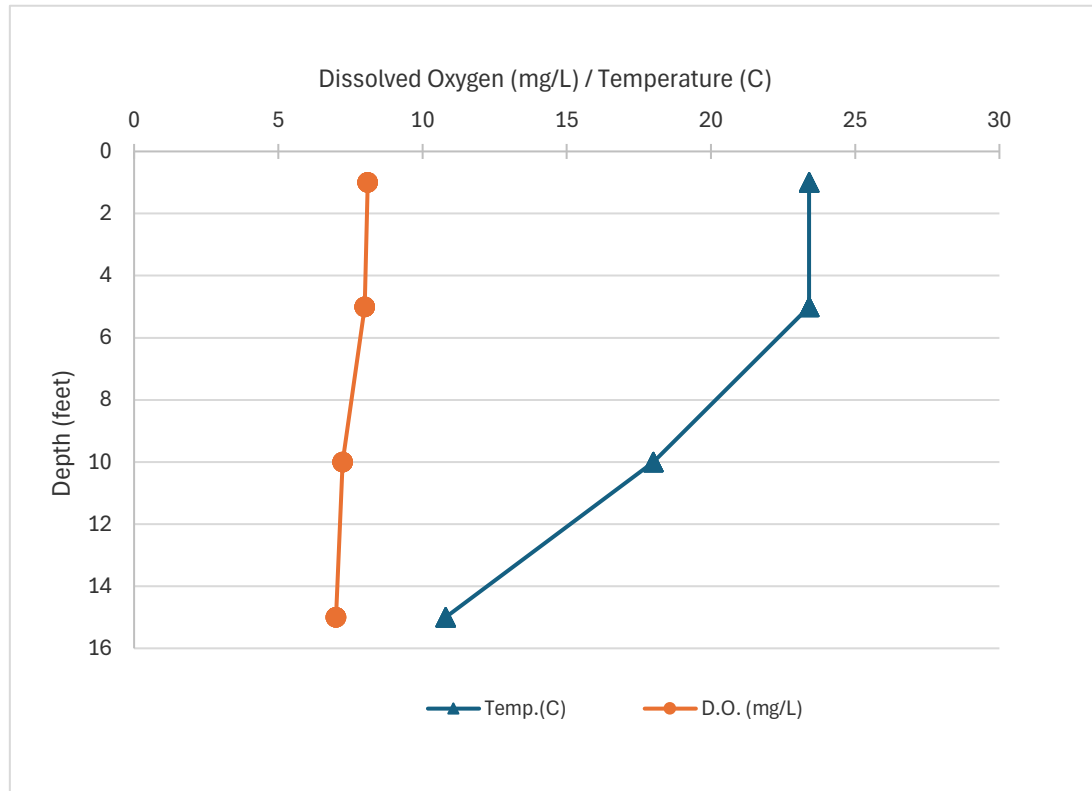
Name: Hunter Lake
 County: Gladwin
 Site ID: 260119
 Date: 6/5/2016

Dissolved Oxygen and Temperature Profile

Depth (ft)	Temp.(C)	D.O. (mg/L)
1	23.4	8.1
1	23.4	8.1
1	23.4	8.1
1	23.4	8.1
1	23.4	8.1
5	23.4	8
5	23.4	8
5	23.4	8
5	23.4	8
5	23.4	8
10	18	7.23
10	18	7.23
10	18	7.23
10	18	7.23
10	18	7.23
15	10.8	7
15	10.8	7
15	10.8	7
15	10.8	7
15	10.8	7

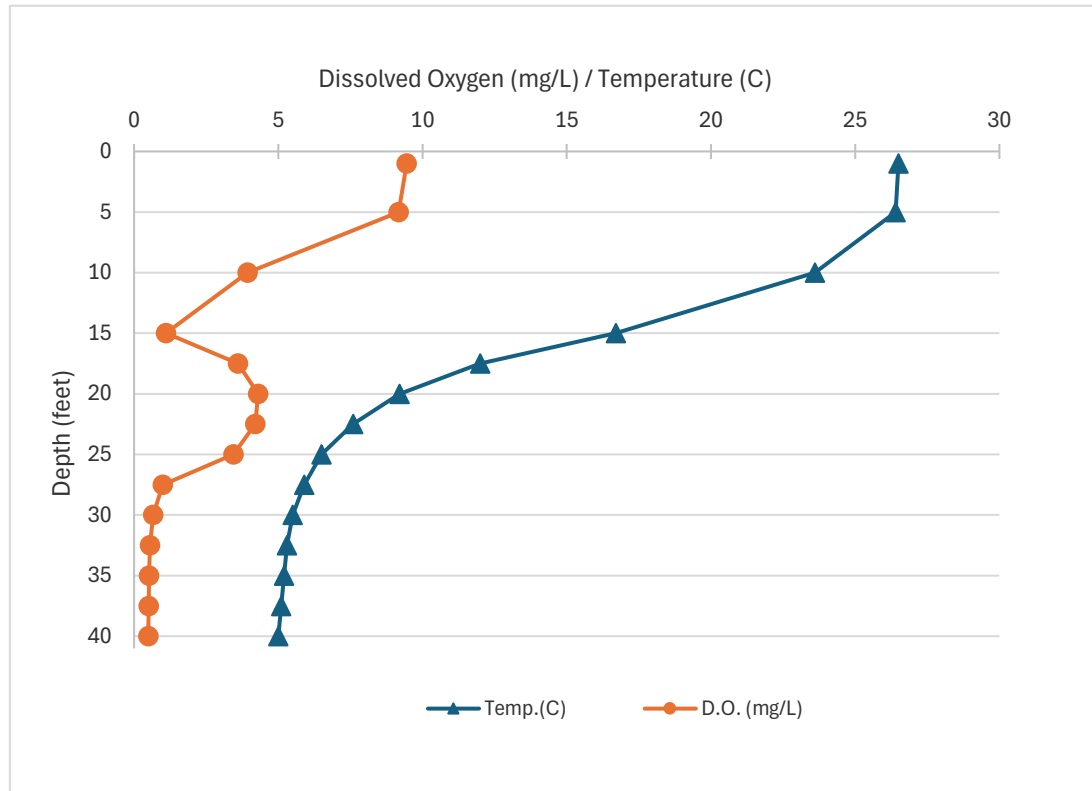
Name: Hunter Lake
 County: Gladwin
 Site ID: 260119
 Date: 8/7/2016

Dissolved Oxygen and Temperature Profile

Depth (ft)	Temp.(C)	D.O. (mg/L)
1	26.5	9.45
5	26.4	9.17
10	23.6	3.93
15	16.7	1.11
17.5	12	3.6
20	9.2	4.3
22.5	7.6	4.2
25	6.5	3.45
27.5	5.9	1
30	5.5	0.66
32.5	5.3	0.55
35	5.2	0.52
37.5	5.1	0.51
40	5	0.49

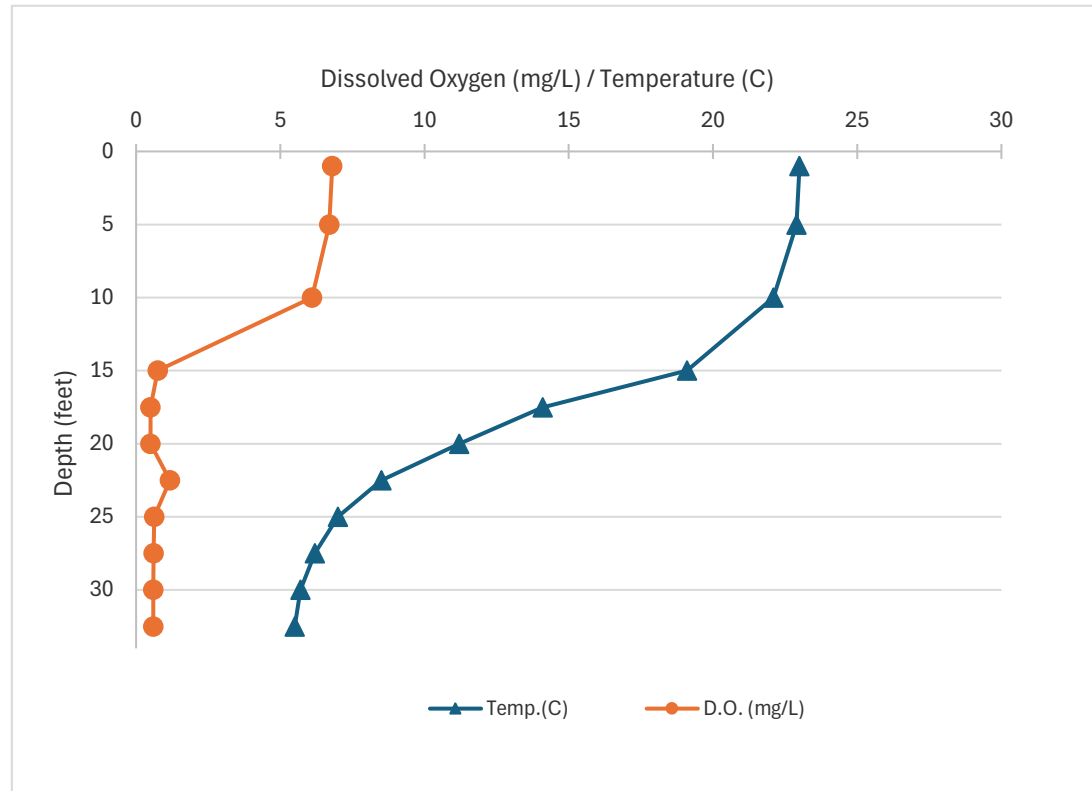
Name: Hunter Lake
County: Gladwin
Site ID: 260119
Date: 9/12/2016

Dissolved Oxygen and Temperature Profile

Depth (ft)	Temp.(C)	D.O. (mg/L)
1	23	6.8
5	22.9	6.7
10	22.1	6.1
15	19.1	0.75
17.5	14.1	0.5
20	11.2	0.5
22.5	8.5	1.17
25	7	0.63
27.5	6.2	0.61
30	5.7	0.6
32.5	5.5	0.6
