2023 Data Report for Painter Lake, Cass County

Site ID: 140108

2023 CLMP Results

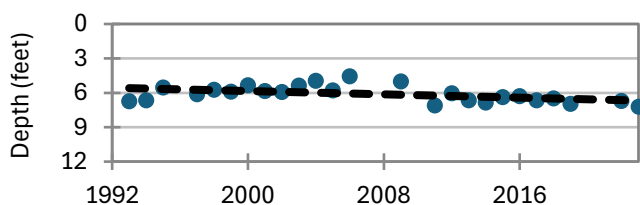
Secchi Disk Transparency (feet)

Year	# Readings	Min	Max	Average	Std. Dev	Carlson TSI
2023	9	6.0	8.0	7.2	0.6	49
2018-2022	34	4.5	9.0	6.7	1.1	50
1993-2017	317	2.5	13.0	6.0	1.3	51
2023 All CLMP Lakes	2825	0.5	51.0	12.2	2.7	43

With a TSI score of 49 based on 2023 Secchi disk transparency, this lake is rated between the mesotrophic and eutrophic classification.

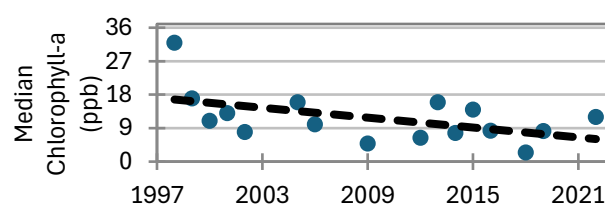
Chlorophyll-a (parts per billion)

Year	# Samples	Min	Max	Median	Std. Dev	Carlson TSI
2022	5	7.1	22.0	12.0	6.6	55
2017-2021	5	1.1	17.0	2.5	6.7	40
1998-2016	69	1.6	190.0	2.5	20.8	54
2023 All CLMP Lakes	687	< 1.0	43.0	3.7	5.3	43

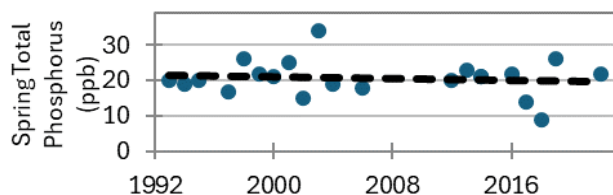
Spring Phosphorus (parts per billion)

Year	# Samples	Min	Max	Average	Std. Dev
2022	1	22.0	22.0	22.0	NA
2017-2021	3	9.0	26.0	16.3	8.7
1993-2016	17	15.0	34.0	21.4	4.2
2023 All CLMP Lakes	220	<5	220.0	20.7	21.3

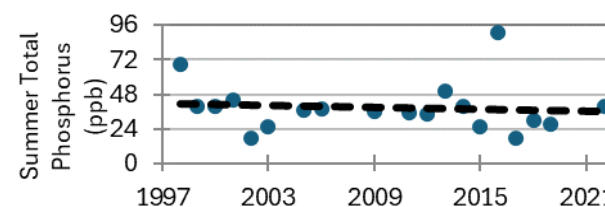
Summer Phosphorus (parts per billion)

Year	# Samples	Min	Max	Average	Std. Dev	Carlson TSI
2022	1	40.0	40.0	40.0	NA	57
2017-2021	2	18.0	30.0	24.0	8.5	50
1998-2016	15	18.0	91.0	41.6	17.9	57
2023 All CLMP Lakes	234	<= 3	150.0	17.4	15.3	45

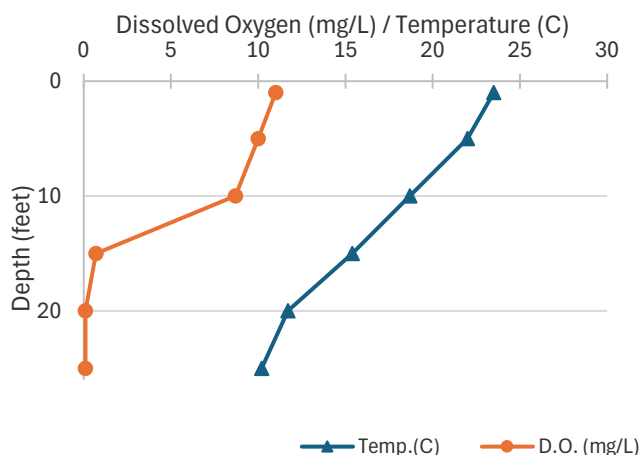
Dissolved Oxygen and Temperature Profile

6/13/2022

Monitoring data indicates that this lake is devoid of oxygen in the bottom waters by early summer and that the lakes remain stratified through early fall.

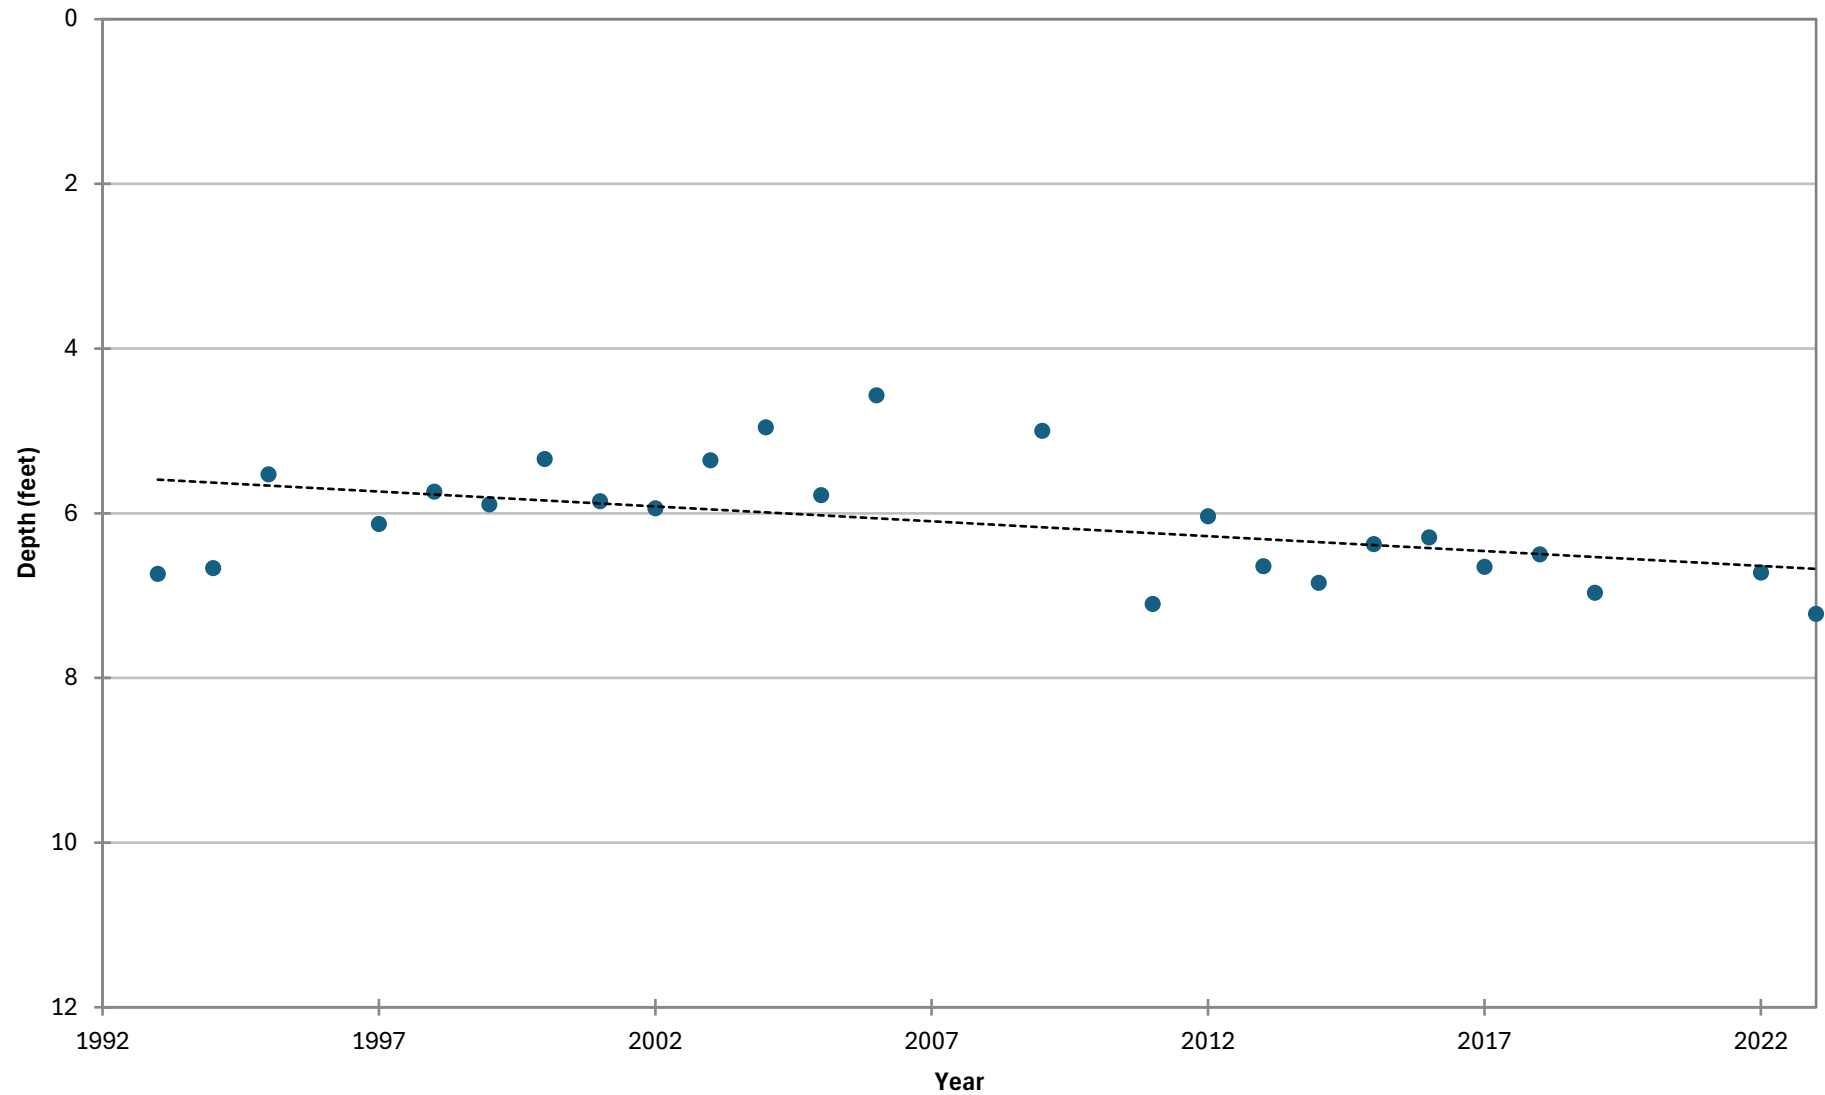
COOPERATIVE LAKES MONITORING PROGRAM
SUMMER MEAN TRANSPARENCY

Long term monitoring shows slight downward slopes on all the parameters and a decrease in TSI score in 2023 from the historic average. These results indicate a slow movement toward lower nutrient levels in this lake over time.

Painter Lake (Cass Co.), 140108

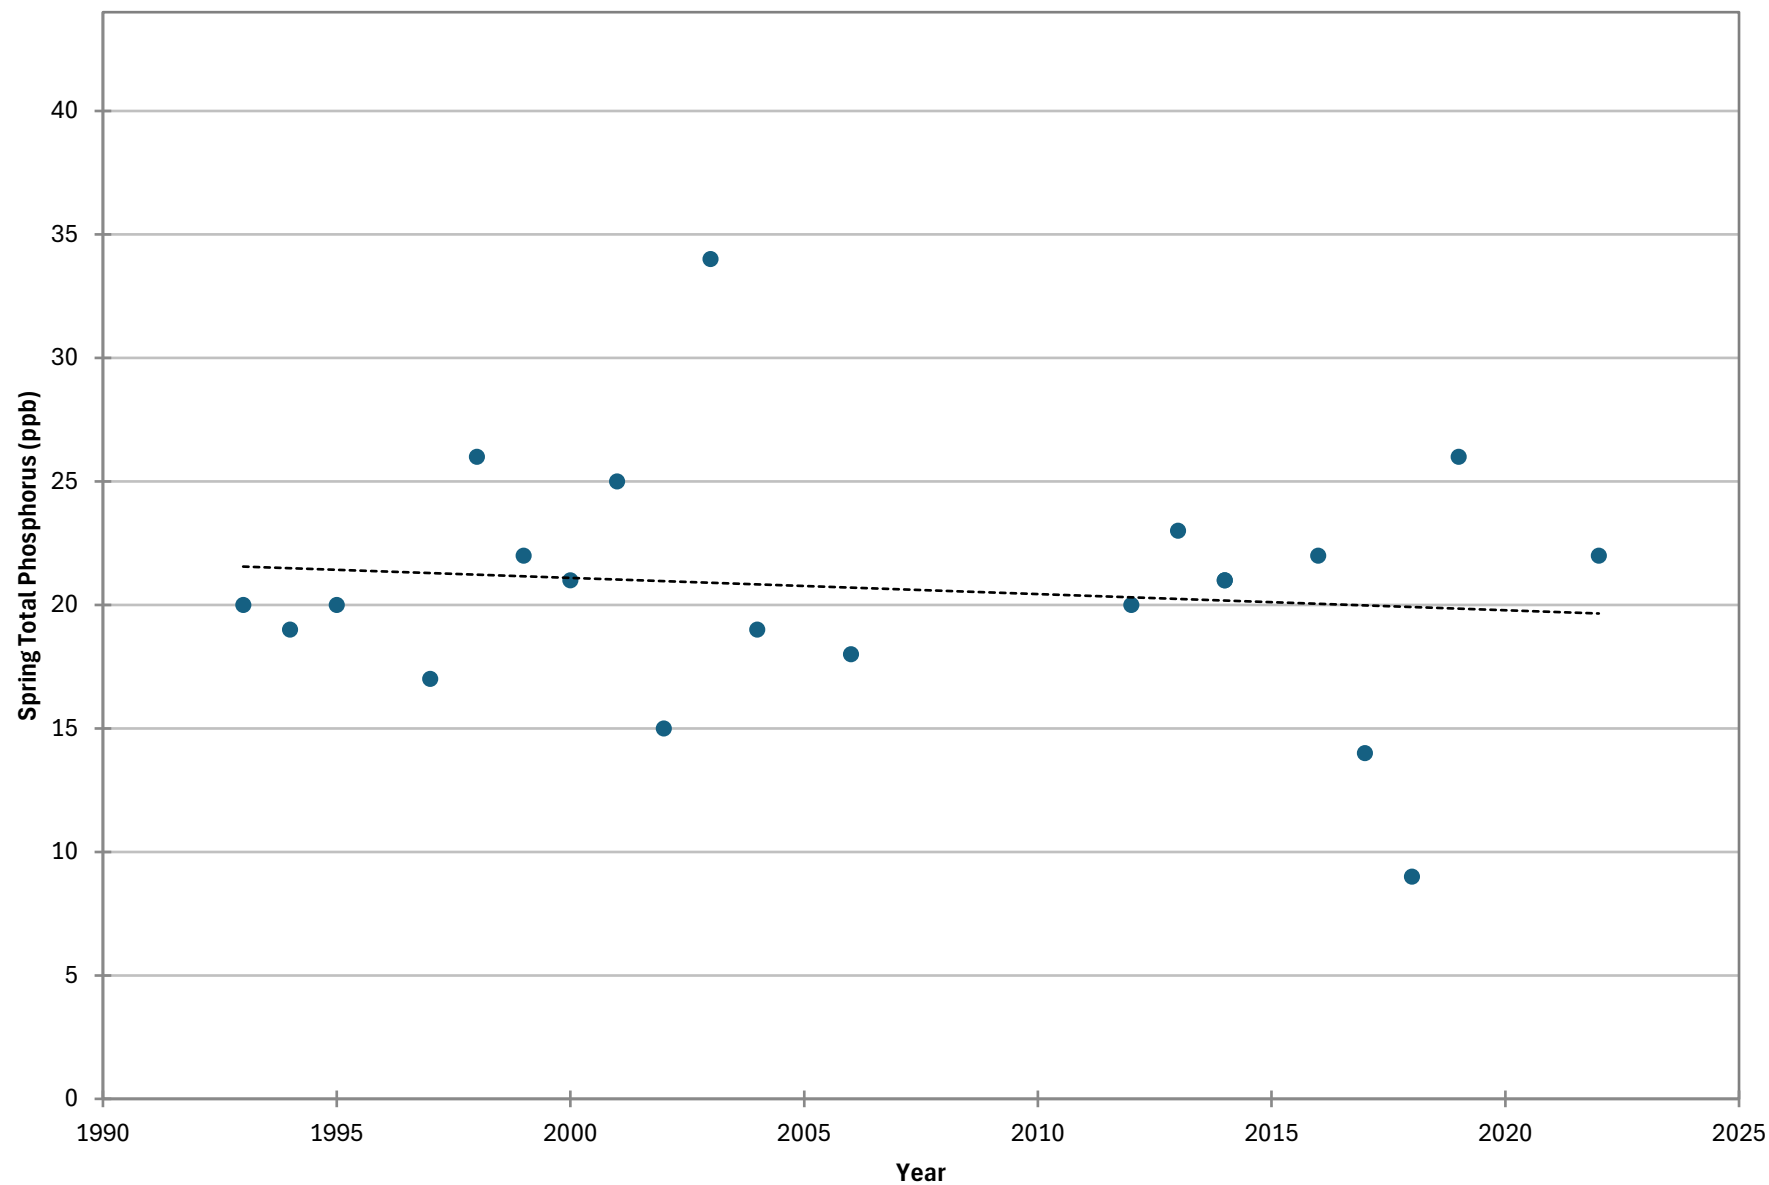
COOPERATIVE LAKES MONITORING PROGRAM
SPRING TOTAL PHOSPHORUS

Painter Lake (Cass Co.), 140108

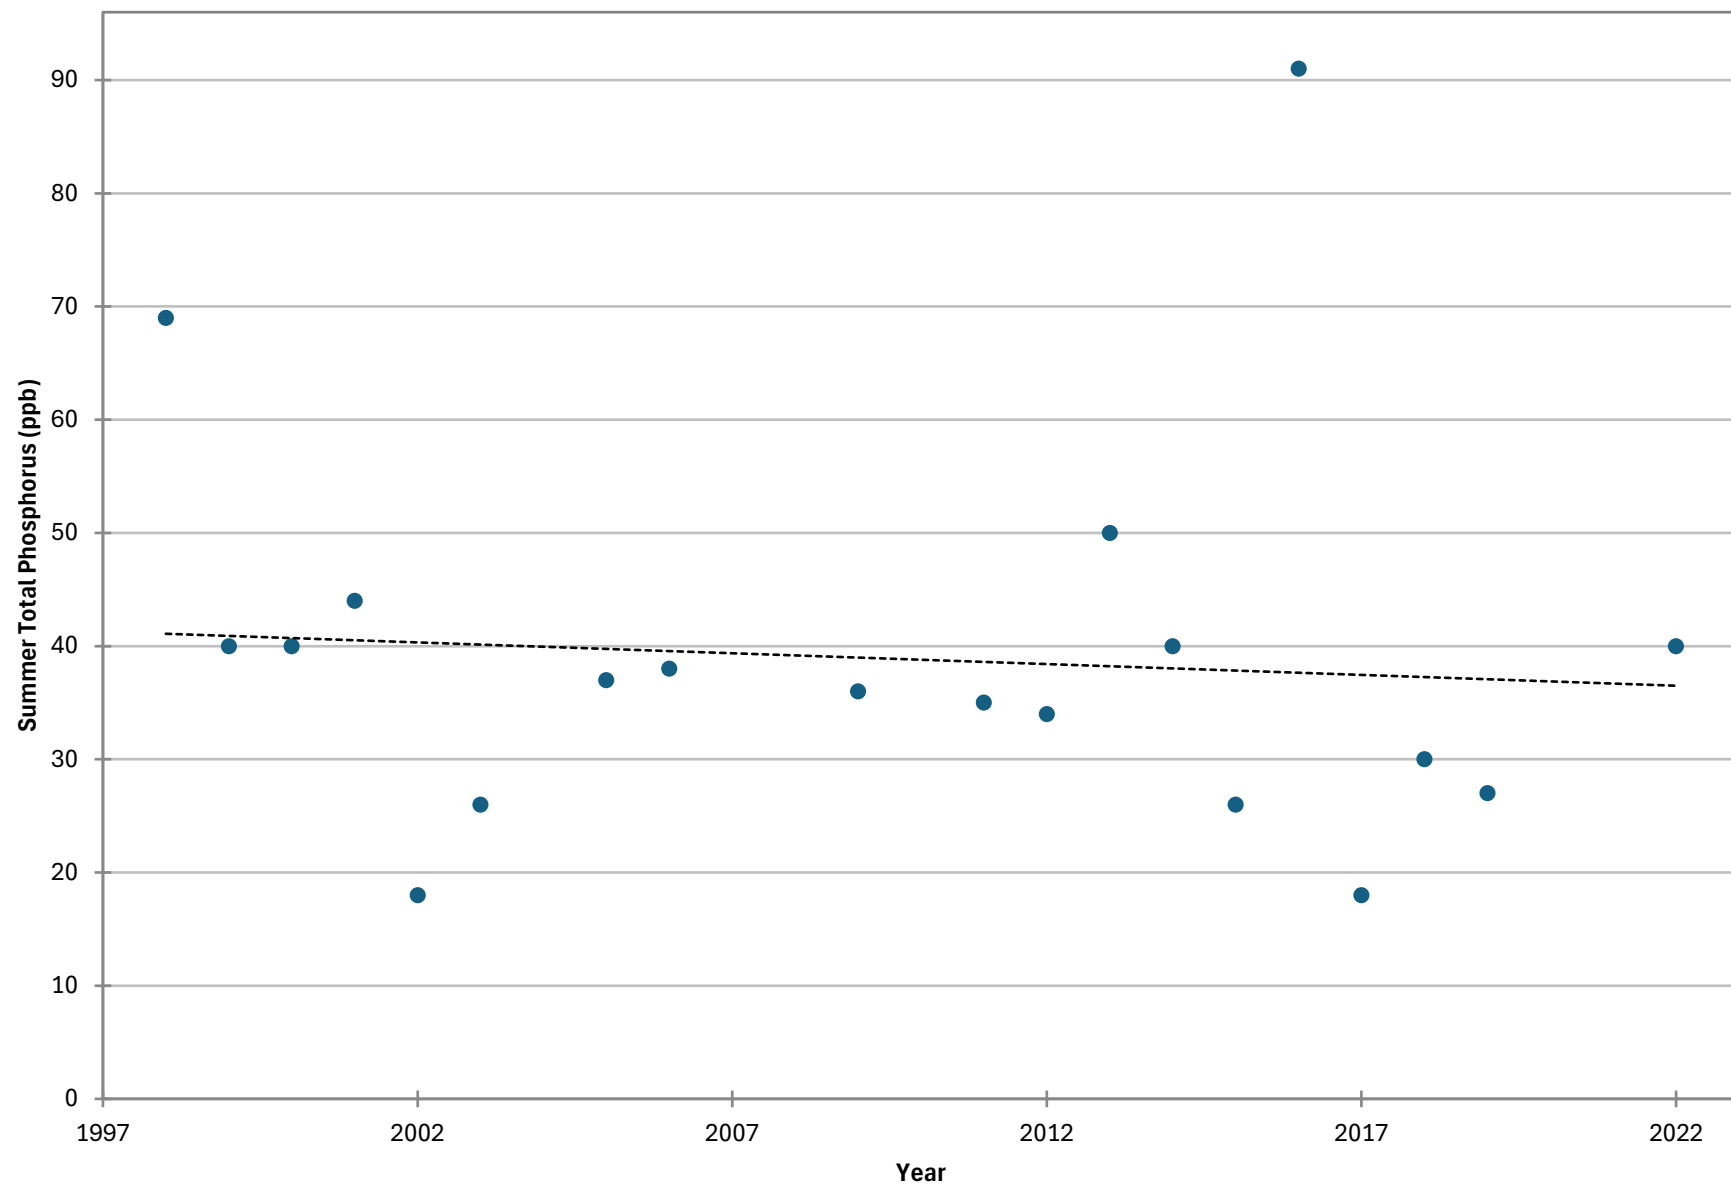
COOPERATIVE LAKES MONITORING PROGRAM
SUMMER TOTAL PHOSPHORUS

Painter Lake (Cass Co.), 140108

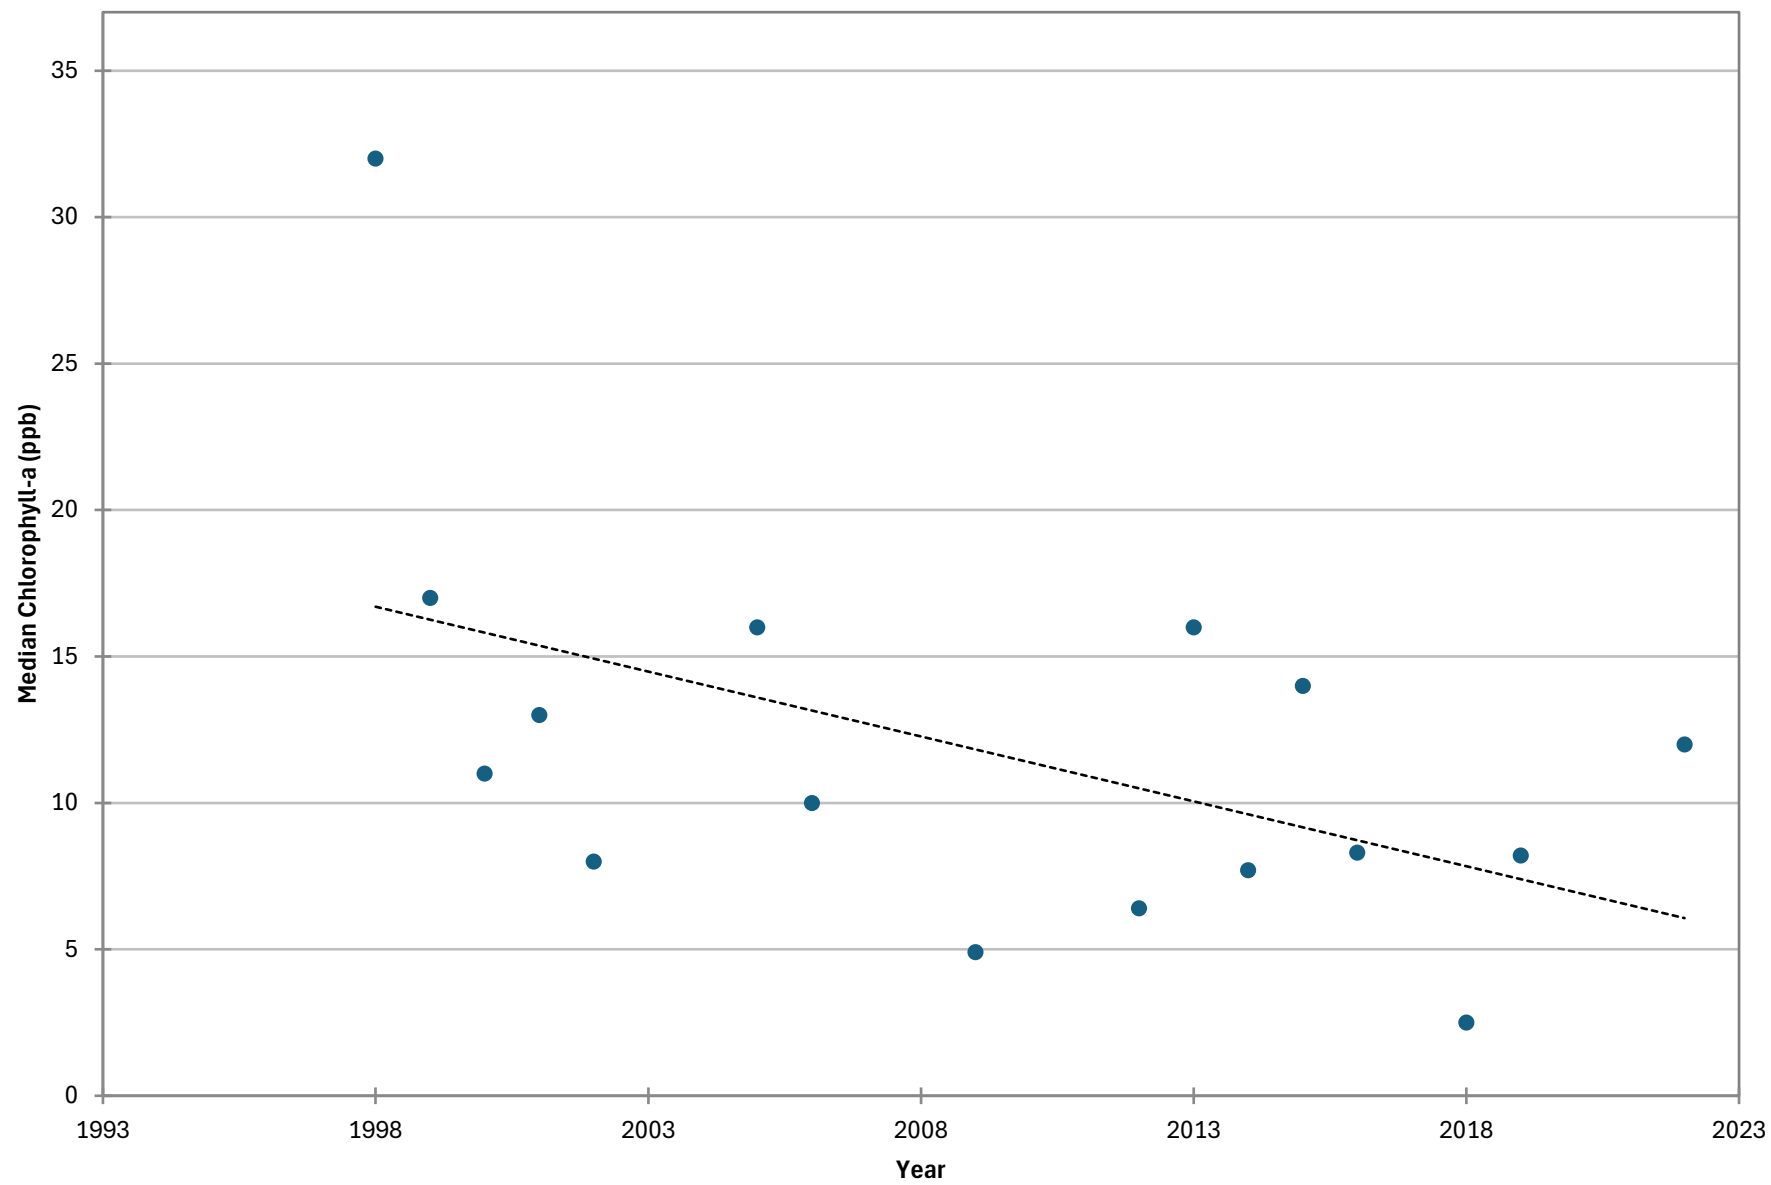
COOPERATIVE LAKES MONITORING PROGRAM
SUMMER MEDIAN CHLOROPHYLL-A

Painter Lake (Cass Co.), 140108

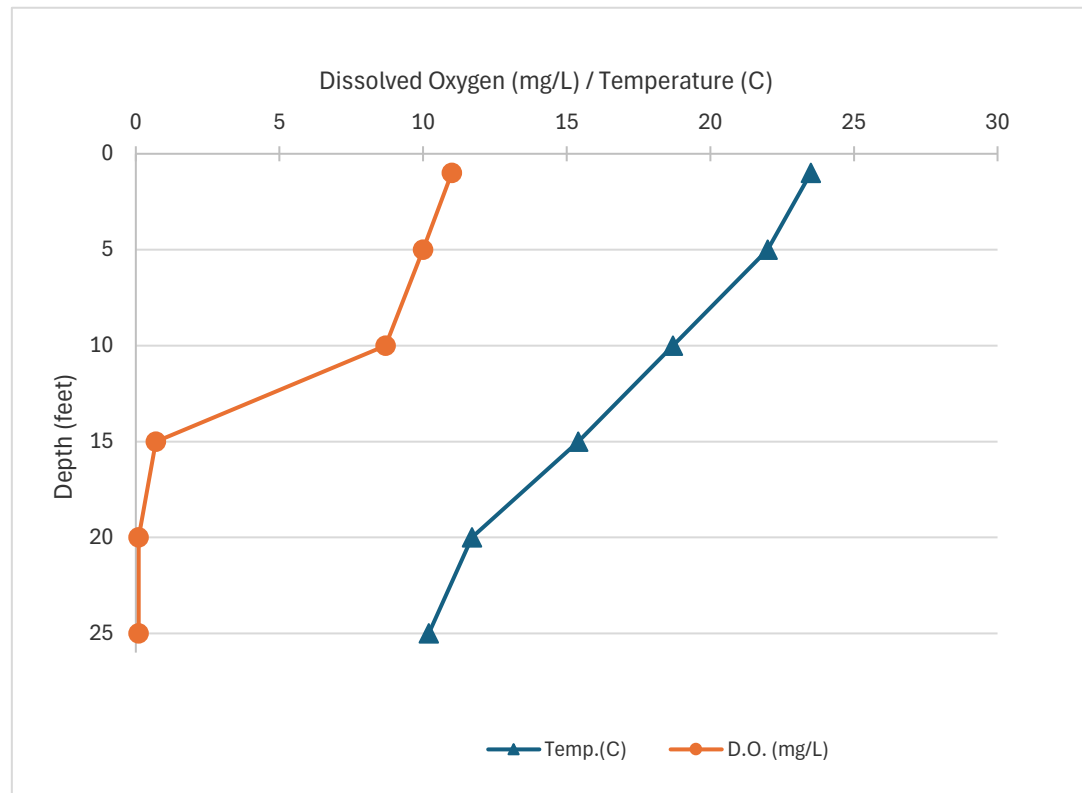
Dissolved Oxygen and Temperature Profile

Name: Painter Lake
County: Cass
Site ID: 140108
Date: 6/13/2022

Depth (ft)	Temp.(C)	D.O. (mg/L)
1	23.5	11
5	22	10
10	18.7	8.7
15	15.4	0.7
20	11.7	0.1
25	10.2	0.1

6/13/2022

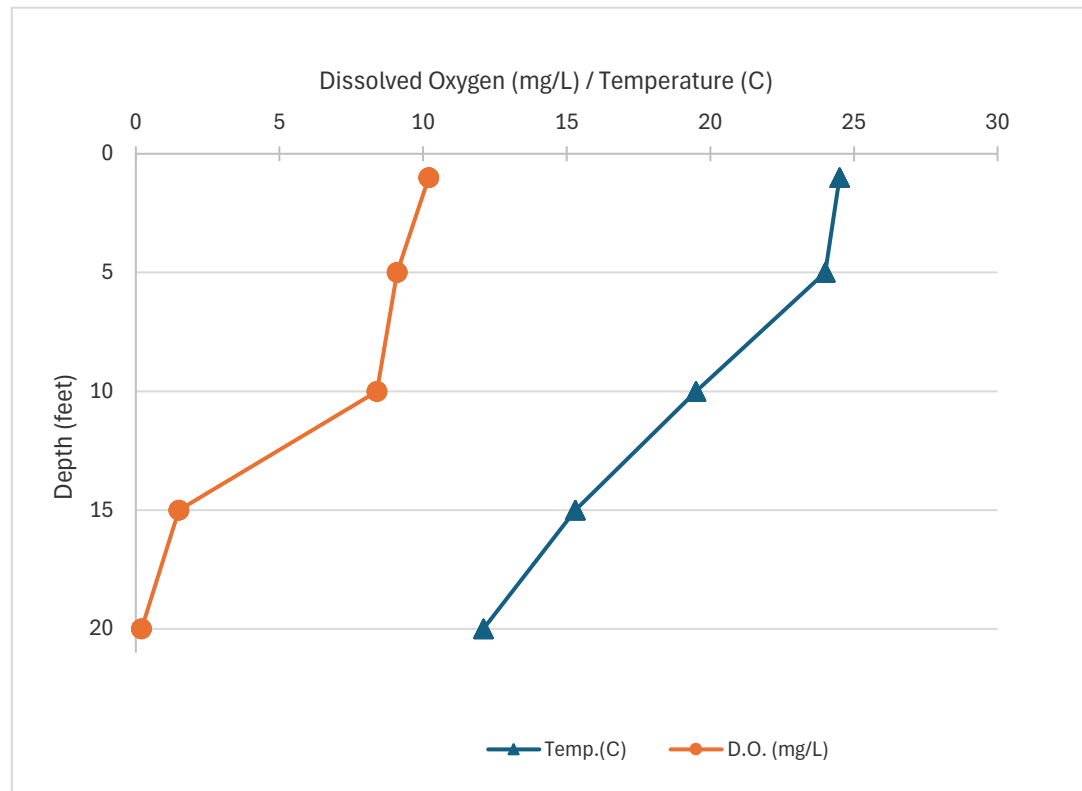
Dissolved Oxygen and Temperature Profile

Name: Painter Lake
County: Cass
Site ID: 140108
Date: 6/20/2022

Depth (ft)	Temp.(C)	D.O. (mg/L)
1	24.5	10.2
1	24.5	10.2
1	24.5	10.2
1	24.5	10.2
5	24	9.1
5	24	9.1
5	24	9.1
5	24	9.1
10	19.5	8.4
10	19.5	8.4
10	19.5	8.4
10	19.5	8.4
15	15.3	1.5
15	15.3	1.5
15	15.3	1.5
15	15.3	1.5
20	12.1	0.2
20	12.1	0.2
20	12.1	0.2
20	12.1	0.2

6/20/2022

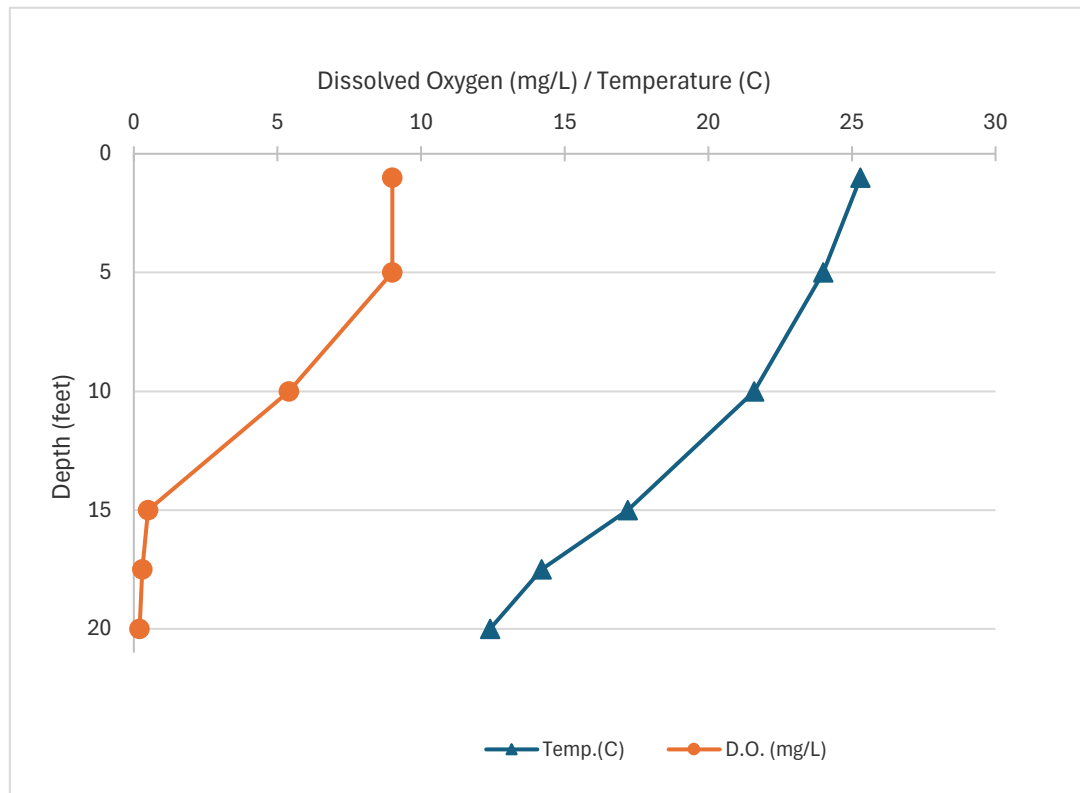
Dissolved Oxygen and Temperature Profile

Name: Painter Lake
County: Cass
Site ID: 140108
Date: 7/2/2022

Depth (ft)	Temp.(C)	D.O. (mg/L)
1	25.3	9
5	24	9
10	21.6	5.4
15	17.2	0.5
17.5	14.2	0.3
20	12.4	0.2

7/2/2022

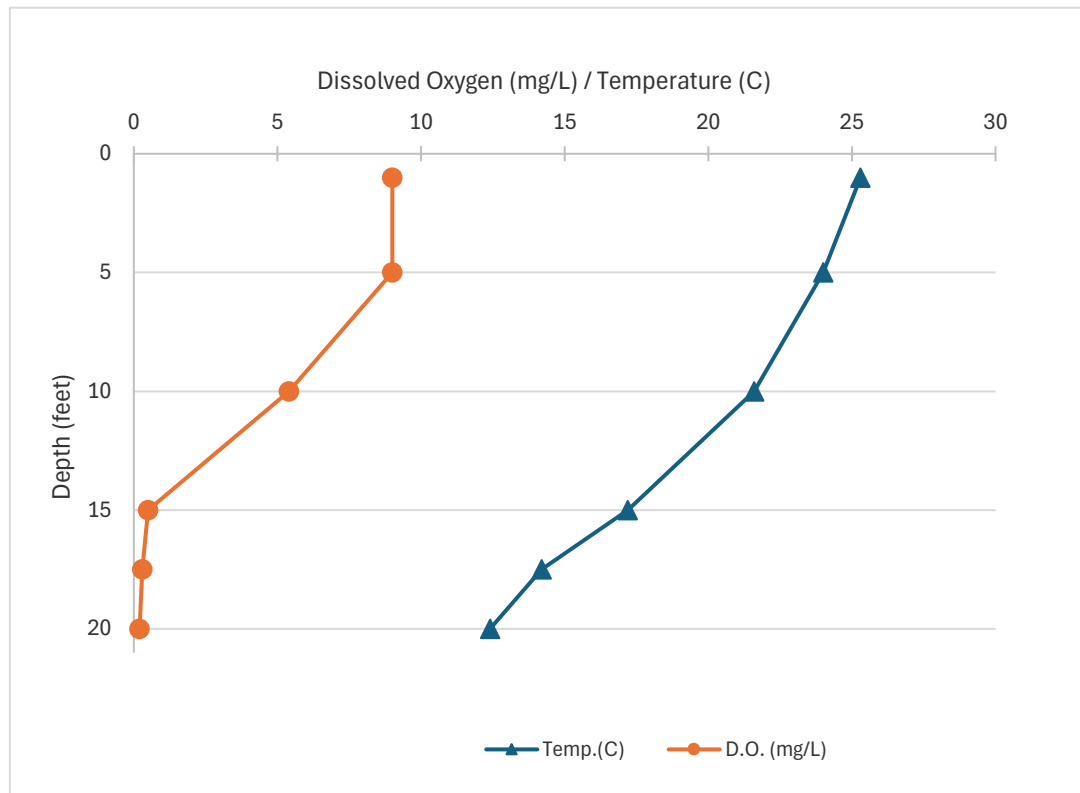
Dissolved Oxygen and Temperature Profile

Name: Painter Lake
County: Cass
Site ID: 140108
Date: 7/7/2022

Depth (ft)	Temp.(C)	D.O. (mg/L)
1	25.3	9
5	24	9
10	21.6	5.4
15	17.2	0.5
17.5	14.2	0.3
20	12.4	0.2

7/7/2022

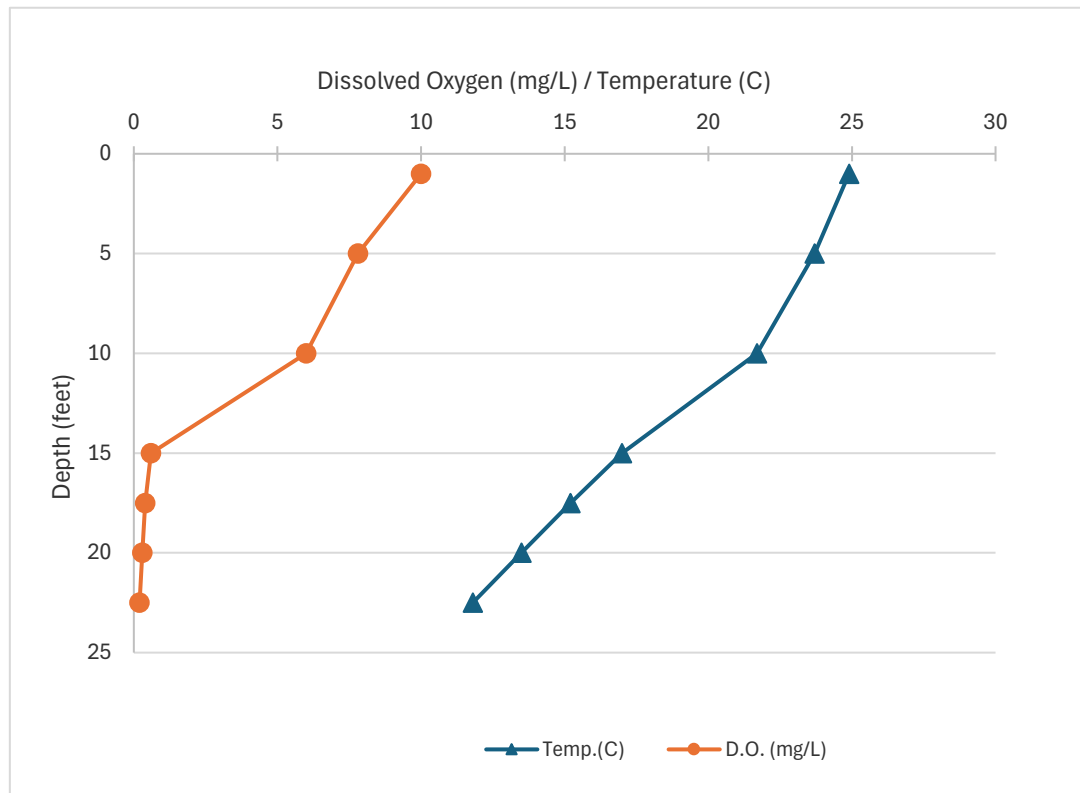
Dissolved Oxygen and Temperature Profile

Name: Painter Lake
County: Cass
Site ID: 140108
Date: 7/16/2022

Depth (ft)	Temp.(C)	D.O. (mg/L)
1	24.9	10
5	23.7	7.8
10	21.7	6
15	17	0.6
17.5	15.2	0.4
20	13.5	0.3
22.5	11.8	0.2

7/16/2022

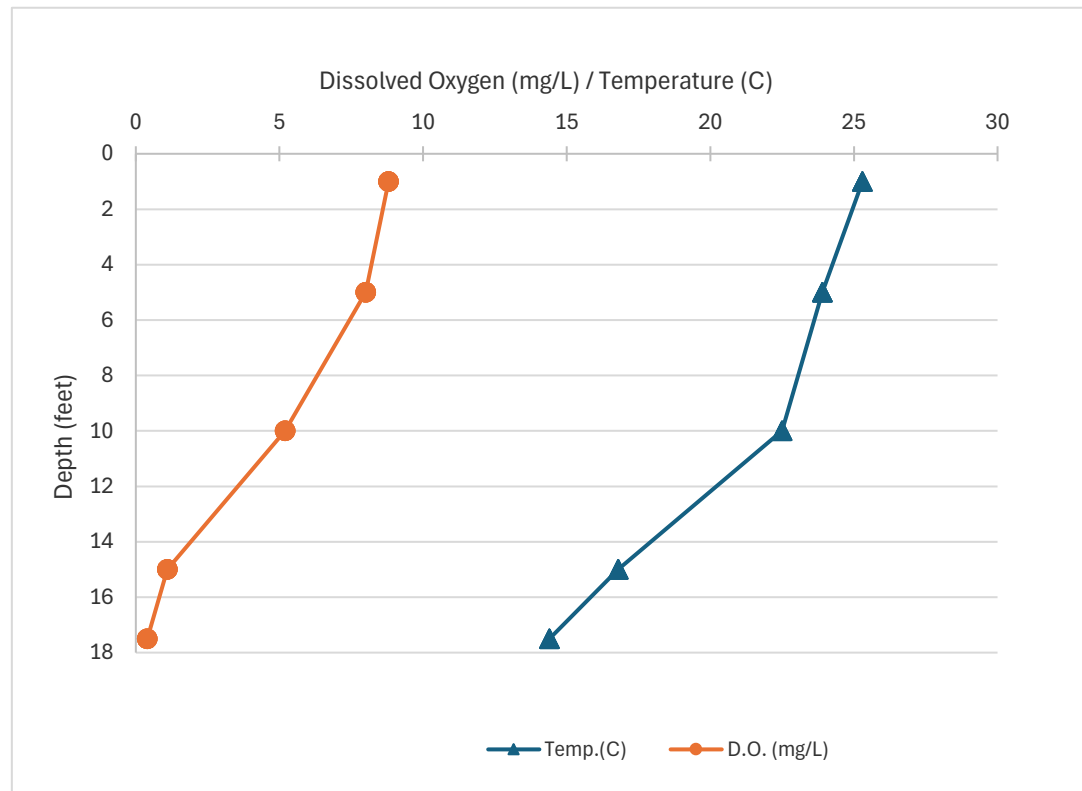
Dissolved Oxygen and Temperature Profile

Name: Painter Lake
 County: Cass
 Site ID: 140108
 Date: 7/18/2022

Depth (ft)	Temp.(C)	D.O. (mg/L)
1	25.3	8.8
1	25.3	8.8
1	25.3	8.8
1	25.3	8.8
5	23.9	8
5	23.9	8
5	23.9	8
5	23.9	8
10	22.5	5.2
10	22.5	5.2
10	22.5	5.2
10	22.5	5.2
15	16.8	1.1
15	16.8	1.1
15	16.8	1.1
15	16.8	1.1
17.5	14.4	0.4
17.5	14.4	0.4
17.5	14.4	0.4
17.5	14.4	0.4

7/18/2022

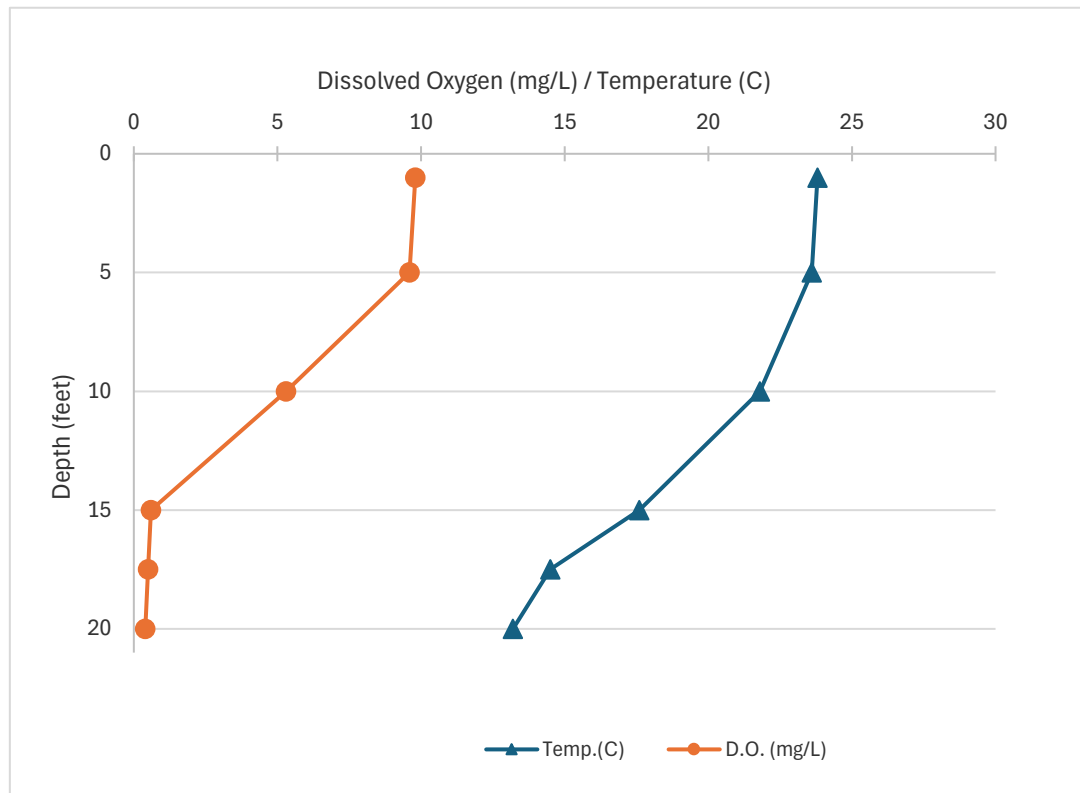
Dissolved Oxygen and Temperature Profile

Name: Painter Lake
County: Cass
Site ID: 140108
Date: 7/30/2022

Depth (ft)	Temp.(C)	D.O. (mg/L)
1	23.8	9.8
5	23.6	9.6
10	21.8	5.3
15	17.6	0.6
17.5	14.5	0.5
20	13.2	0.4

7/30/2022

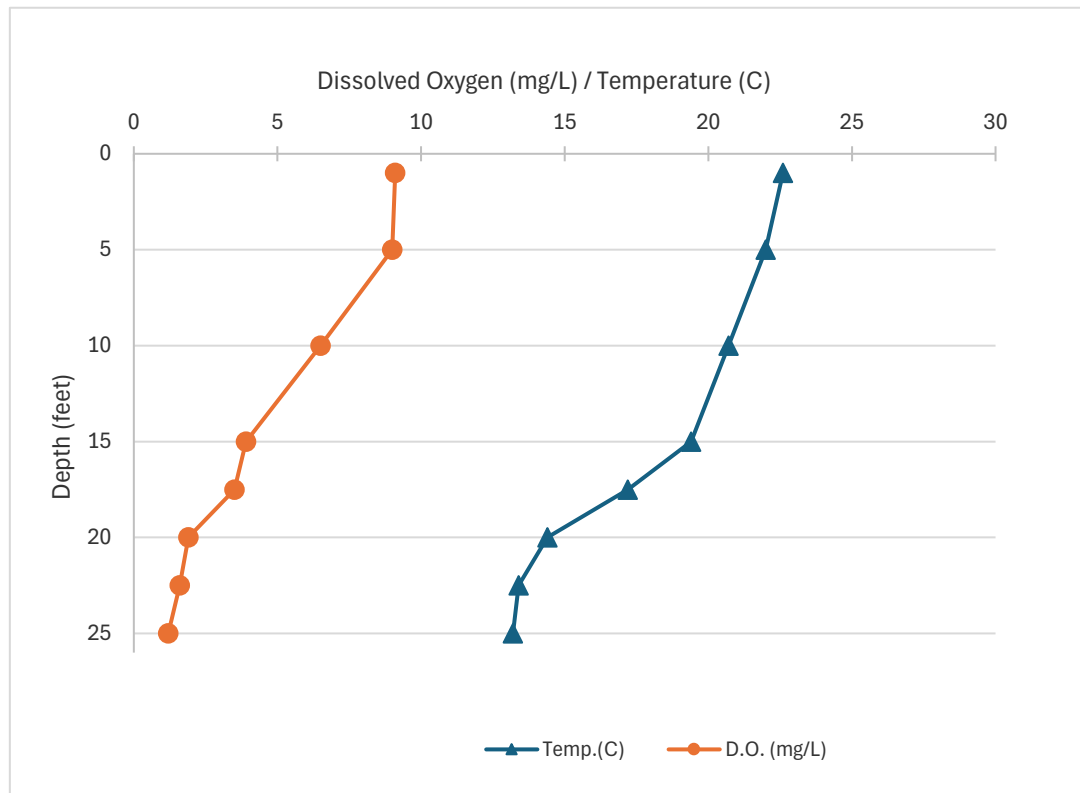
Dissolved Oxygen and Temperature Profile

Name: Painter Lake
County: Cass
Site ID: 140108
Date: 8/16/2022

Depth (ft)	Temp.(C)	D.O. (mg/L)
1	22.6	9.1
5	22	9
10	20.7	6.5
15	19.4	3.9
17.5	17.2	3.5
20	14.4	1.9
22.5	13.4	1.6
25	13.2	1.2

8/16/2022

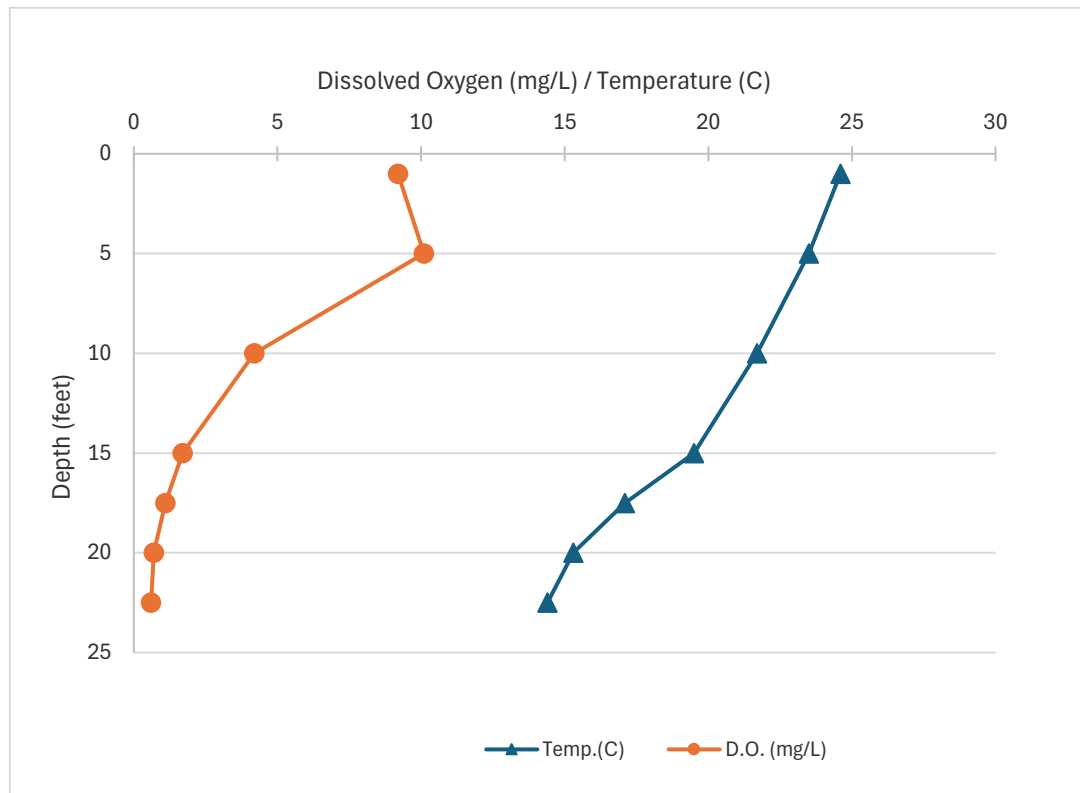
Dissolved Oxygen and Temperature Profile

Name: Painter Lake
County: Cass
Site ID: 140108
Date: 9/3/2022

Depth (ft)	Temp.(C)	D.O. (mg/L)
1	24.6	9.2
5	23.5	10.1
10	21.7	4.2
15	19.5	1.7
17.5	17.1	1.1
20	15.3	0.7
22.5	14.4	0.6

9/3/2022

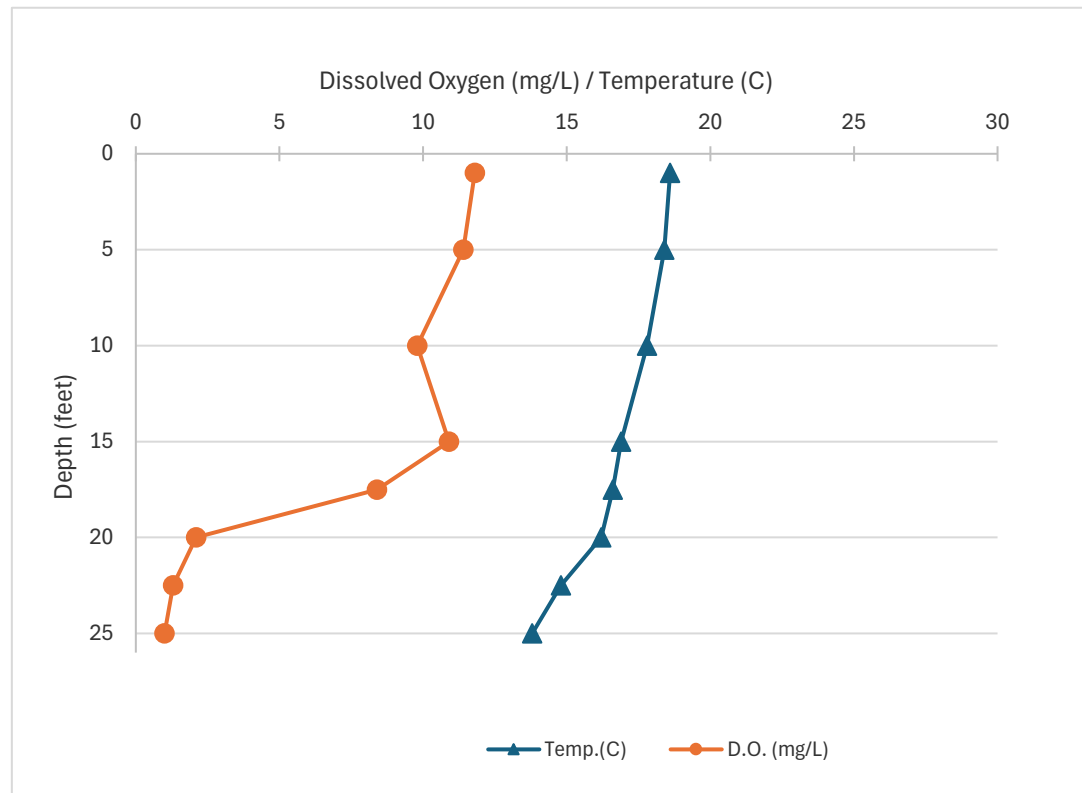
Dissolved Oxygen and Temperature Profile

Name: Painter Lake
County: Cass
Site ID: 140108
Date: 9/24/2022

Depth (ft)	Temp.(C)	D.O. (mg/L)
1	18.6	11.8
5	18.4	11.4
10	17.8	9.8
15	16.9	10.9
17.5	16.6	8.4
20	16.2	2.1
22.5	14.8	1.3
25	13.8	1

9/24/2022
