# 2023 Data Report for

### Rose Lake, Shiawassee County

## Rose Lake, Shiawassee County 2023 CLMP Results

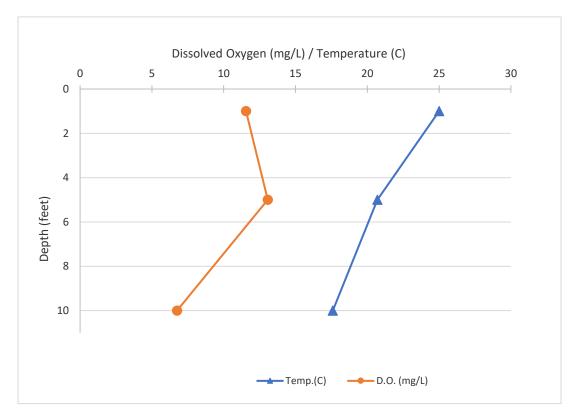
Name: Rose Lake County: Shiawassee Site ID: 780276 Date: 9/5/2023

Depth (ft)	Temp.(C)	D.O. (mg/L)
1	25	11.56
5	20.7	13.07
10	17.6	6.75

### **Dissolved Oxygen and Temperature Profile**
