2023 Data Report for

Tamarack Lake, Livingston County

Site ID: 470610

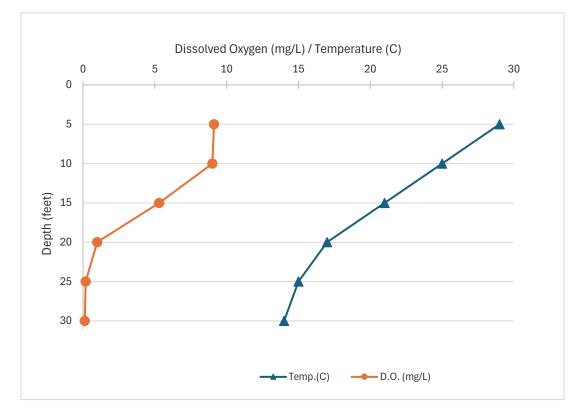
8/14/2013

Name:Tamarack LakeCounty:LivingstonSite ID:470610Date:8/14/2013

Dissolved Oxygen and Temperature Profile

Depth (ft)	Temp.(C)		D.O. (mg/L)
5		29	9.12
10		25	9.01
15		21	5.3
20		17	0.99
25		15	0.18
30		14	0.12
