2023 Data Report for Turtle Lake, Benzie County

Site ID: 100140

Turtle Lake, Benzie County 2023 CLMP Results

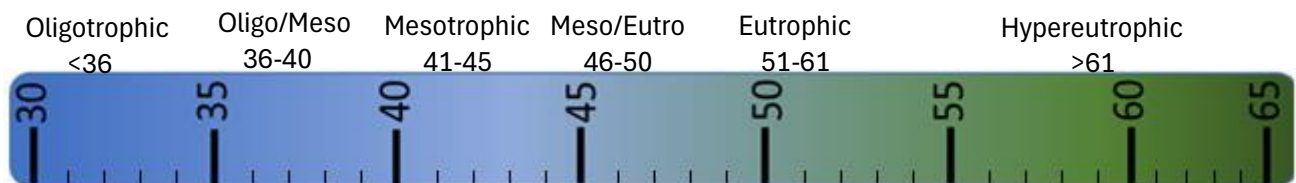
TSI for Turtle Lake in 2023	
Average	41
Secchi Disk	39
Summer TP	44
Chlorophyll-a

In 1977, limnologist Dr. Robert Carlson developed a numerical scale (0-100) where the numbers indicate the level of nutrient enrichment. Using the proper equations, we can convert results from Summer Total Phosphorus, Secchi Depth, and Chlorophyll-a to this Trophic Status Index (TSI). The TSI numbers are furthermore grouped into general categories (oligotrophic, mesotrophic, eutrophic, and hypereutrophic), to quickly give us a way to understand the general nutrient level of any lake.

^ Average
 ^ Secchi Transparency
 ^ Total Phosphorus

With an average TSI score of 41 based on 2023 Secchi transparency and summer total phosphorus data, this lake is rated as mesotrophic.

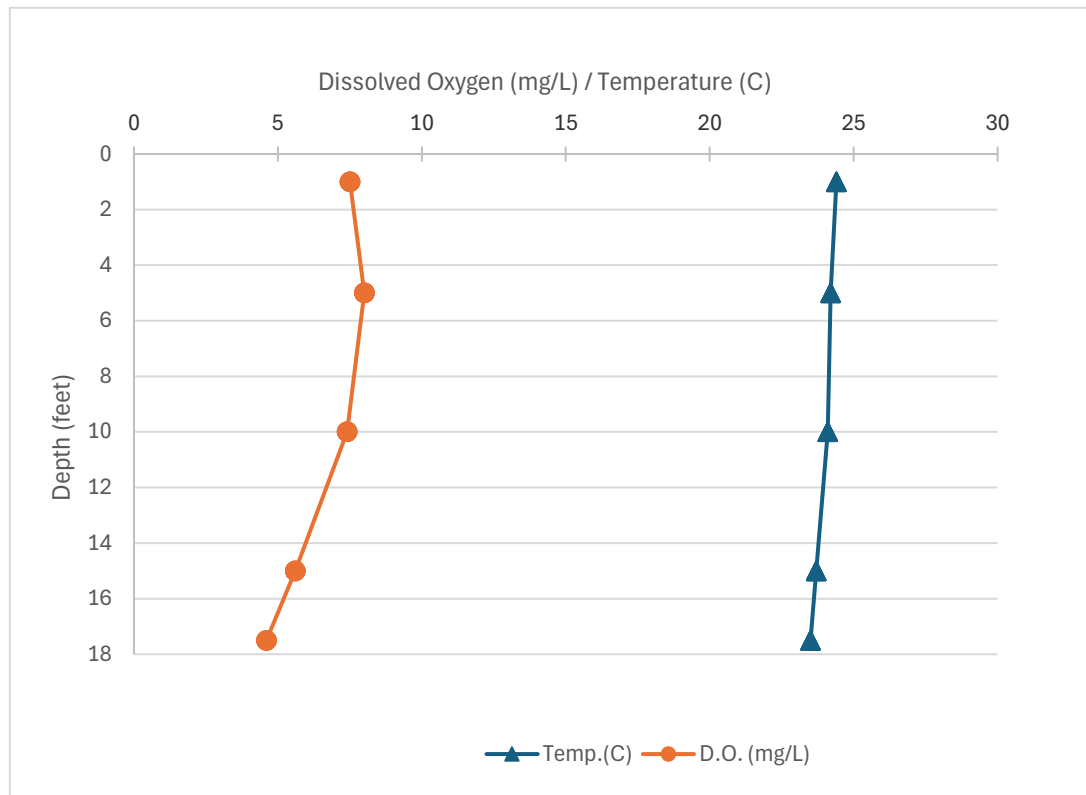
Name: Turtle Lake
 County: Benzie
 Site ID: 100140
 Date: 8/1/2019

Depth (ft)	Temp.(C)	D.O. (mg/L)
1	24.4	7.5
1	24.4	7.5
1	24.4	7.5
1	24.4	7.5
5	24.2	8
5	24.2	8
5	24.2	8
5	24.2	8
10	24.1	7.4
10	24.1	7.4
10	24.1	7.4
10	24.1	7.4
15	23.7	5.6
15	23.7	5.6
15	23.7	5.6
15	23.7	5.6
17.5	23.5	4.6
17.5	23.5	4.6
17.5	23.5	4.6
17.5	23.5	4.6

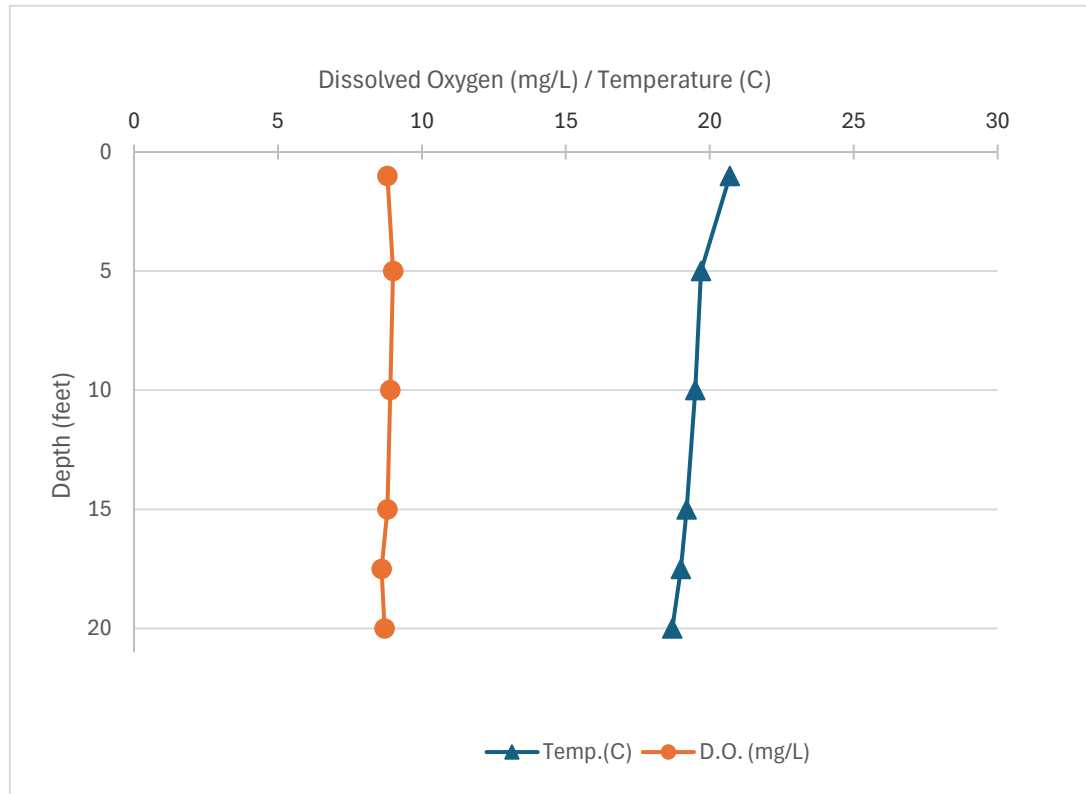
Name: Turtle Lake
County: Benzie
Site ID: 100140
Date: 9/5/2019

Depth (ft)	Temp.(C)	D.O. (mg/L)
1	20.7	8.8
5	19.7	9
10	19.5	8.9
15	19.2	8.8
17.5	19	8.6
20	18.7	8.7
