2023 Data Report for

Ann Lake, Benzie County

Site ID: 100082

Ann Lake, Benzie County 2023 CLMP Results

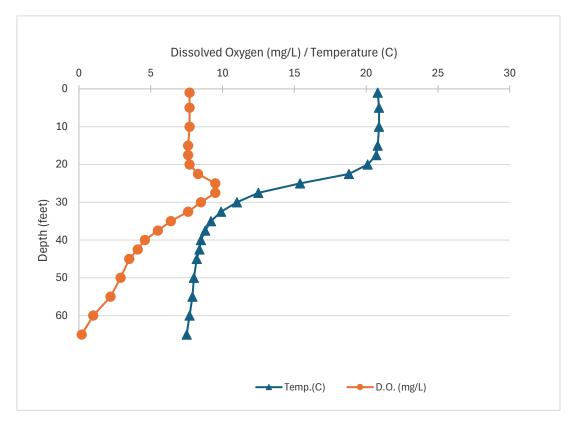
Name: Ann Lake County: Benzie Site ID: 100082 Date: 9/9/2023

Depth (ft)	Temp.(C)	D.O. (mg/L)
1	20.8	7.7
5	20.9	7.7
10	20.9	7.7
15	20.8	7.6
17.5	20.7	7.6
20	20.1	7.7
22.5	18.8	8.3
25	15.4	9.5
27.5	12.5	9.5
30	11	8.5
32.5	9.9	7.6
35	9.2	6.4
37.5	8.8	5.5
40	8.5	4.6
42.5	8.4	4.1
45	8.2	3.5
50	8	2.9
55	7.9	2.2
60	7.7	1
65	7.5	0.2

Dissolved Oxygen and Temperature Profile
