# 2023 Data Report for Crystal Lake, Hillsdale County

Site ID: 300269

# Crystal Lake, Hillsdale County 2023 CLMP Results

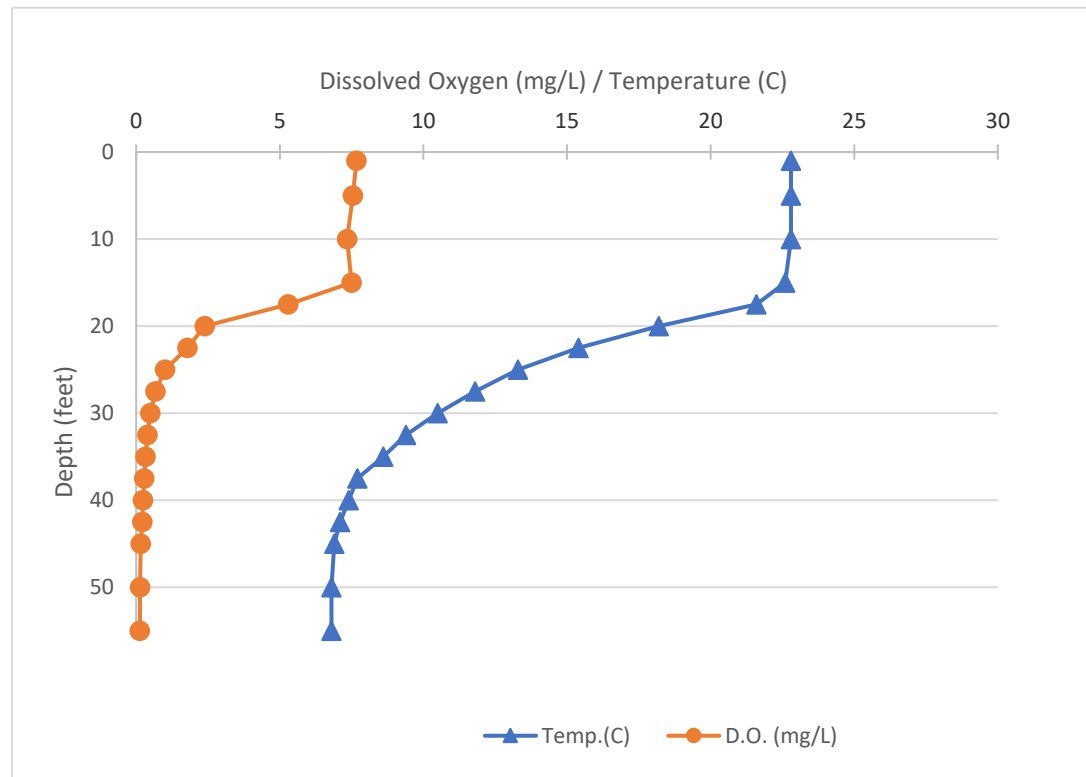
9/10/2023

### Dissolved Oxygen and Temperature Profile

Depth (ft)	Temp.(C)	D.O. (mg/L)
1	22.8	7.67
5	22.8	7.54
10	22.8	7.35
15	22.6	7.5
17.5	21.6	5.3
20	18.2	2.39
22.5	15.4	1.79
25	13.3	1.01
27.5	11.8	0.67
30	10.5	0.49
32.5	9.4	0.39
35	8.6	0.33
37.5	7.7	0.28
40	7.4	0.24
42.5	7.1	0.21
45	6.9	0.16
50	6.8	0.14
55	6.8	0.13
