# 2023 Data Report for Eagle Lake, Cass County

Site ID: 140057

# Eagle Lake, Cass County 2023 CLMP Results

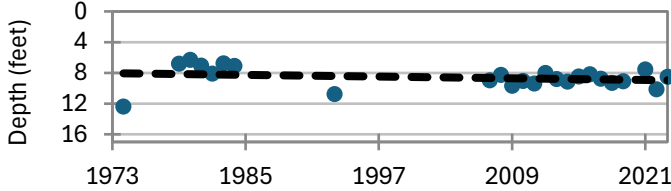
## Secchi Disk Transparency (feet)

Year	# Readings	Min	Max	Average	Std. Dev	Carlson TSI
2023	10	5.5	12.0	8.5	2.4	46
2018-2022	75	4.0	32.0	9.0	4.5	45
1974-2017	308	3.0	28.0	8.5	3.8	46
2023 All CLMP Lakes	2825	0.5	51.0	12.2	2.7	43

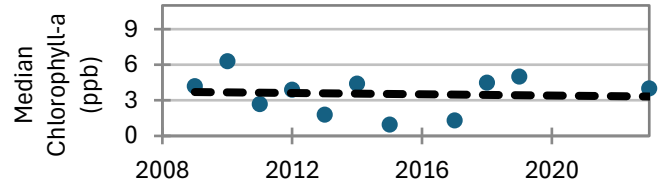
## Chlorophyll-a (parts per billion)

Year	# Samples	Min	Max	Median	Std. Dev	Carlson TSI
2023	5	1.3	7.2	4.0	2.5	44
2018-2022	16	<1.0	9.9	4.8	2.0	46
2009-2017	42	<1.0	9.9	4.8	2.3	42
2023 All CLMP Lakes	687	< 1.0	43.0	3.7	5.3	43

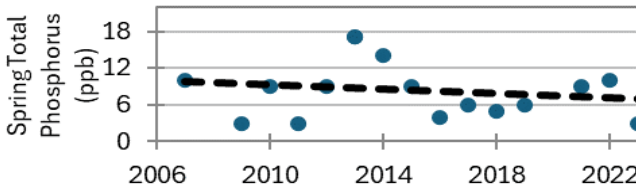
## Spring Phosphorus (parts per billion)

Year	# Samples	Min	Max	Average	Std. Dev	Carlson TSI
2023	1	<=3 W	<=3 W	<=3 W	NA	NA
2018-2022	4	5.0	10.0	7.5	2.4	39
2007-2017	11	<=3 W	17.0	9.2	5.1	41
2023 All CLMP Lakes	220	<5	220.0	20.7	21.3	45

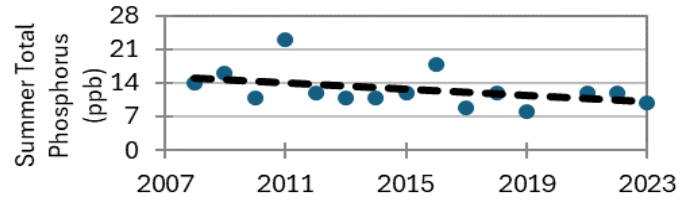
## Summer Phosphorus (parts per billion)

Year	# Samples	Min	Max	Average	Std. Dev	Carlson TSI
2023	1	10.0	10.0	10.0	NA	37
2018-2022	4	8.0	12.0	11.0	2.0	39
2008-2017	10	9.0	23.0	13.7	4.2	41
2023 All CLMP Lakes	234	<= 3	150.0	17.4	15.3	45

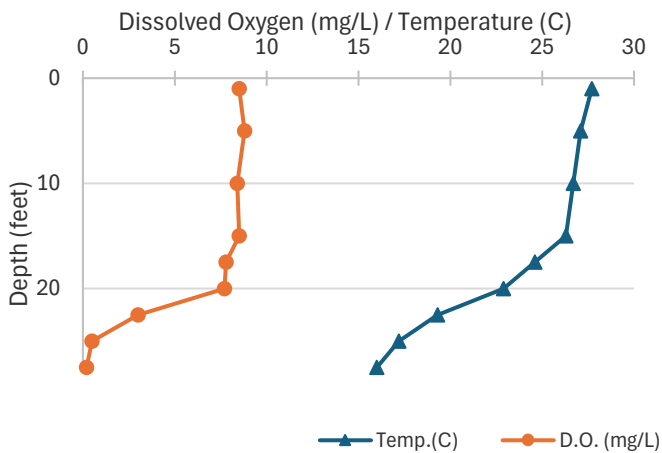
8/1/2023

## Dissolved Oxygen and Temperature Profile

The lake keeps some dissolved oxygen in the bottom waters through early-summer, but by mid-summer the lake has stratified and the bottom water is devoid of oxygen.

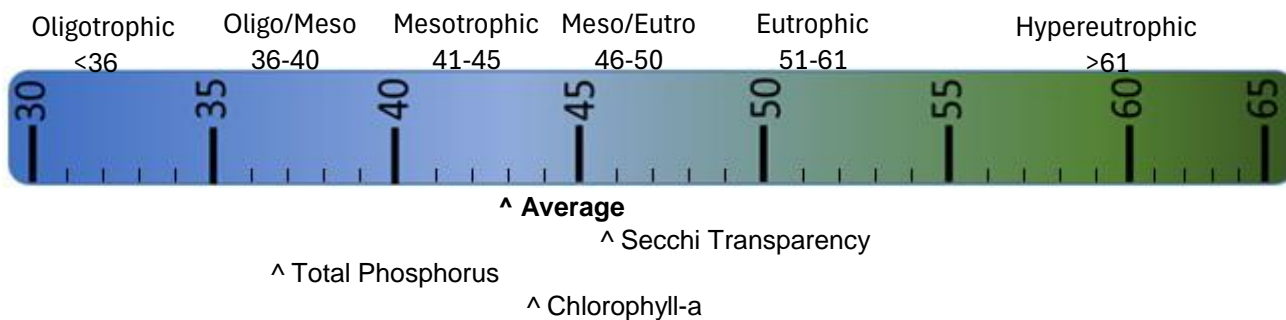
With an average TSI score of 43 based on 2023 Secchi transparency, chlorophyll-a, and summer total phosphorus data, this lake is rated as mesotrophic.

TSI for Eagle Lake in 2023	
Average	43
Secchi Disk	46
Summer TP	37
Chlorophyll-a	44

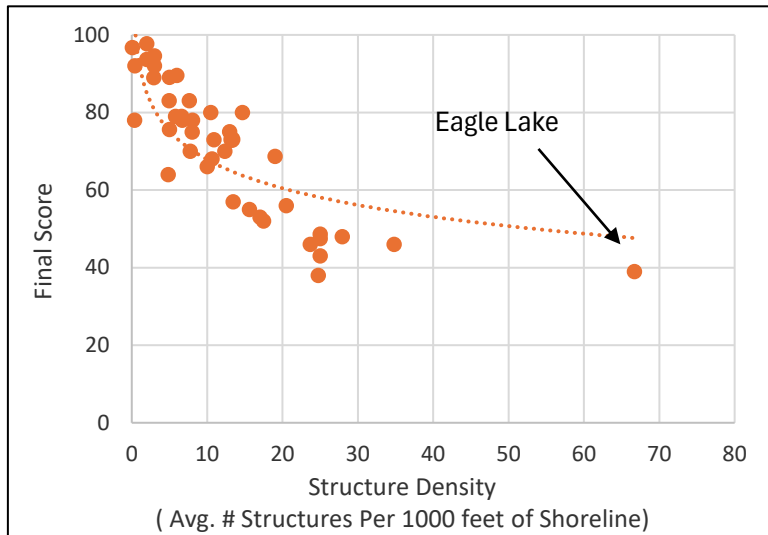
### How does your lake compare to others in the program?

<b>Eagle Lake:</b>	
Number of Sections:	7
Number of Structures:	467
Structure Density:	66.7
Final Score:	39

<b>All 42 Participating Lakes from 2015-2018:</b>	
Avg. Number of Sections:	16.3
Avg. Number of Structures:	248.5
Avg. Structure Density:	15.2
Avg. Final Score:	70.5

There is a very tight relationship between Final Score and Structure Density. It will be interesting to see if and how this changes as more lakes go through this scoring process.

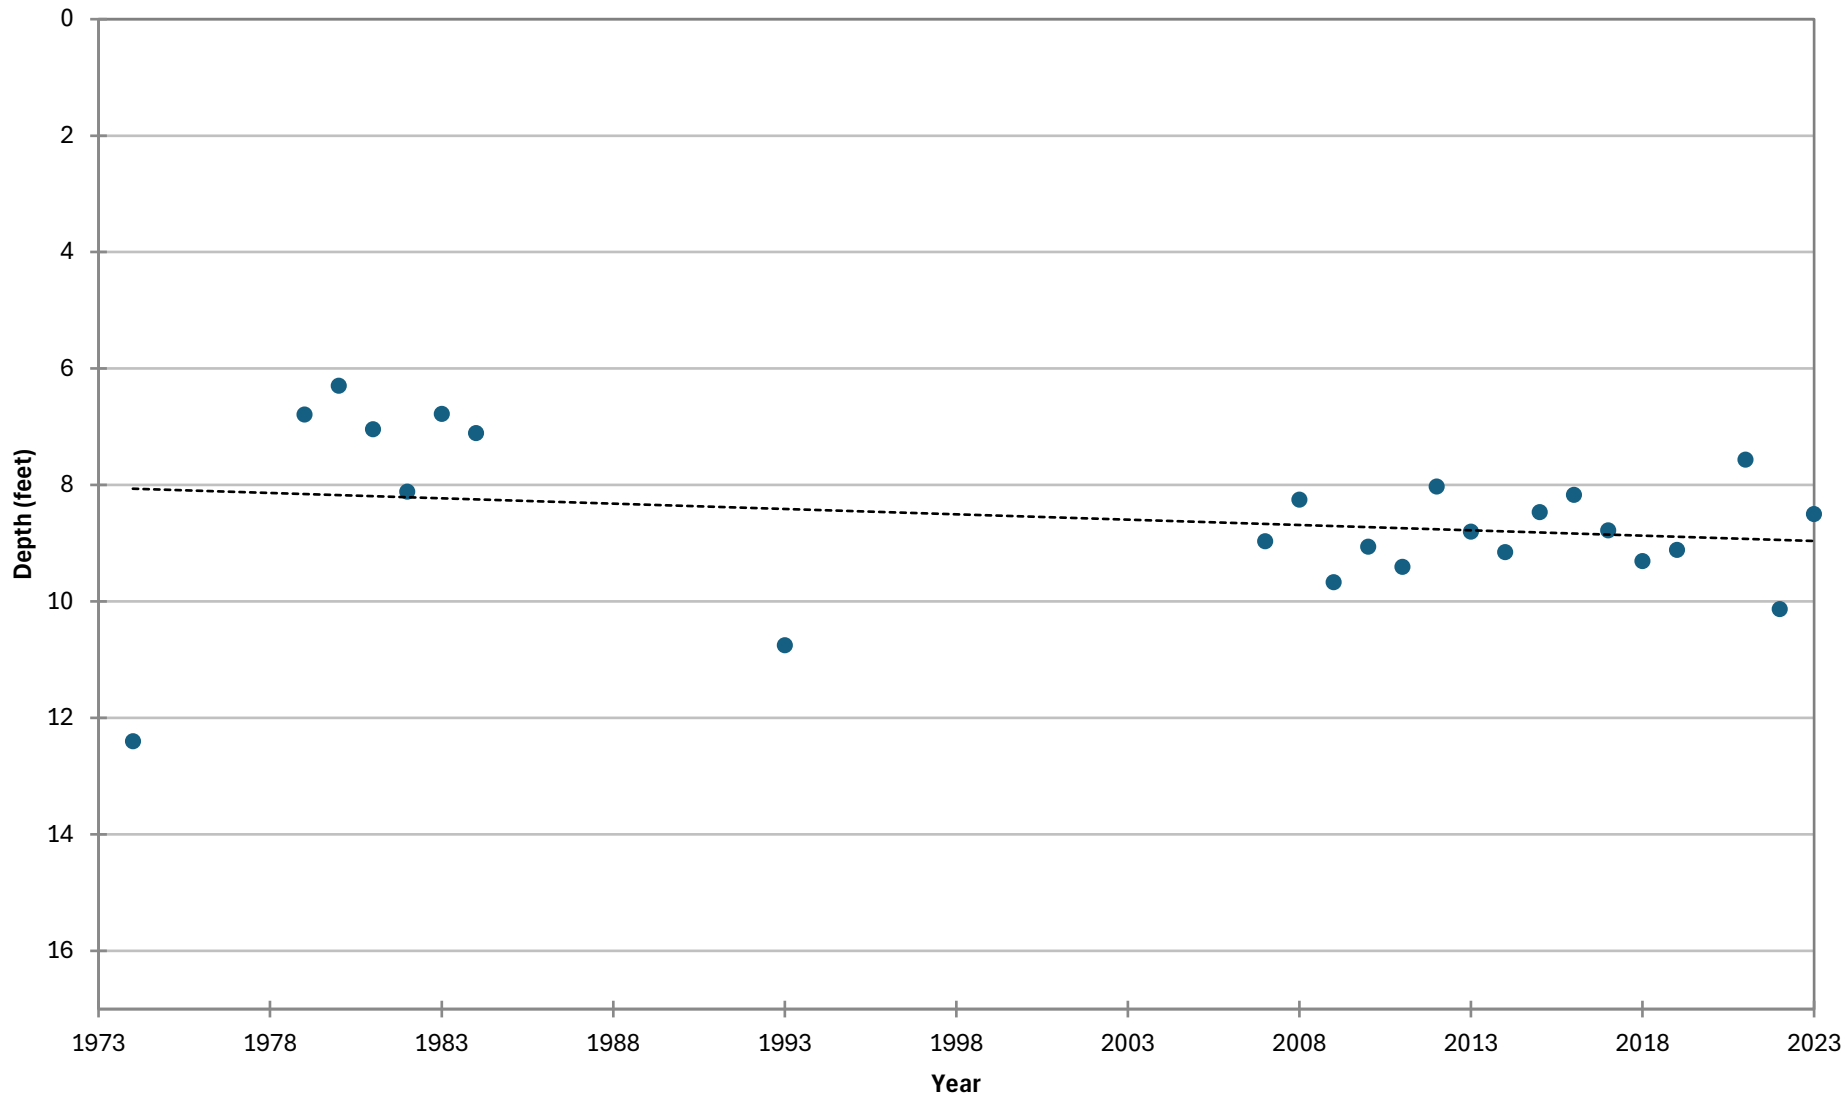
**Eagle Lake (Cass Co.), 140057**

COOPERATIVE LAKES MONITORING PROGRAM  
SUMMER MEAN TRANSPARENCY

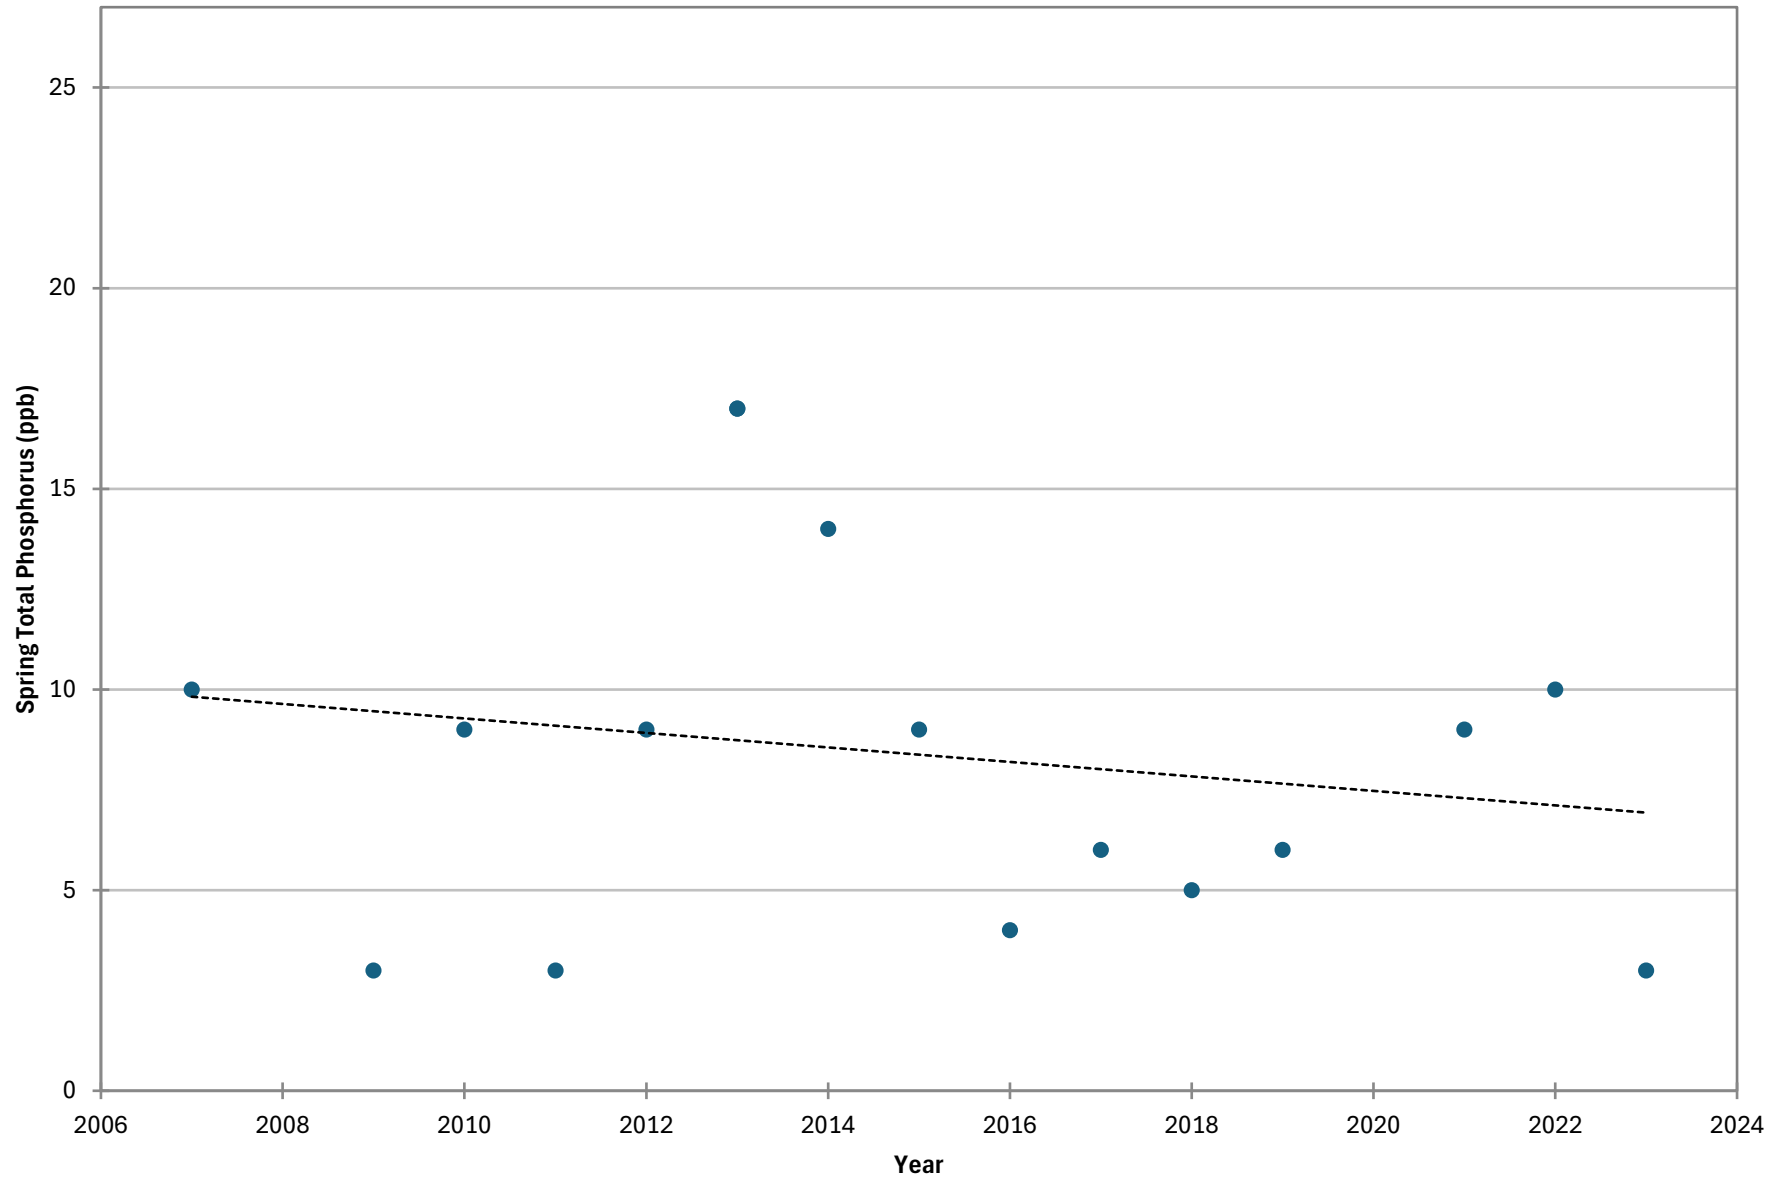
**Eagle Lake (Cass Co.), 140057**

COOPERATIVE LAKES MONITORING PROGRAM  
SPRING TOTAL PHOSPHORUS

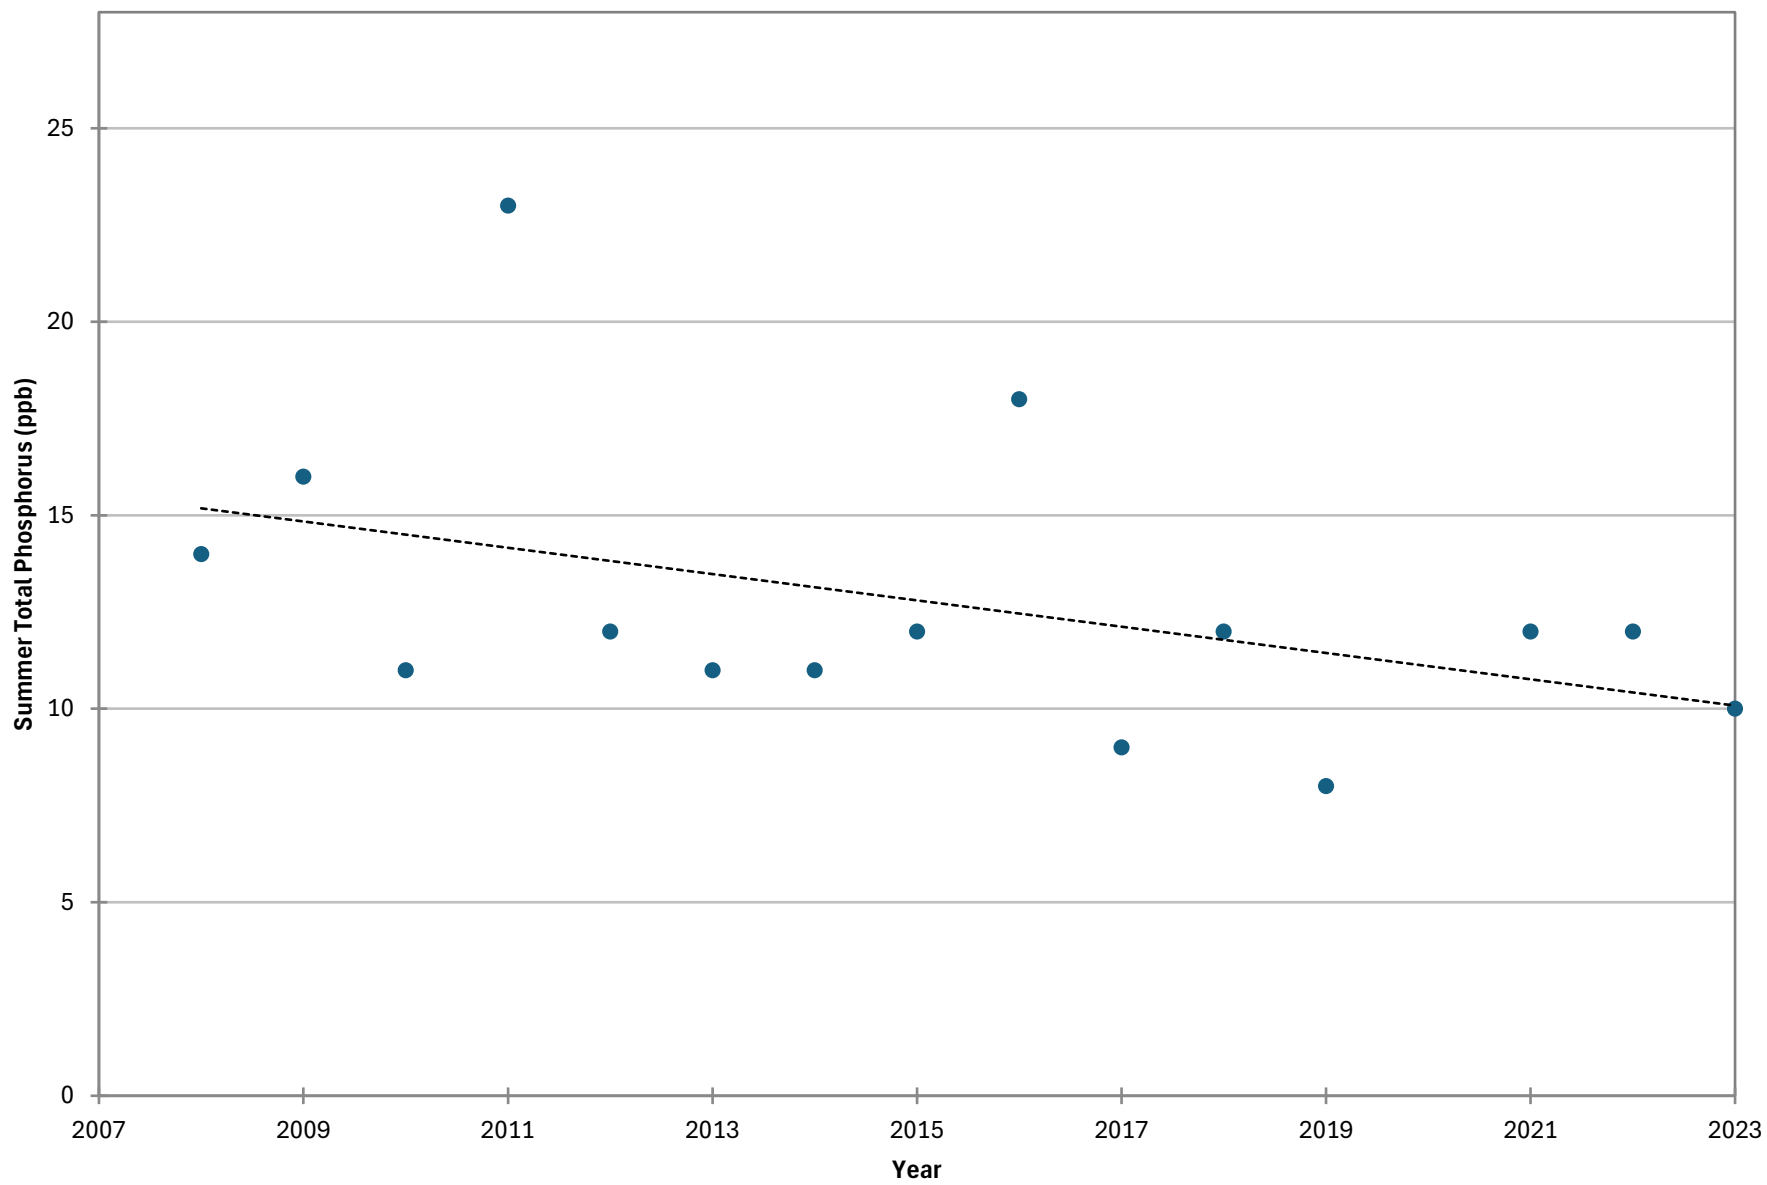
**Eagle Lake (Cass Co.), 140057**

COOPERATIVE LAKES MONITORING PROGRAM  
SUMMER TOTAL PHOSPHORUS

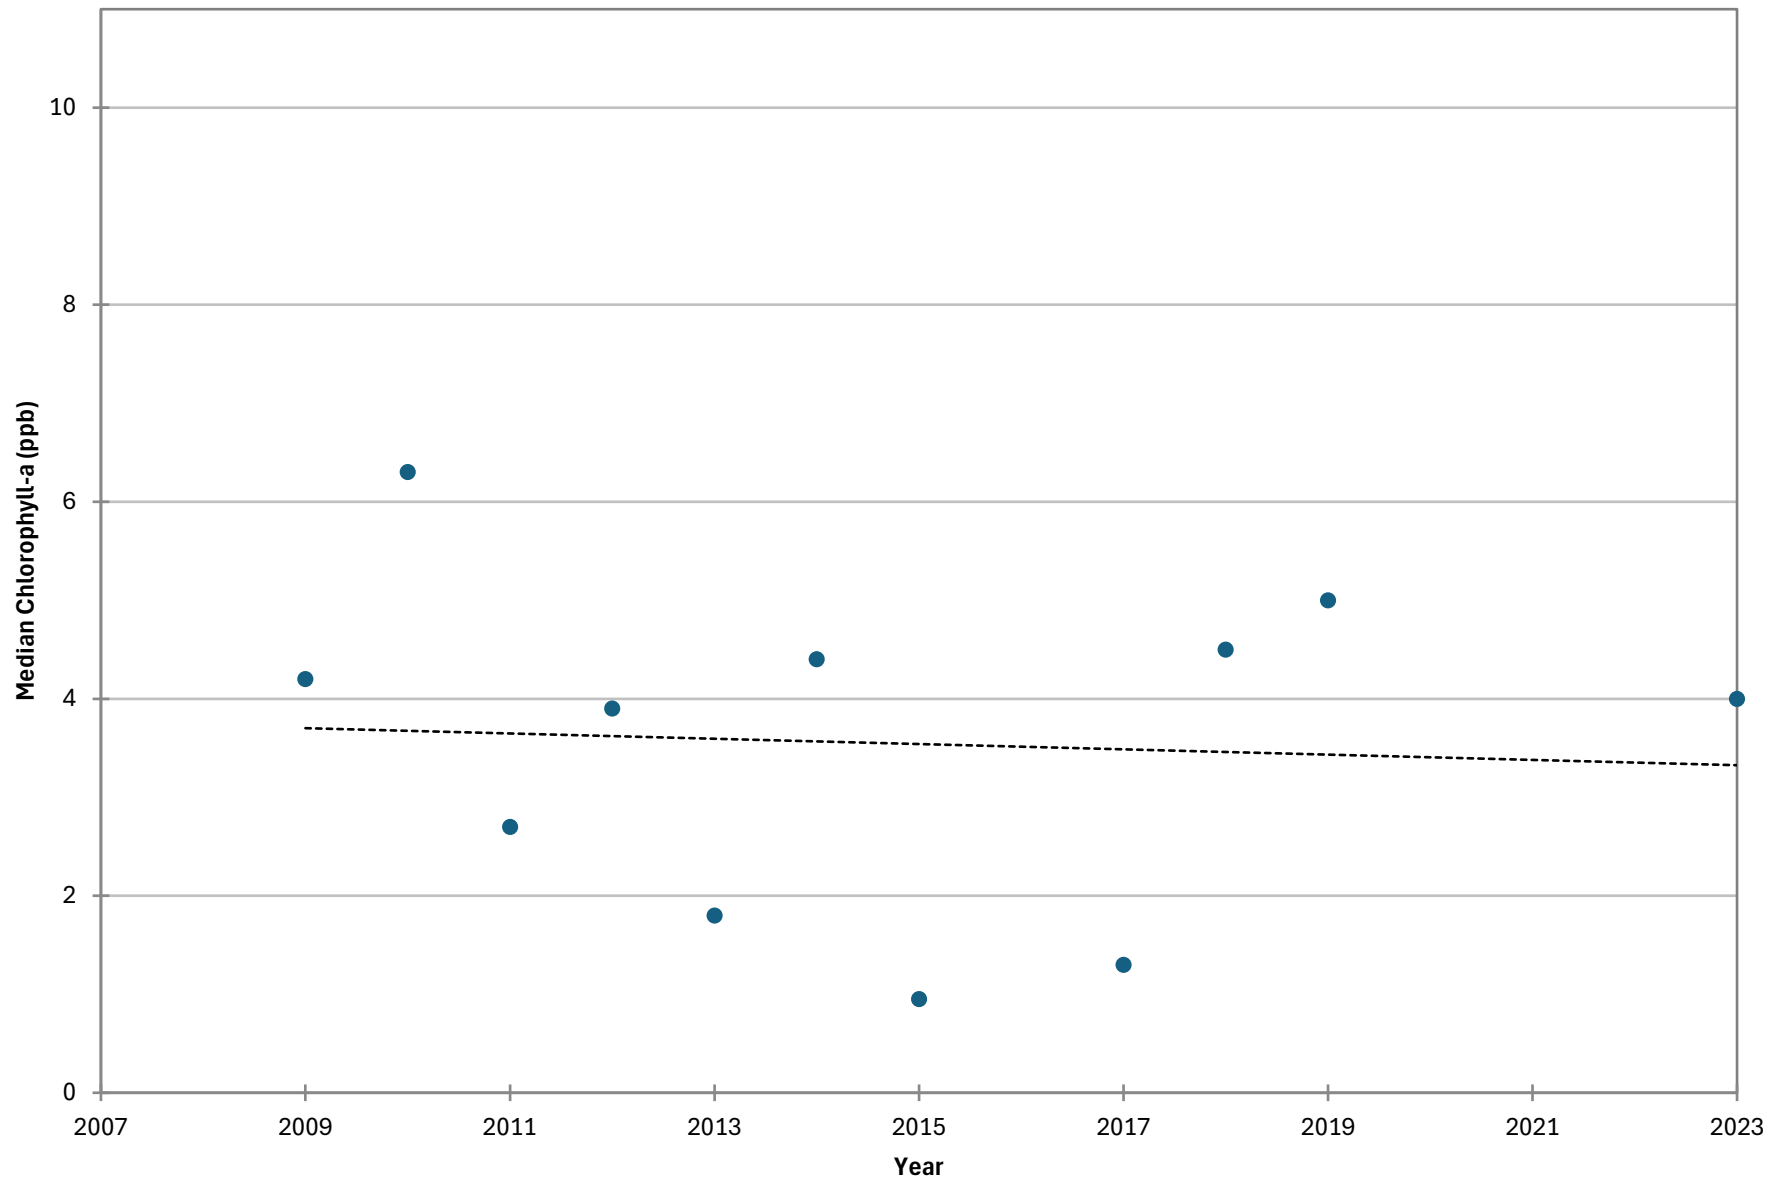
**Eagle Lake (Cass Co.), 140057**

COOPERATIVE LAKES MONITORING PROGRAM  
SUMMER MEDIAN CHLOROPHYLL-A

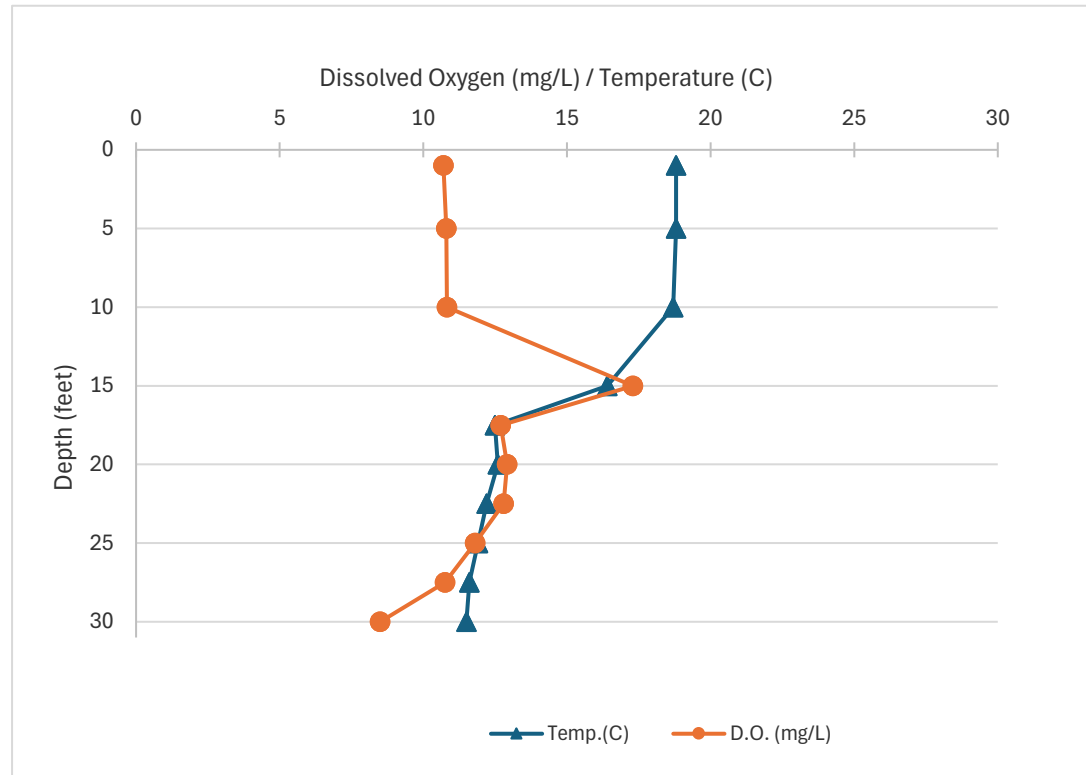
5/18/2023

### Dissolved Oxygen and Temperature Profile

Depth (ft)	Temp.(C)	D.O. (mg/L)
1	18.8	10.7
1	18.8	10.7
5	18.8	10.8
5	18.8	10.8
10	18.7	10.82
10	18.7	10.82
15	16.4	17.3
15	16.4	17.3
17.5	12.5	12.7
17.5	12.5	12.7
20	12.6	12.92
20	12.6	12.92
22.5	12.2	12.8
22.5	12.2	12.8
25	11.9	11.8
25	11.9	11.8
27.5	11.6	10.76
27.5	11.6	10.76
30	11.5	8.5
30	11.5	8.5

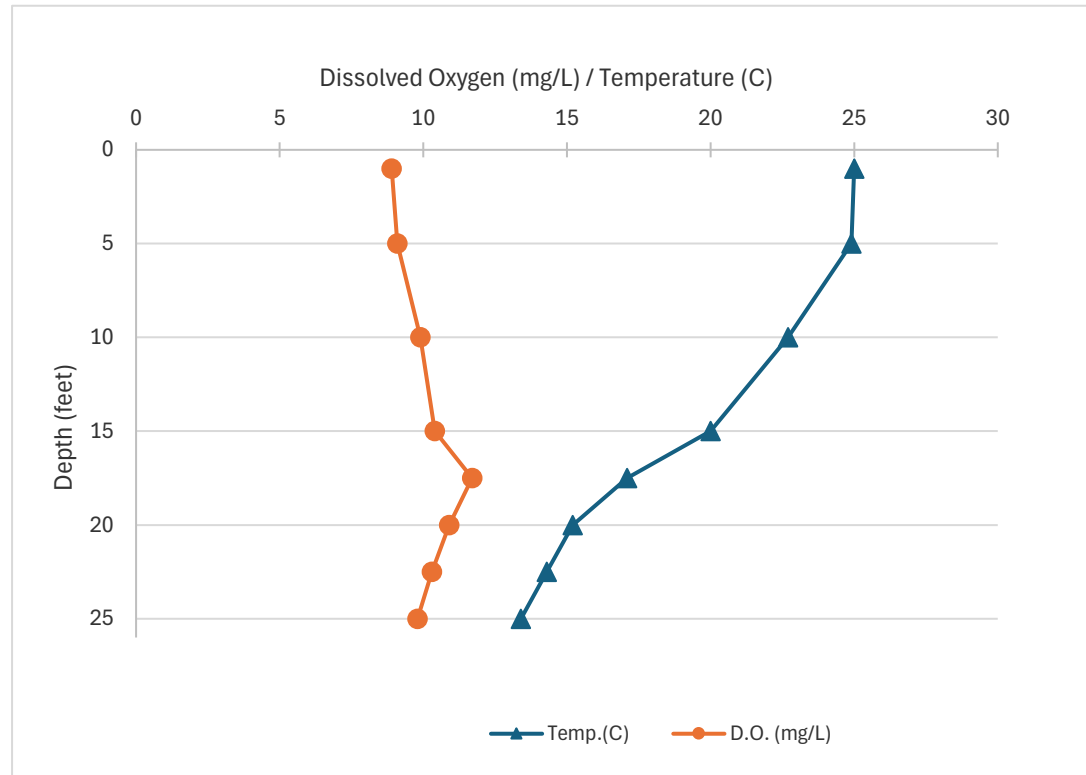
5/31/2023

### Dissolved Oxygen and Temperature Profile

Depth (ft)	Temp.(C)	D.O. (mg/L)
1	25	8.9
5	24.9	9.1
10	22.7	9.9
15	20	10.4
17.5	17.1	11.7
20	15.2	10.9
22.5	14.3	10.3
25	13.4	9.8

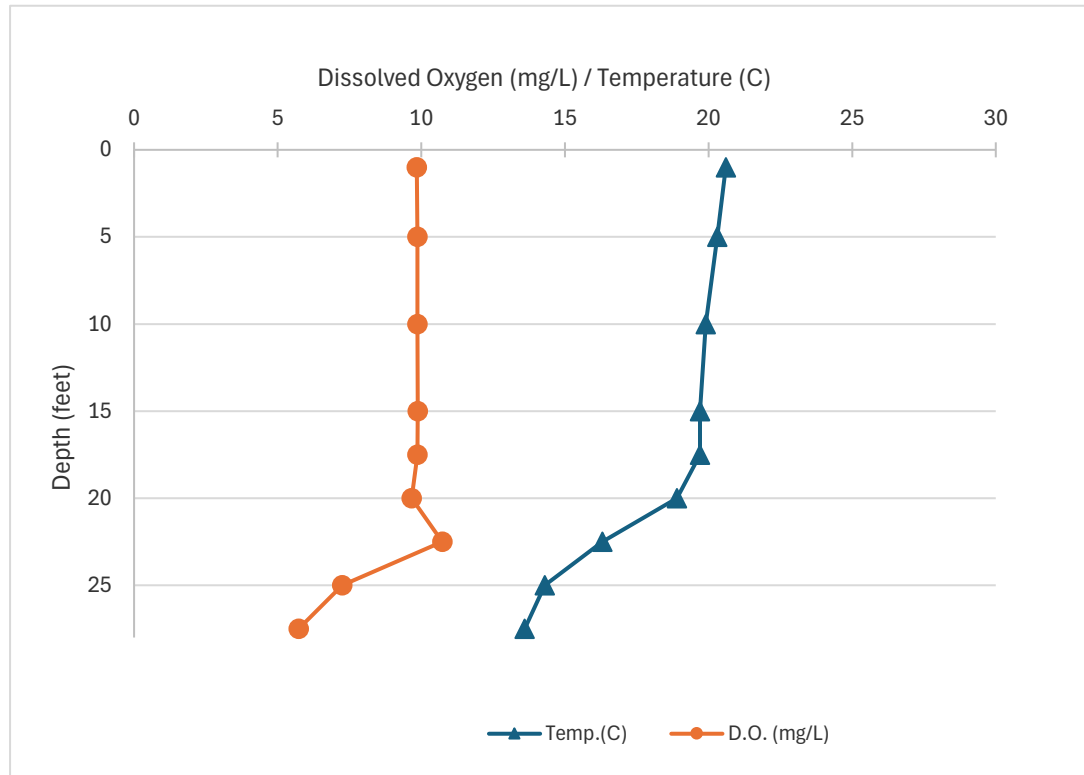
6/14/2023

### Dissolved Oxygen and Temperature Profile

Depth (ft)	Temp.(C)	D.O. (mg/L)
1	20.6	9.84
5	20.3	9.86
10	19.9	9.87
15	19.7	9.88
17.5	19.7	9.87
20	18.9	9.67
22.5	16.3	10.73
25	14.3	7.25
27.5	13.6	5.73

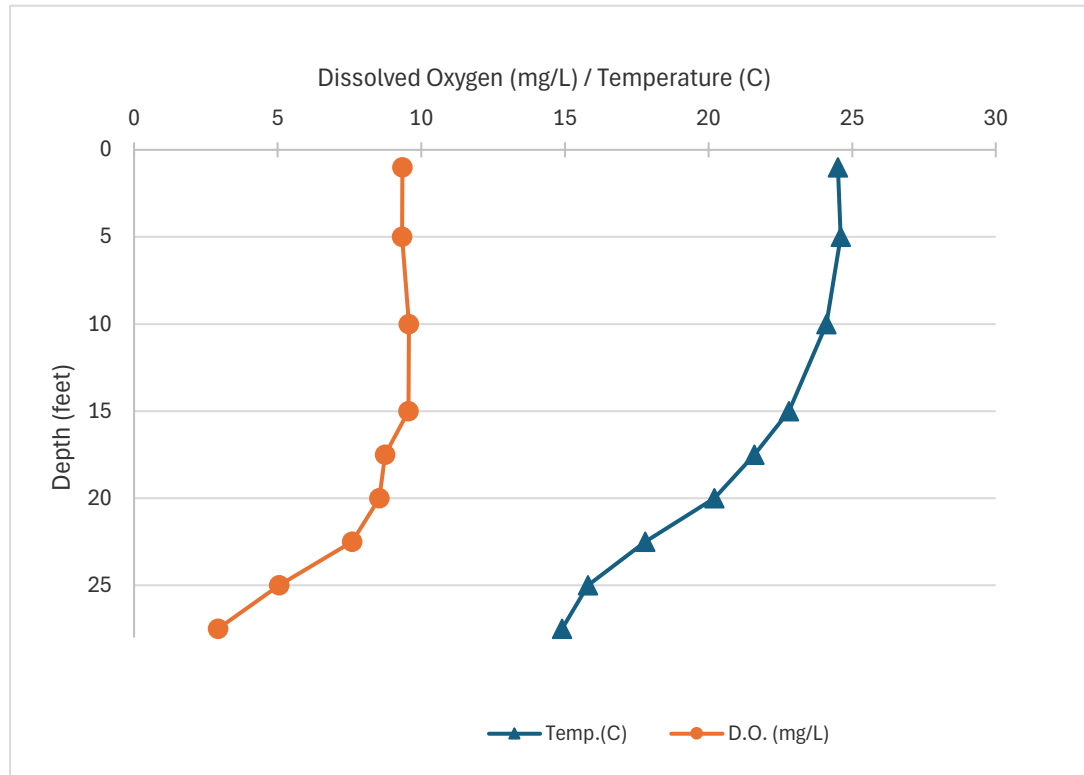
7/1/2023

### Dissolved Oxygen and Temperature Profile

Depth (ft)	Temp.(C)	D.O. (mg/L)
1	24.5	9.34
5	24.6	9.33
10	24.1	9.57
15	22.8	9.55
17.5	21.6	8.74
20	20.2	8.54
22.5	17.8	7.59
25	15.8	5.05
27.5	14.9	2.92

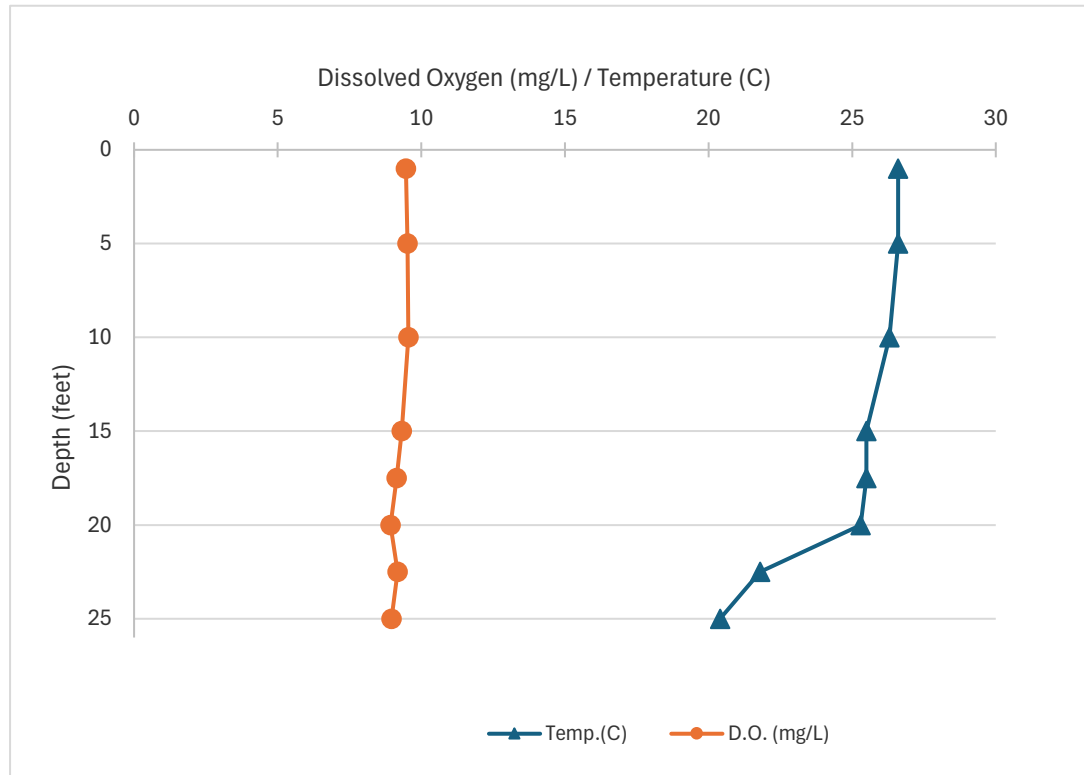
7/20/2023

### Dissolved Oxygen and Temperature Profile

Depth (ft)	Temp.(C)	D.O. (mg/L)
1	26.6	9.46
5	26.6	9.52
10	26.3	9.55
15	25.5	9.32
17.5	25.5	9.14
20	25.3	8.93
22.5	21.8	9.17
25	20.4	8.96

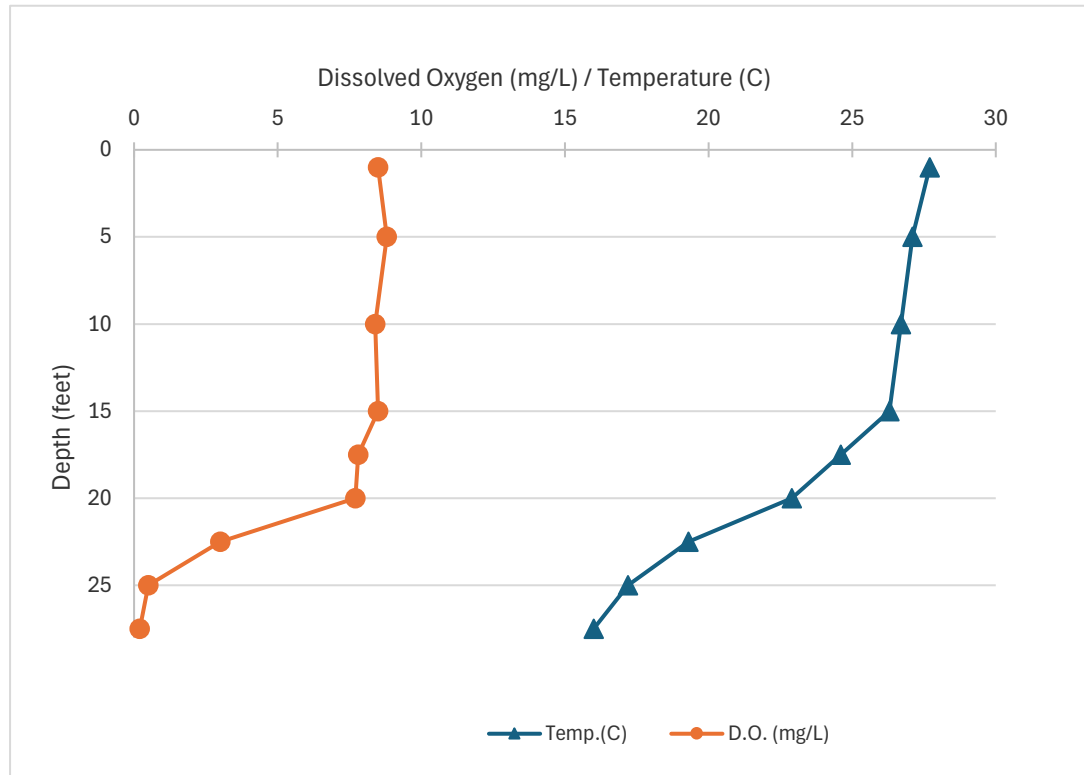
8/1/2023

### Dissolved Oxygen and Temperature Profile

Depth (ft)	Temp.(C)	D.O. (mg/L)
1	27.7	8.5
5	27.1	8.8
10	26.7	8.4
15	26.3	8.5
17.5	24.6	7.8
20	22.9	7.7
22.5	19.3	3
25	17.2	0.5
27.5	16	0.2

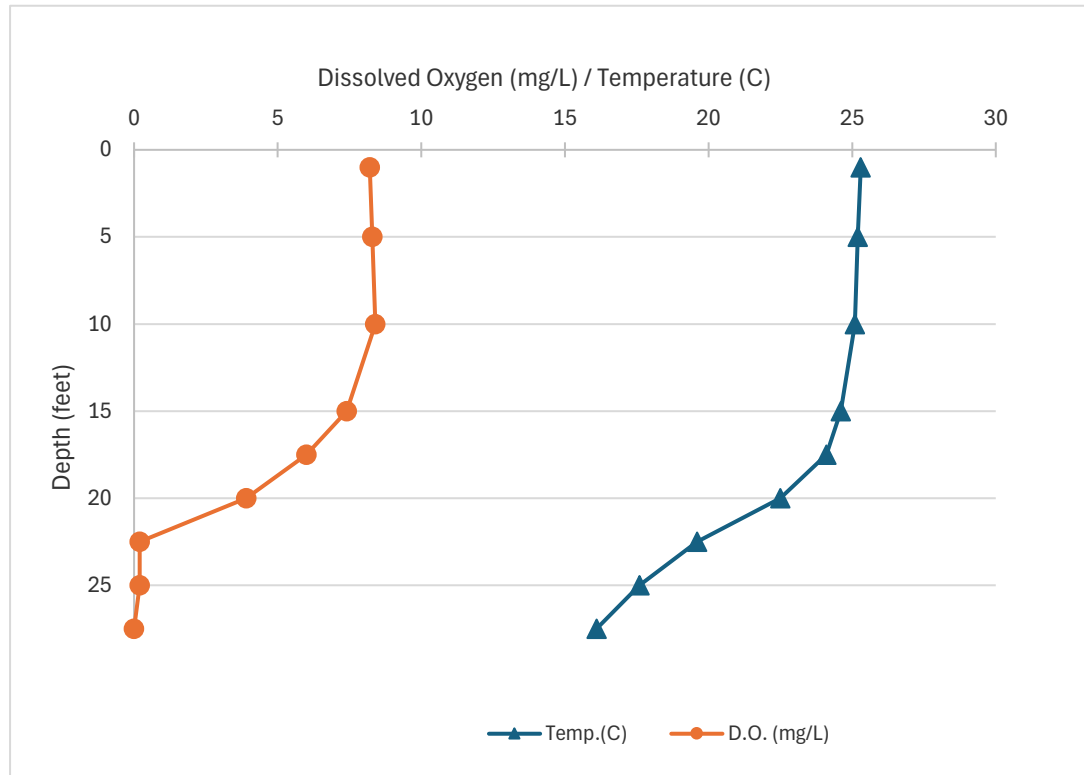
8/13/2023

### Dissolved Oxygen and Temperature Profile

Depth (ft)	Temp.(C)	D.O. (mg/L)
1	25.3	8.2
5	25.2	8.3
10	25.1	8.4
15	24.6	7.4
17.5	24.1	6
20	22.5	3.9
22.5	19.6	0.2
25	17.6	0.2
27.5	16.1	0

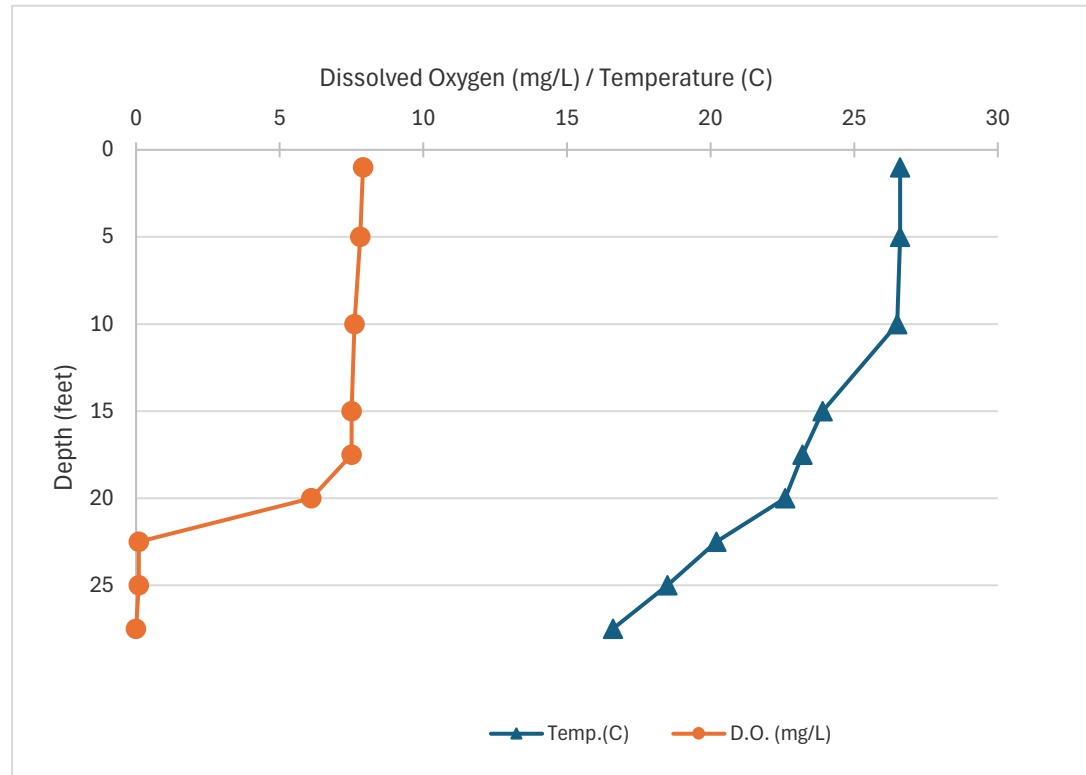
8/26/2023

### Dissolved Oxygen and Temperature Profile

Depth (ft)	Temp.(C)	D.O. (mg/L)
1	26.6	7.9
5	26.6	7.8
10	26.5	7.6
15	23.9	7.5
17.5	23.2	7.5
20	22.6	6.1
22.5	20.2	0.1
25	18.5	0.1
27.5	16.6	0

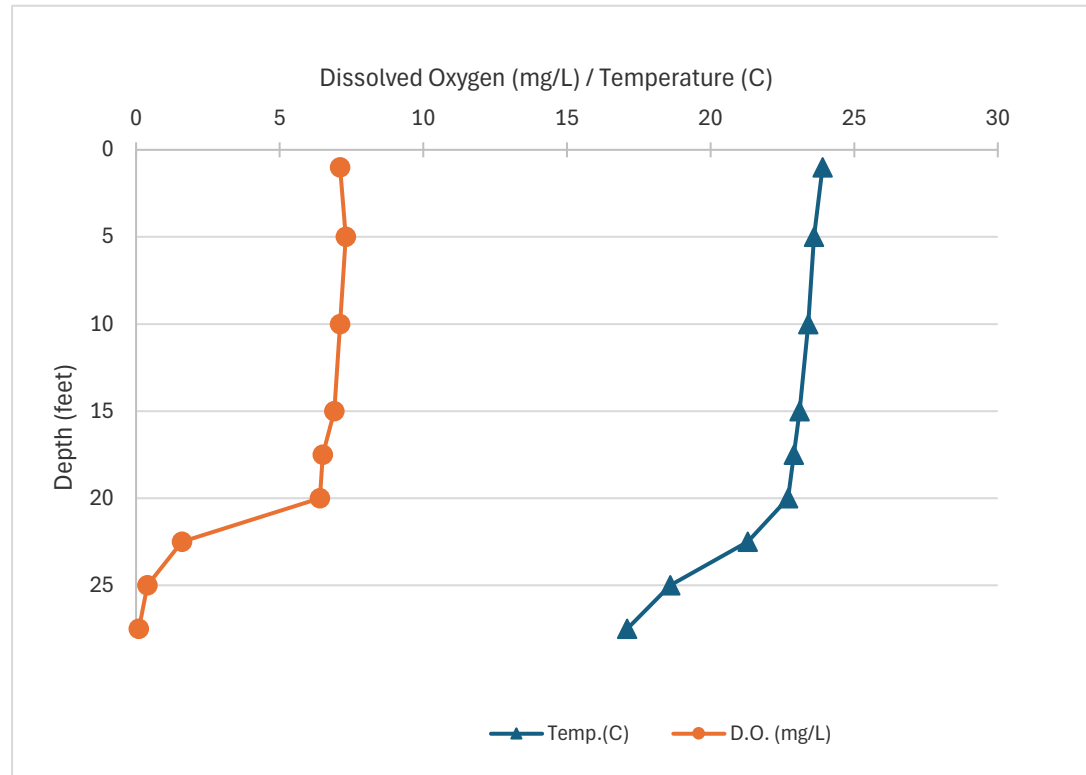
9/9/2023

### Dissolved Oxygen and Temperature Profile

Depth (ft)	Temp.(C)	D.O. (mg/L)
1	23.9	7.1
5	23.6	7.3
10	23.4	7.1
15	23.1	6.9
17.5	22.9	6.5
20	22.7	6.4
22.5	21.3	1.6
25	18.6	0.4
27.5	17.1	0.1

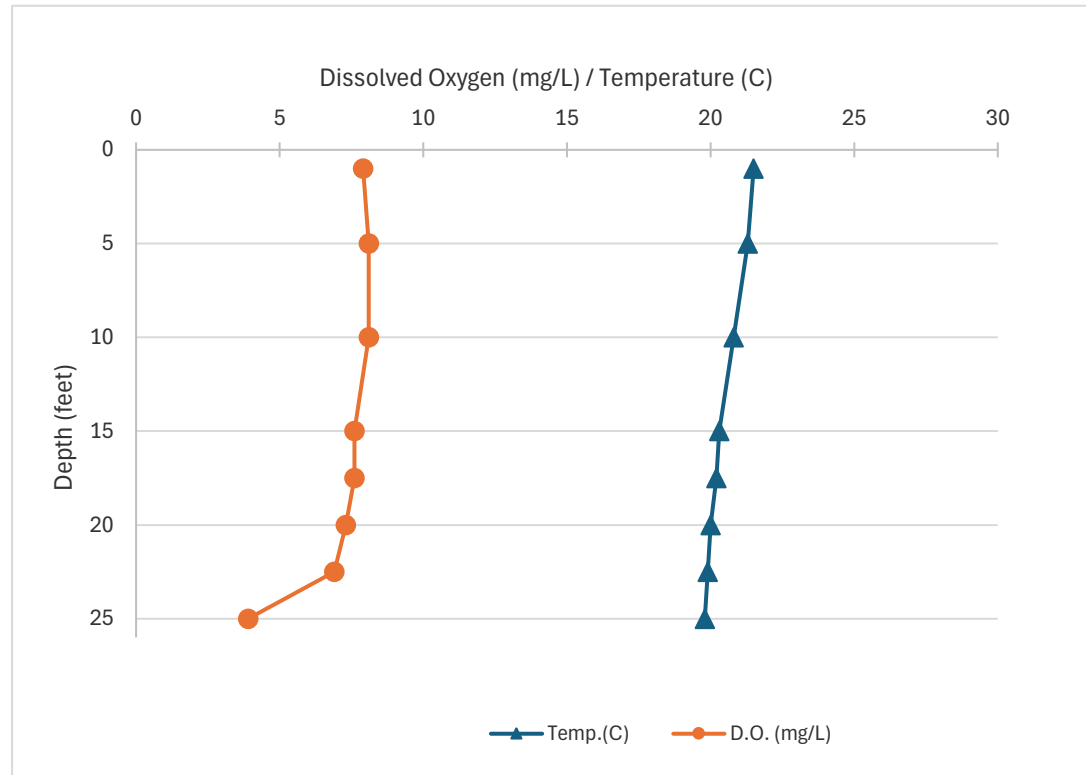
9/21/2023

### Dissolved Oxygen and Temperature Profile

Depth (ft)	Temp.(C)	D.O. (mg/L)
1	21.5	7.9
5	21.3	8.1
10	20.8	8.1
15	20.3	7.6
17.5	20.2	7.6
20	20	7.3
22.5	19.9	6.9
25	19.8	3.9
