2023 Data Report for

Fox Lake, Muskegon County

Site ID: 610321

Fox Lake, Muskegon County 2023 CLMP Results

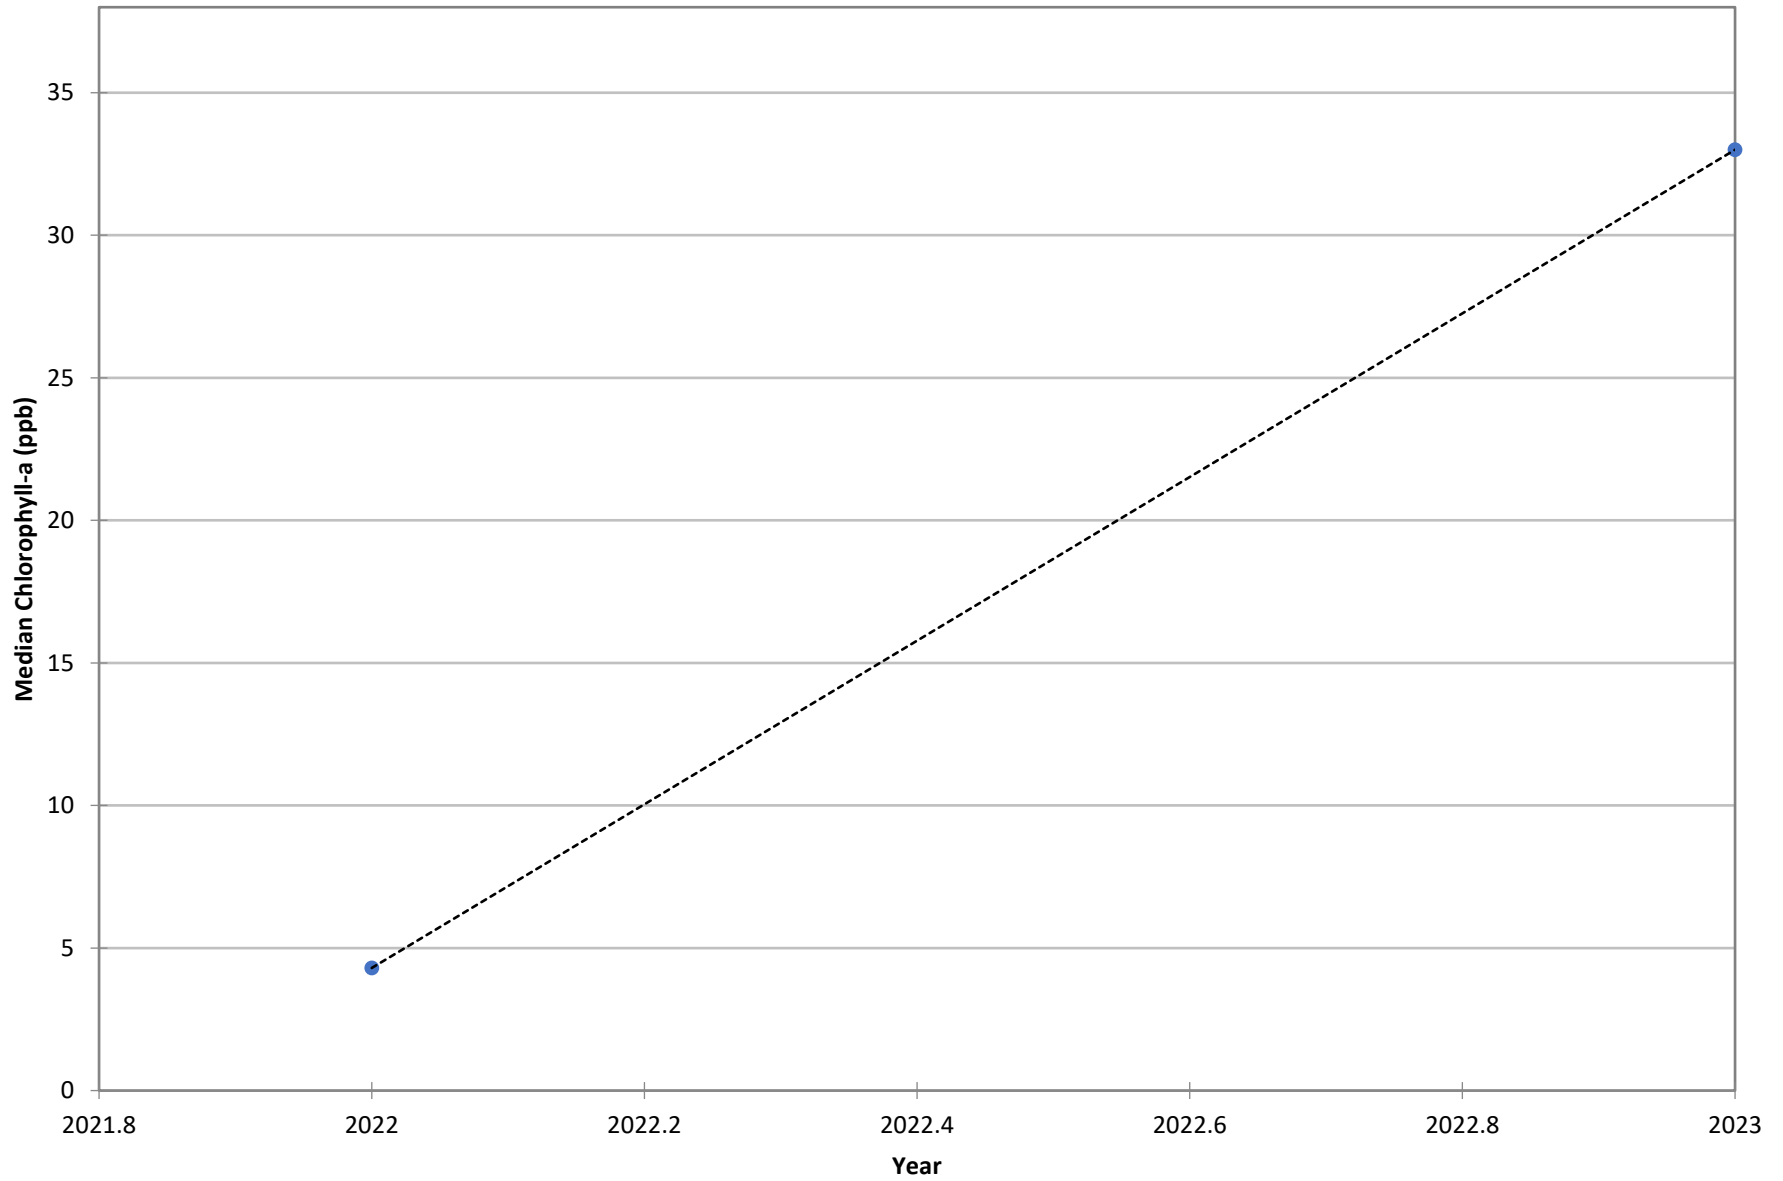
Fox Lake (Muskegon Co.), 610321

COOPERATIVE LAKES MONITORING PROGRAM
SUMMER MEDIAN CHLOROPHYLL-A
