# 2023 Data Report for

# Fremont Lake, Newaygo County

Site ID: 620029

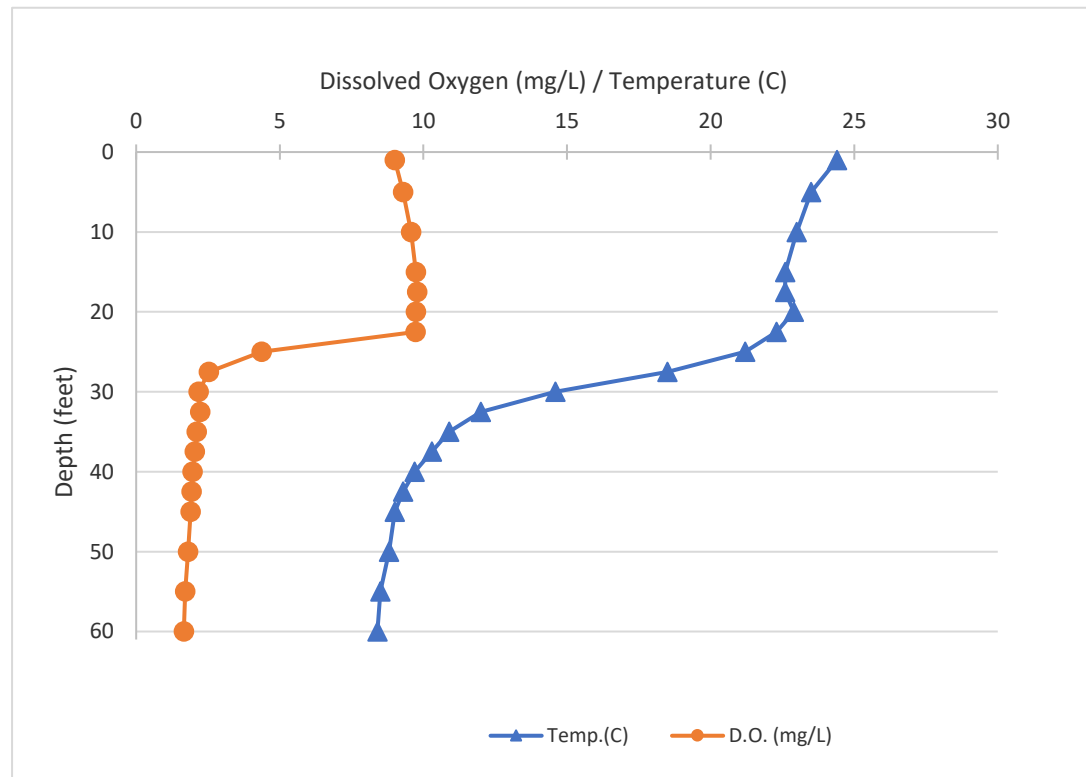
9/8/2022

### Dissolved Oxygen and Temperature Profile

Depth (ft)	Temp.(C)	D.O. (mg/L)
1	24.4	9
5	23.5	9.3
10	23	9.57
15	22.6	9.74
17.5	22.6	9.79
20	22.9	9.74
22.5	22.3	9.73
25	21.2	4.37
27.5	18.5	2.53
30	14.6	2.17
32.5	12	2.23
35	10.9	2.11
37.5	10.3	2.04
40	9.7	1.96
42.5	9.3	1.93
45	9	1.9
50	8.8	1.81
55	8.5	1.71
60	8.4	1.66
