2023 Data Report for Grass Lake, Gladwin County

Site ID: 260158

Grass Lake, Gladwin County 2023 CLMP Results

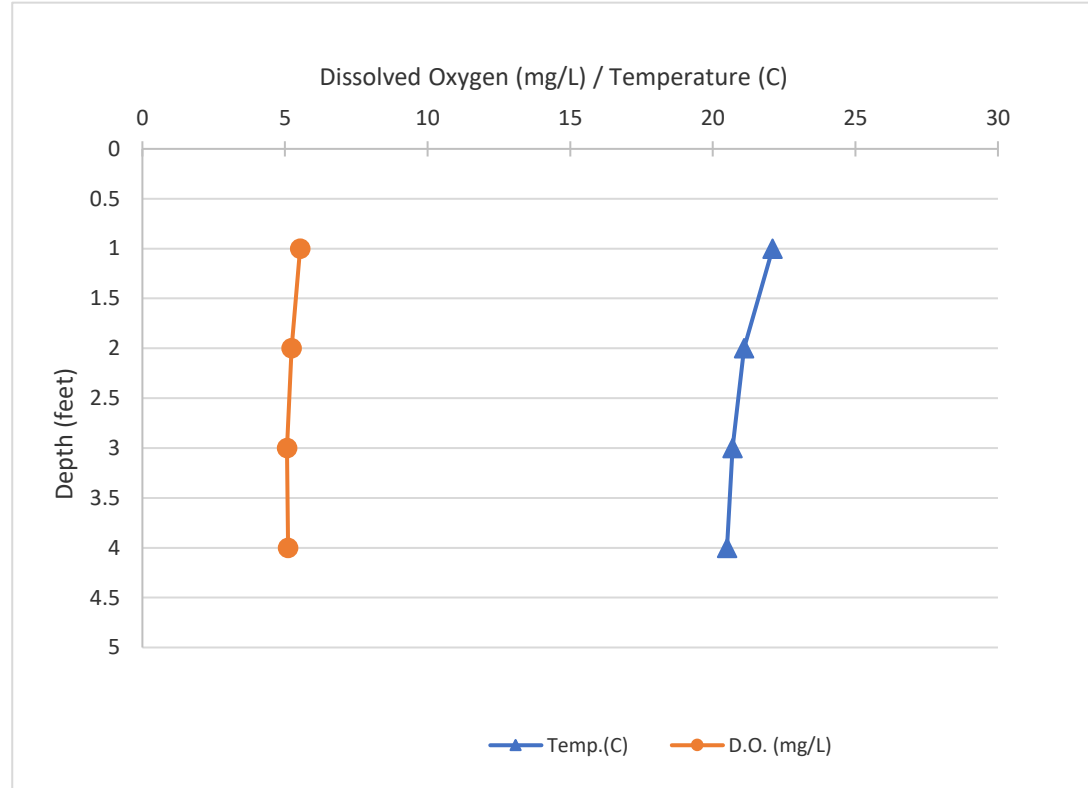
Dissolved Oxygen and Temperature Profile

Depth (ft)	Temp.(C)	D.O. (mg/L)
1	22.1	5.53
2	21.1	5.23
3	20.7	5.07
4	20.5	5.11
