2023 Data Report for Hubbard Lake, Alcona County

Site ID: 010106

Hubbard Lake, Alcona County 2023 CLMP Results

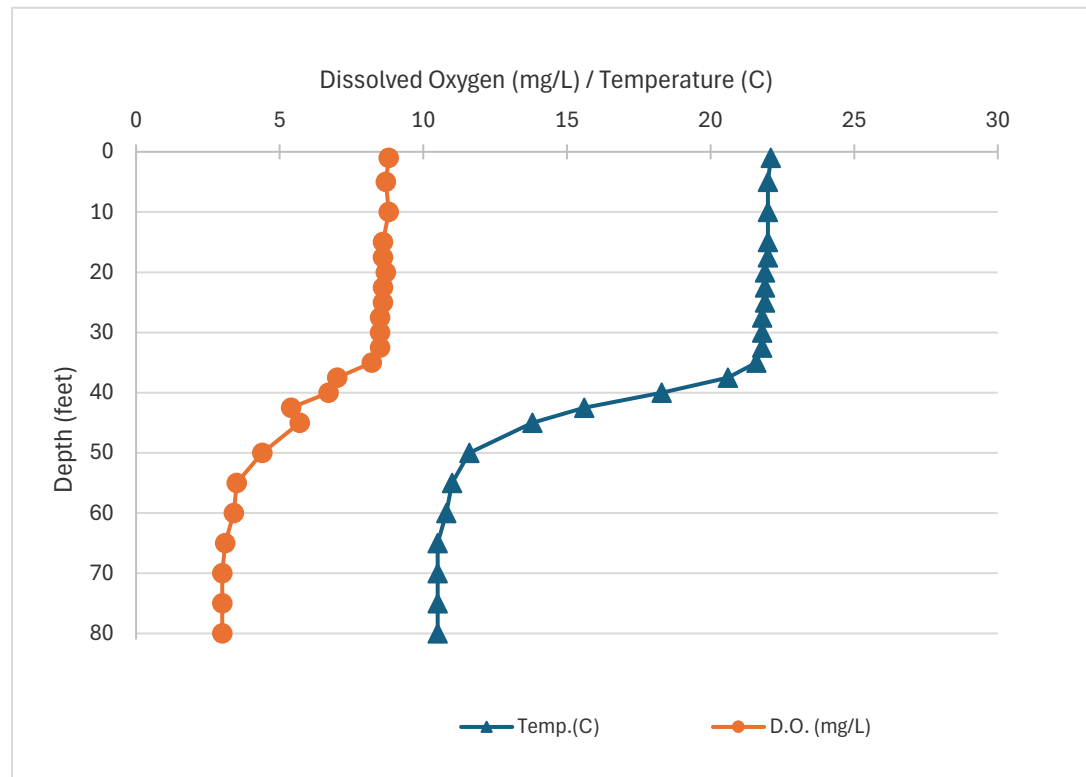
9/12/2016

Dissolved Oxygen and Temperature Profile

Depth (ft)	Temp.(C)	D.O. (mg/L)
1	22.1	8.8
5	22	8.7
10	22	8.8
15	22	8.6
17.5	22	8.6
20	21.9	8.7
22.5	21.9	8.6
25	21.9	8.6
27.5	21.8	8.5
30	21.8	8.5
32.5	21.8	8.5
35	21.6	8.2
37.5	20.6	7
40	18.3	6.7
42.5	15.6	5.4
45	13.8	5.7
50	11.6	4.4
55	11	3.5
60	10.8	3.4
65	10.5	3.1
70	10.5	3
75	10.5	3
80	10.5	3
