# 2023 Data Report for Kassuba Lake, Otsego County

Site ID: 690170

# Kassuba Lake, Otsego County 2023 CLMP Results

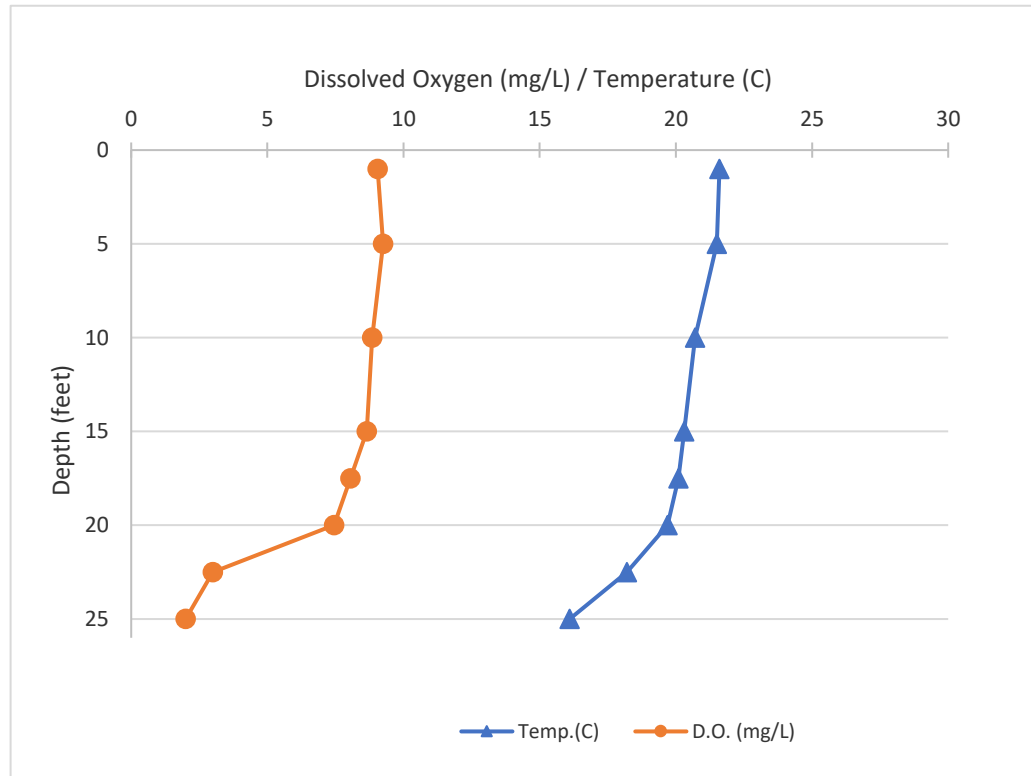
Name: Kassuba Lake  
County: Otsego  
Site ID: 690170  
Date: 9/3/2023

Depth (ft)	Temp.(C)	D.O. (mg/L)
1	21.6	9.05
5	21.5	9.25
10	20.7	8.85
15	20.3	8.65
17.5	20.1	8.05
20	19.7	7.45
22.5	18.2	3
25	16.1	2

This lake stratifies in late summer and remains stratified into early fall. The data indicate that despite stratification, this lake maintains some oxygen in the bottoms waters throughout the monitoring season.
