2023 Data Report for

Kimball Lake, Newaygo County

Site ID: 620276

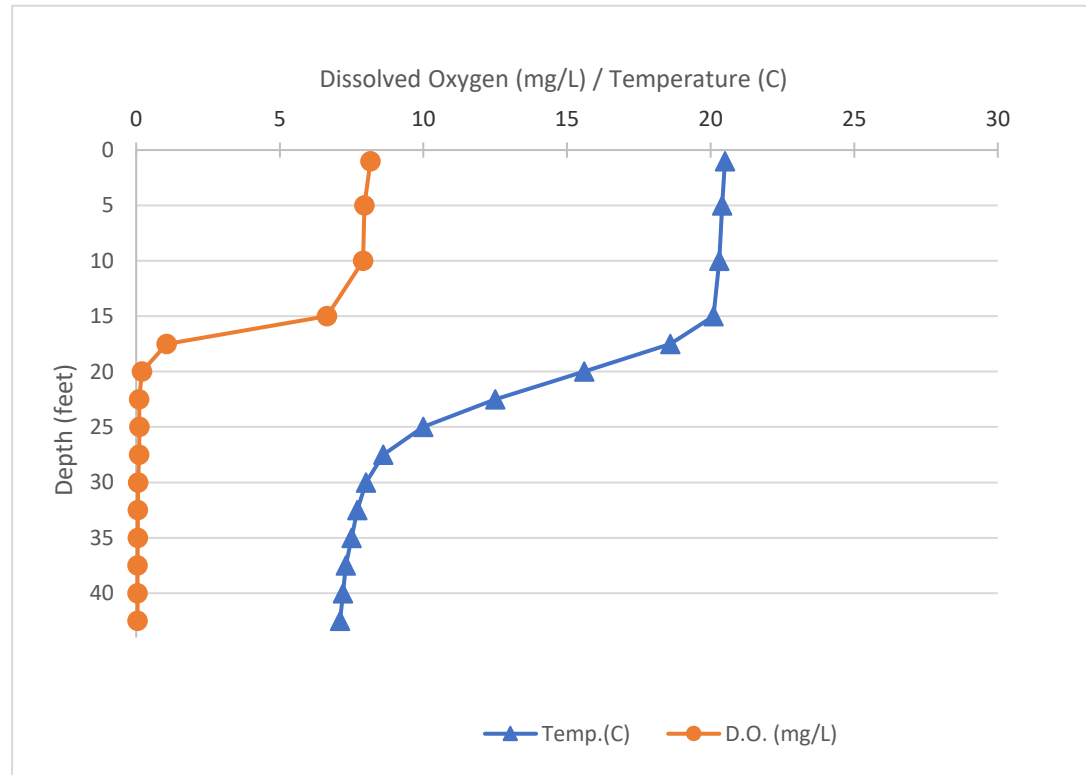
9/16/2023

Depth (ft)	Temp.(C)	D.O. (mg/L)
1	20.5	8.16
5	20.4	7.95
10	20.3	7.9
15	20.1	6.64
17.5	18.6	1.06
20	15.6	0.2
22.5	12.5	0.1
25	10	0.11
27.5	8.6	0.1
30	8	0.07
32.5	7.7	0.06
35	7.5	0.06
37.5	7.3	0.05
40	7.2	0.05
42.5	7.1	0.05
