2023 Data Report for

Lake Lancer, Gladwin County

Site ID: 260116

Lake Lancer, Gladwin County 2023 CLMP Results

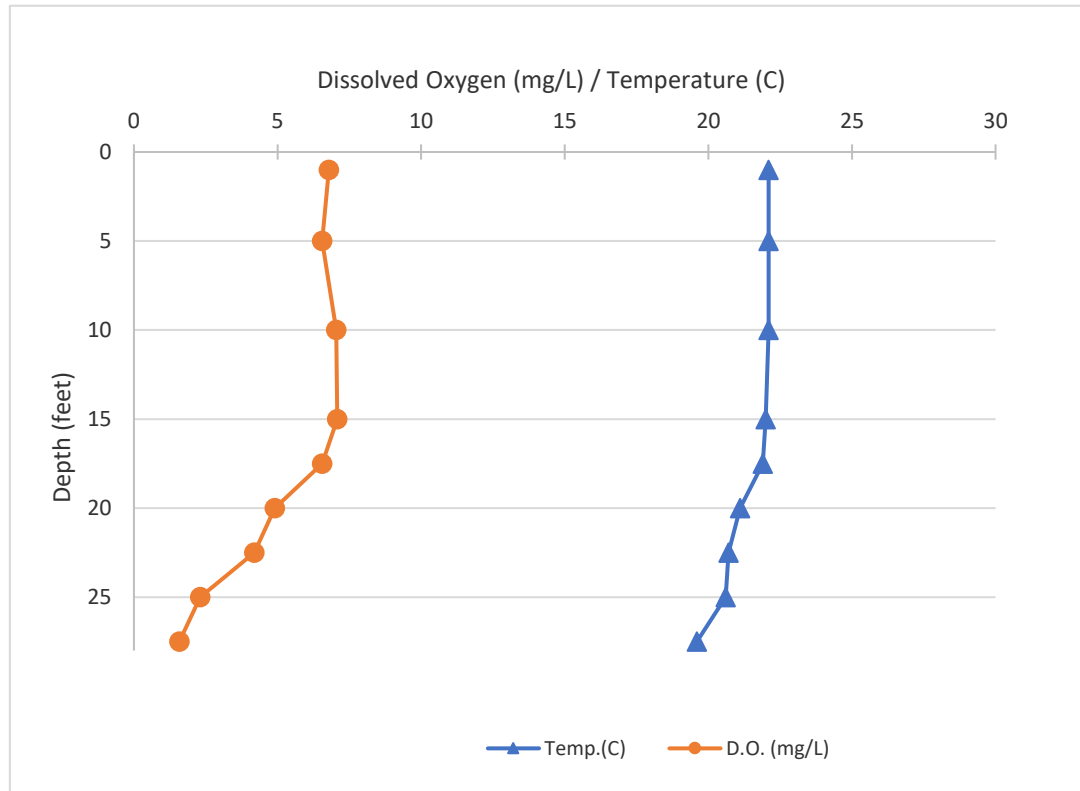
Name: Lake Lancer
County: Gladwin
Site ID: 260116
Date: 9/8/2023

Depth (ft)	Temp.(C)	D.O. (mg/L)
1	22.1	6.79
5	22.1	6.55
10	22.1	7.04
15	22	7.08
17.5	21.9	6.55
20	21.1	4.9
22.5	20.7	4.19
25	20.6	2.31
27.5	19.6	1.58
