2023 Data Report for Long Lake, Benzie County

Site ID: 100270

Long Lake, Benzie County 2023 CLMP Results

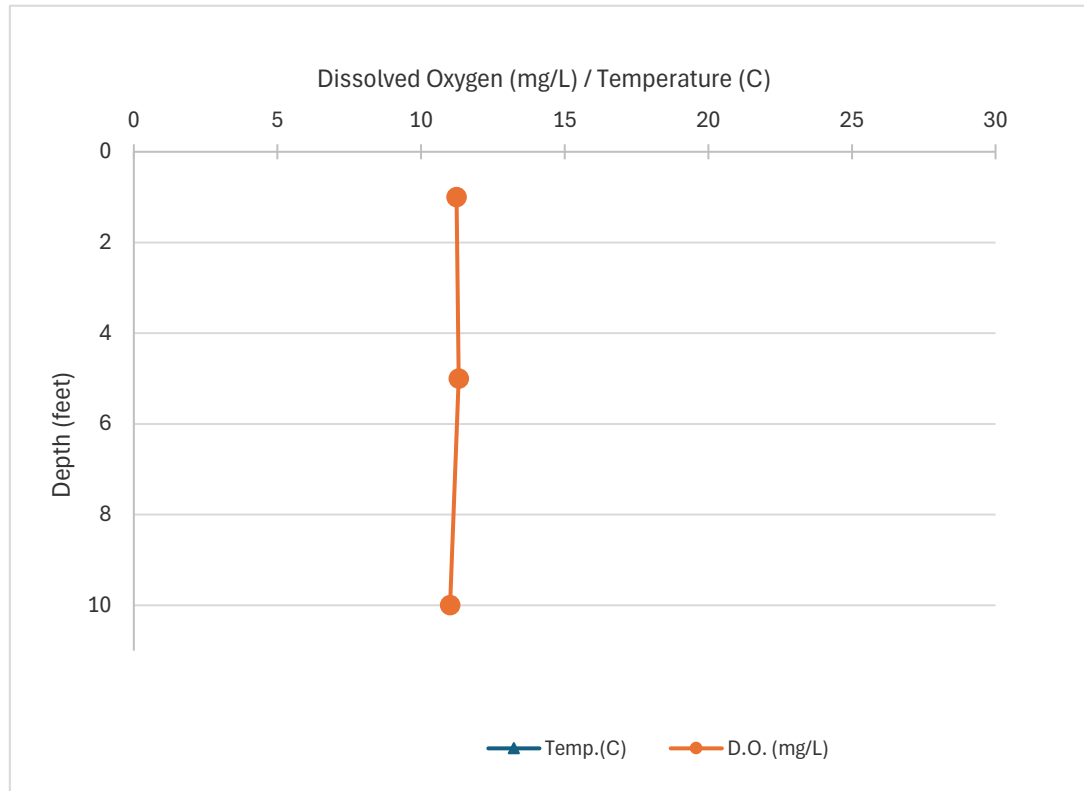
Dissolved Oxygen and Temperature Profile

Name: Long Lake
County: Benzie
Site ID: 100270
Date: 9/30/2022

Depth (ft)	Temp.(C)	D.O. (mg/L)
1	57.1	11.24
5	56.8	11.31
10	54.4	11.01
